300Z's

Major Overhaul

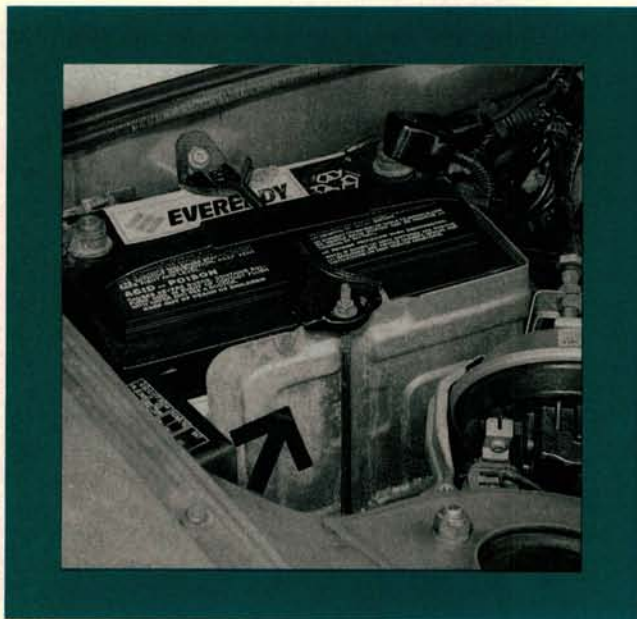
1 It's plenty hot under the 300's low hood. Batteries can have a shorter than normal service life as a result. Battery shields on later models deflect some of the heat. Replacement batteries may be shorter than the original. Install the available spacer below the battery for proper mounting.

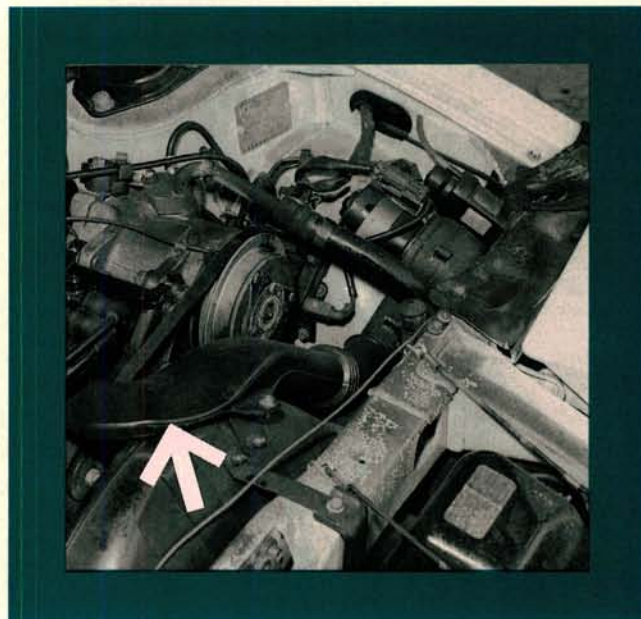
2 High underhood heat can also cause hot restart difficulty. Fuel containing alcohol seems to aggravate the restart problem. Later models use a bottom feed injector design to prevent vapor lock and fuel boiling. The injector cooling fan (arrow) on turbo models also helps.

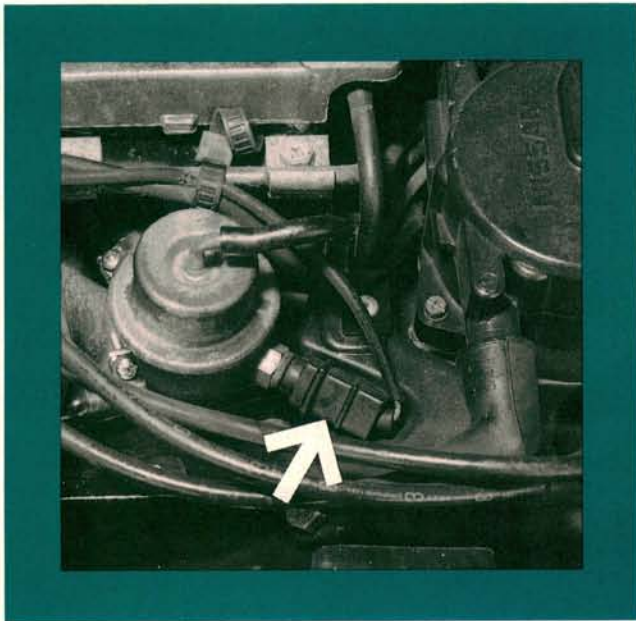
3 This sensor in the fuel pressure regulator monitors fuel temperature. During hot restarts, the ECU closes the pressure regulator control vacuum solenoid valve to raise the fuel pressure and prevent vapor lock. This system wasn't 100 percent effective on 1984 models and was modified on later models.

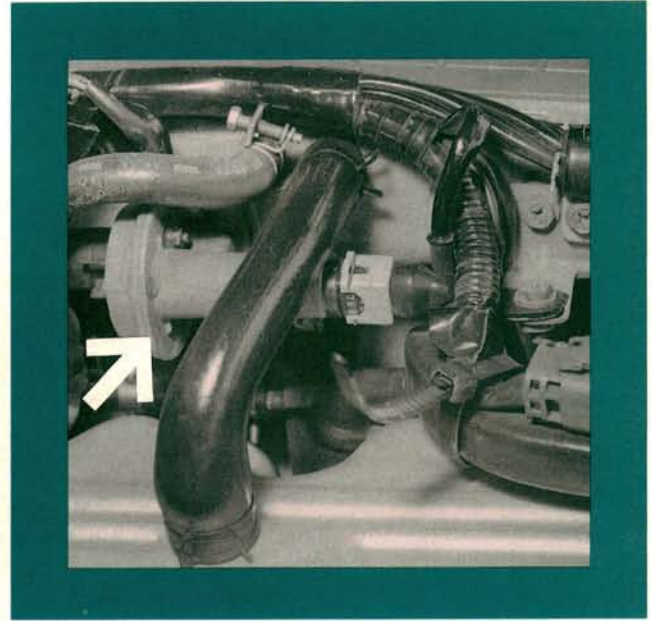
4 A sluggish cold air regulator will cause a low idle speed when cold. The engine may also load up and stall due to the extra cold enrichment. The regulator must open so air can bypass the closed throttle plate. Cleaning the valve seldom helps. A weak bimetal spring is usually to blame.

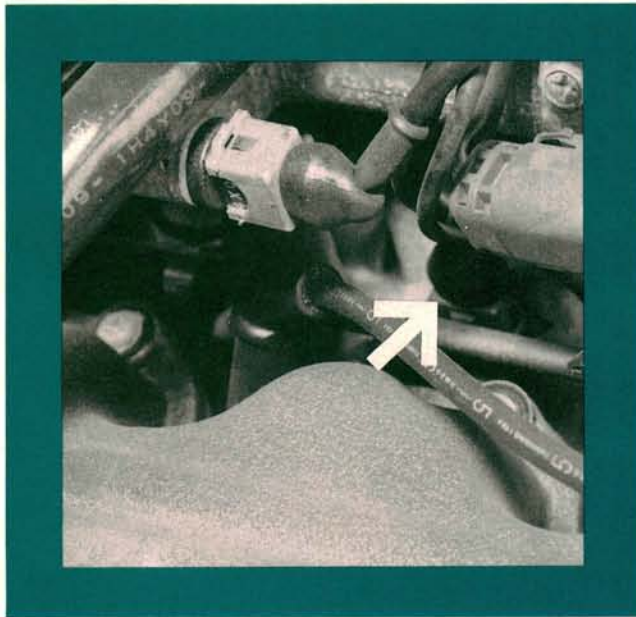
5 The injectors are buried under the intake plenum. Injector harness connector corrosion can be a problem, especially in humid climates. The connectors may look fine, but even a small voltage drop can cause an intermittent miss. Solder all connections and use shrink wrap when replacing connectors.

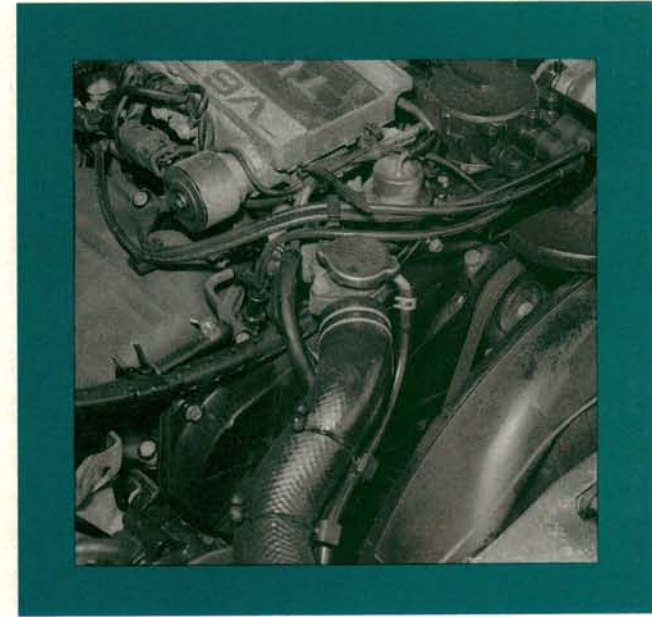
6 Timing belt replacement is an important preventive maintenance service at 60,000 miles or sooner. This engine can bend internal moving parts in an expensive fashion if the belt breaks. We've also heard reports of head bolts breaking, then jamming the camshaft and stripping the timing belt.

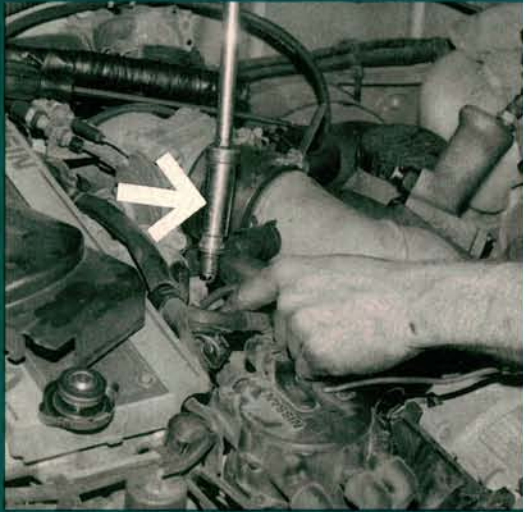
7 Changing the spark plugs can be a challenge. This swivel socket with attached extension helps a lot. Road dirt and other unfriendly debris may settle in the recessed areas around the spark plugs. To avoid internal engine damage, clean these areas with compressed air before removing the plugs.

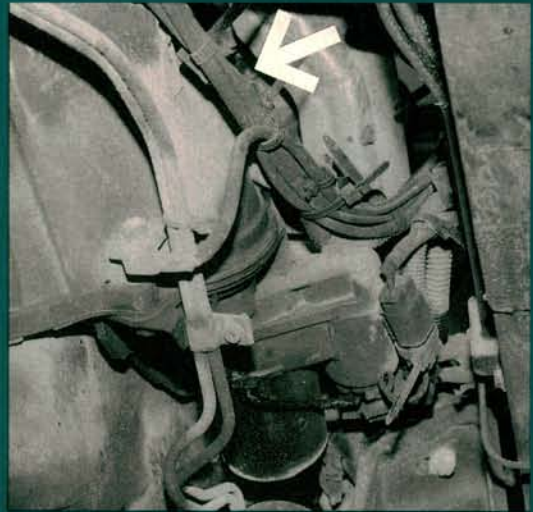
8 Replacing the oil filter below the right exhaust manifold also takes patience, especially when the engine is hot. A cap socket that grabs the end of the filter works best because there's not enough room for a strap wrench. Removing the filter from below using a flex ratchet is less messy than from above.

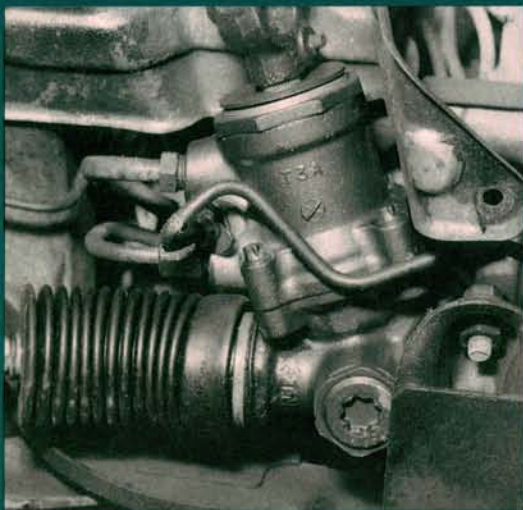
9 Power steering rack leaks have been a common occurrence on 300's. If the rack shaft seals are leaking, the boots will be filled with fluid. Visually inspect the rest of the rack for leakage. Use care when installing the hose fittings, the aluminum housings will crack or cross thread very easily.

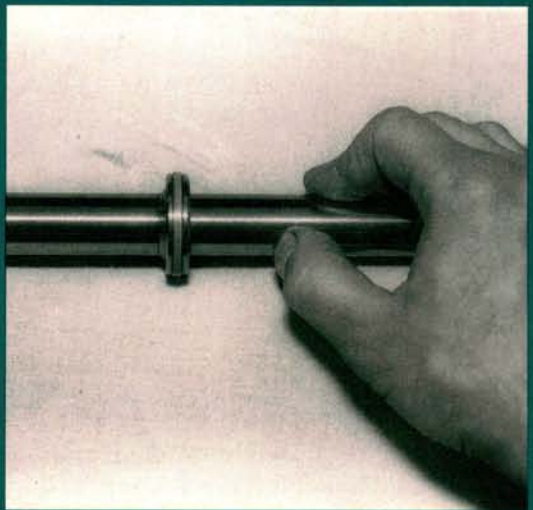
10 Rack repair or replacement is a judgement call. Replacement parts are available if you go the repair route. Installing new seals with worn rack parts will guarantee a comeback. Run your finger nail over the rack shaft. Even a small amount of rack shaft wear will cause seal leakage later.

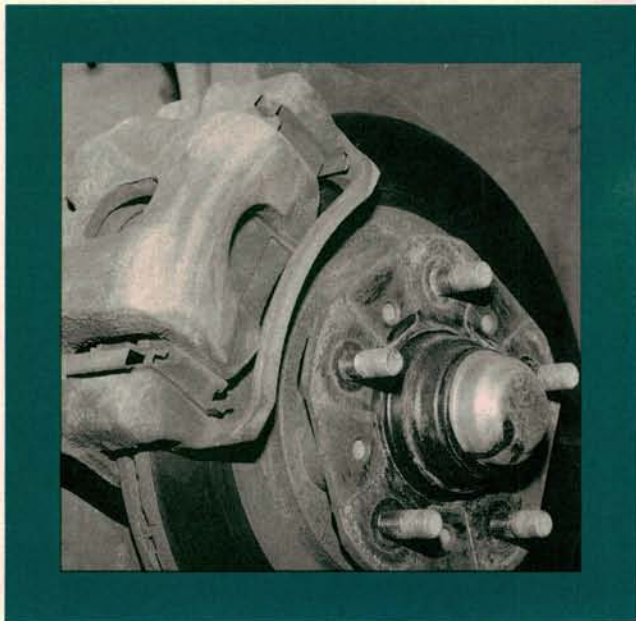
11 Rotor thickness variations caused brake pulsation problems on some 300's. Factory "countermeasure" rotors that are machined to closer production tolerances (0.0005 mm) are available to correct this problem. These rotors should not be turned before installation. Most brake lathes can't match this accuracy.

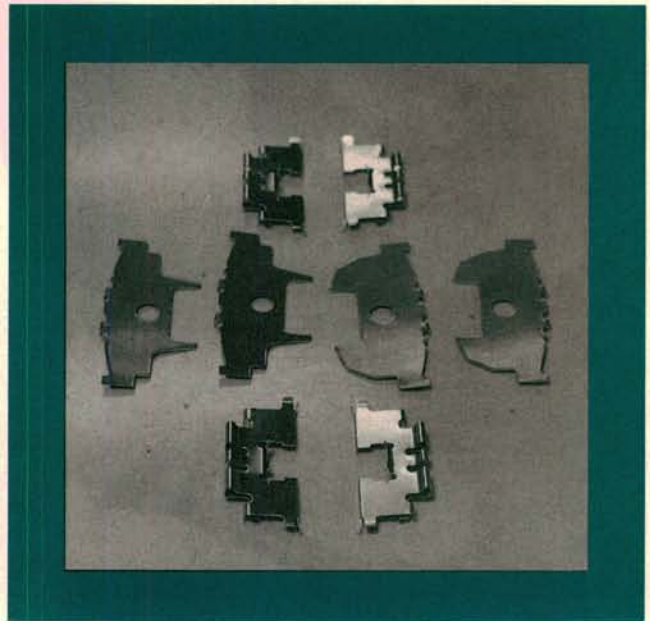
12 The condition of front and rear brake hardware can have a big effect on brake noise. Brake shims get rusty and disappear in cold weather states. Worn rear brake slide pins will cause a rattling noise over bumps. The noise goes away if you apply the brakes slightly. Slide pins are not available separately.

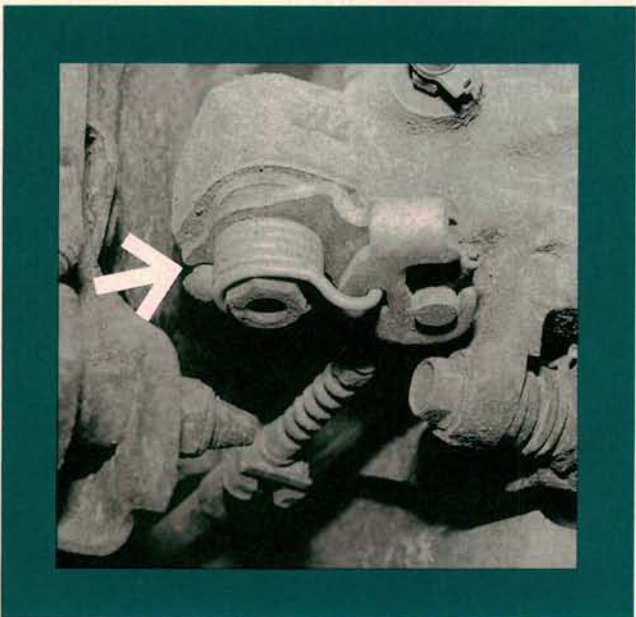
13 Make sure the parking brake mechanism operates smoothly. Binding parking brake cables accelerate rear brake pad wear. There should be 0-3 mm clearance between the rear caliper parking brake lever and the stopper pin when the parking brake is released. Rusted cables are common.

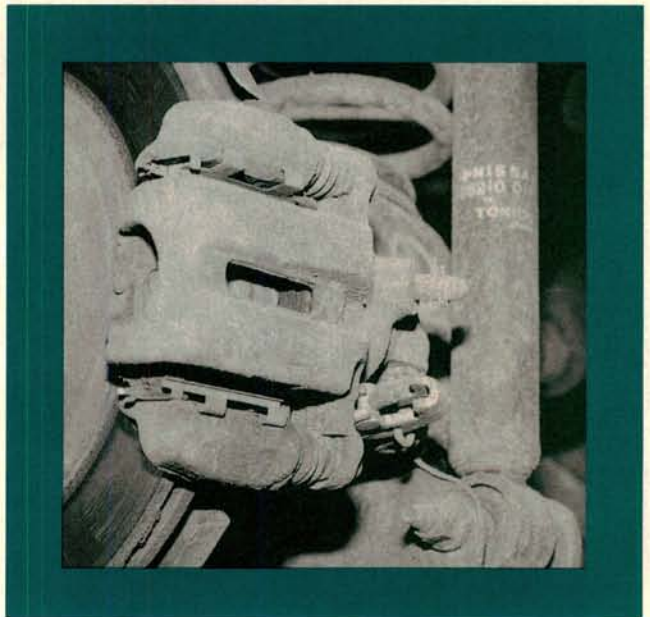
14 Dragging brakes may also be caused by a caliper parking brake mechanism that is binding internally. Disconnect the parking brake cable. If the caliper lever now moves freely, the cable is to blame. If the lever still doesn't release completely, the problem is inside the caliper.

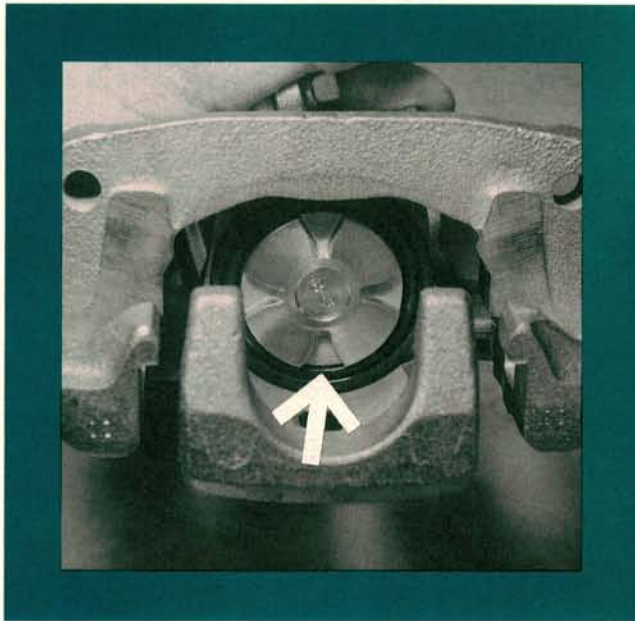
15 Before new rear pads can be installed, the caliper pistons must be turned clockwise to retract the pistons into the calipers. Check behind the dust shield before turning the piston. Rear calipers may begin to leak after piston retraction if the seals are weak or the pistons are rusted.

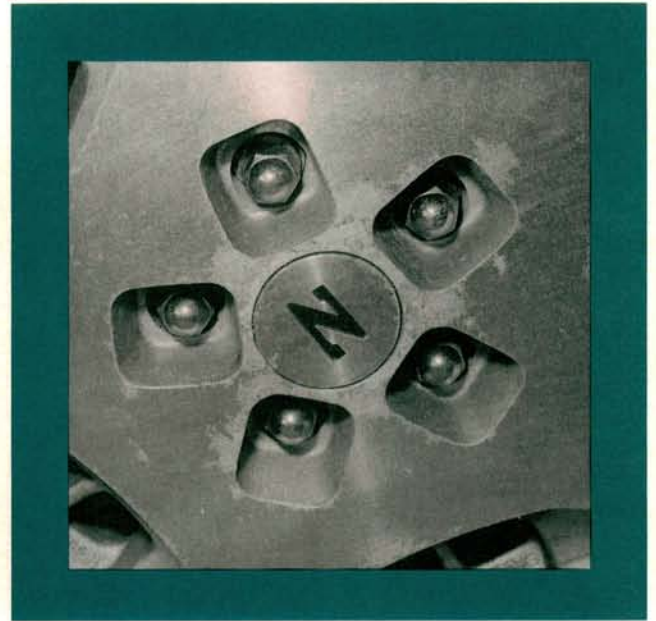
16 Start the lug nuts by hand, then tighten in a diagonal pattern to avoid cross threading, wheel damage, and rotor warpage. The alloy wheels are centered by the lug nuts, not the hub flange, so the lug nuts must be tightened alternately and evenly to center the wheel. Finish the job with a torque wrench.

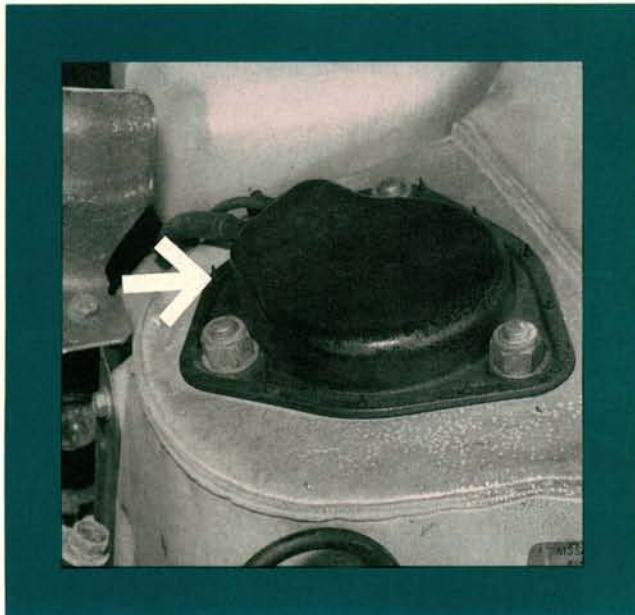
17 Rear shocks seem to wear out and leak more quickly than the front struts. The rear suspension may bottom over large bumps after the fluid leaks out. The electrically adjustable struts and shocks (arrow) on turbo models can be very expensive to replace. Always support the rear suspension before removing a rear shock.

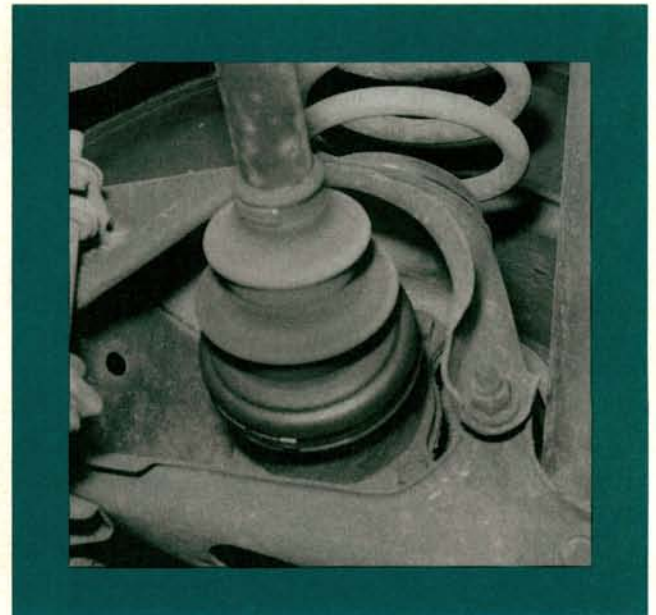
18 A clicking noise from the rear during acceleration and deceleration may have two different causes. Worn rear CV joints are responsible in some cases. The spacer between the inner and outer wheel bearings may also shift and click. An updated axle flange and revised torque specifications were introduced to correct this problem.

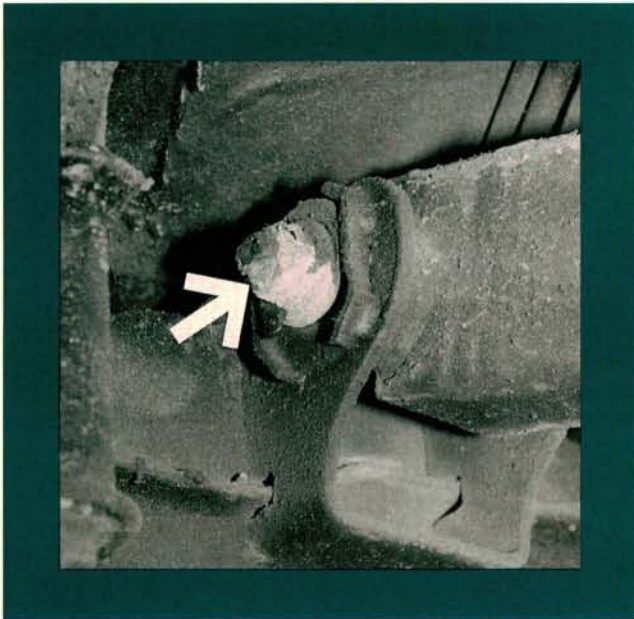
19 Front and rear toe are the only adjustable alignment specifications. Rear toe is adjusted by turning this eccentric bolt at the inner pivot point of the lower control arm. Weak rear springs can affect ride height and will cause camber and toe changes and accelerated rear tire wear.

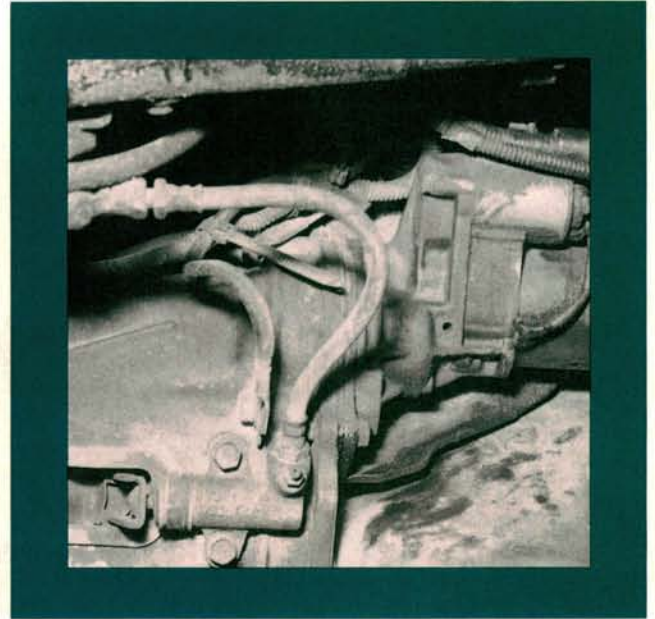
20 Transmission removal and clutch replacement doesn't get much easier than this rear drive setup. To avoid hard shifting complaints, always use the correct lube in manual transmissions. Many complaints (especially in cold weather) are caused by using the wrong gear lube instead of the specified 75W-90 or 80W-90.

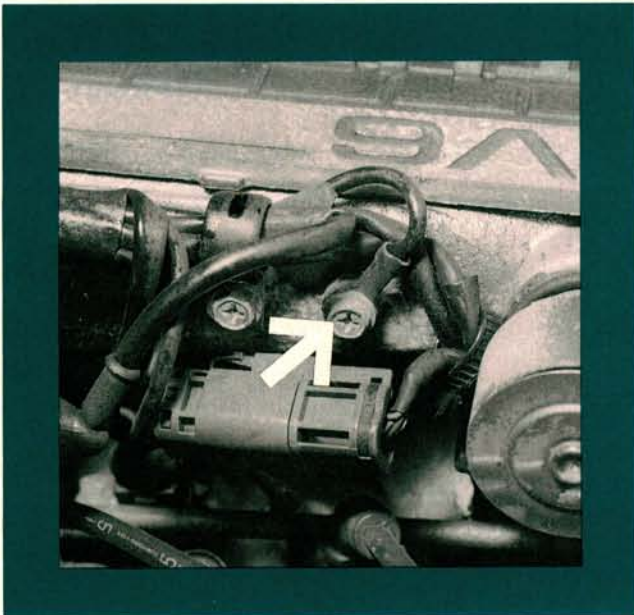
21 Electrical problems aren't as common as you might expect for a car with so many accessories crammed into such a small area. An important ECCS grounding terminal is located at the corner of the intake manifold (arrow). A loose or dirty connection here can cause rough running and stalling at idle.

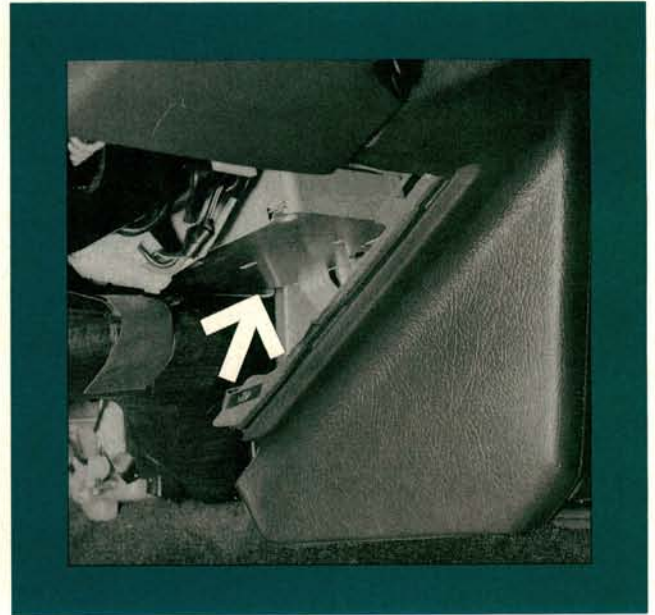
22 The diagnostic pages for the digital dash board are long enough to make a nice small town phone book. Display problems may be caused by poor solder connections inside the control unit (arrow). Check the control unit circuit board for opens if you're feeling brave and want to save the customer some money.
