Dual Citizenship

Service Tips

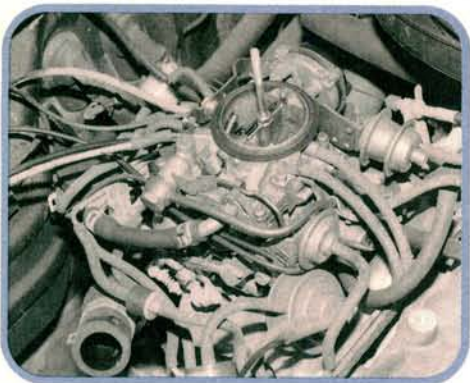
5

A factory modification kit is available to correct hesitation problems on carbureted models. The kit modifies the primary and secondary fuel circuits, accelerator pump, altitude compensator, and power circuit. This 1986 Nova has already had the kit components installed.

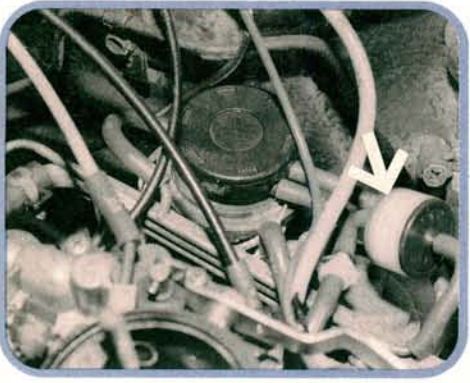
7

An overactive EGR valve may also cause a hesitation during light acceleration on 1985-86 models. EGR vacuum modulator restrictor kits were offered separately, then as part of the carburetor modification kit. Install the restrictor between the "R" port on the EGR vacuum modulator and the carburetor EGR port.

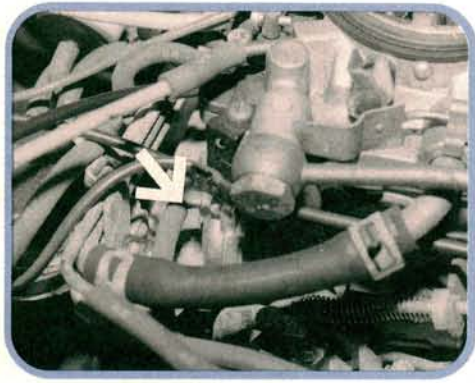
8

A leaking auxiliary accelerator pump (AAP) diaphragm will cause the engine to run very rich during warmup and may also affect warm operation. Locate the AAP at the rear of the carburetor (arrow), then remove its vacuum hose. If the vacuum hose is wet with fuel, the AAP diaphragm must be replaced.

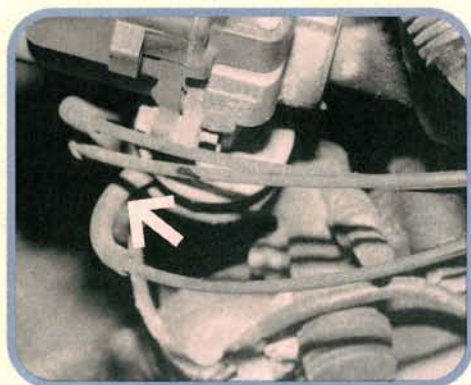
9

Fuel from a leaking AAP can turn up in some pretty out of the way places. Remove the vacuum hoses from the distributor vacuum advance canisters. If you find fuel in the hoses, test the advance mechanisms with a vacuum pump. The leaking AAP fuel may have damaged the vacuum advance diaphragms.

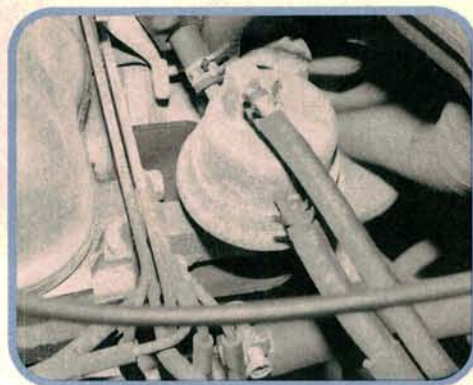
10

Look for telltale fuel stains around the underside of the fuel pump if a customer complains of a fuel smell while driving. Heat from the engine may evaporate the small amount of fuel leaking from the fuel pump diaphragm before the fuel has a chance to form a puddle on the ground.

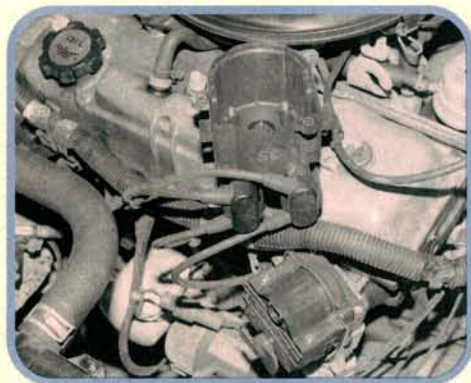
11

The Corolla/Nova's engine is equipped with Toyota's Integrated Ignition Assembly (IIA) distributor. Remove the distributor cap during a major service to check the pickup coil wiring. Vacuum advance movement may cause the wiring to become frayed. Also check the condition of the cap and rotor.

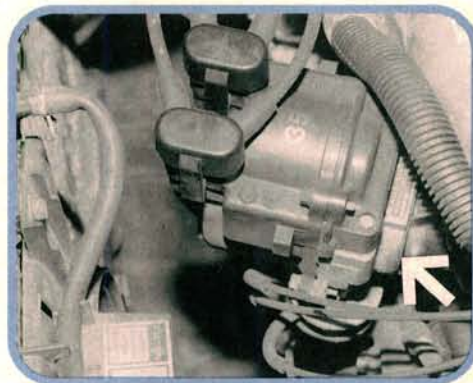
12

Ignition timing seldom requires adjustment. Even though the distributor stays put, the o-ring that seals the distributor to the cylinder head may become brittle over time and cause an oil leak. The oil leaks down the front of the head and block and can easily be misdiagnosed as a leaking head gasket.

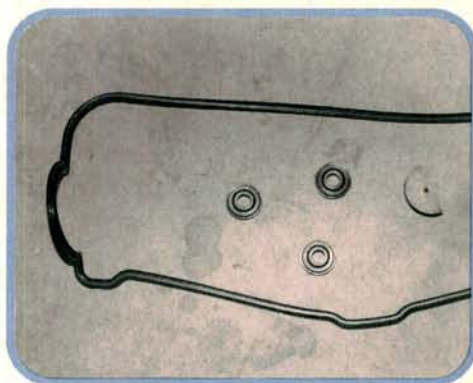
14

The valve cover is sealed to the head by a one piece formed rubber gasket and grommets. Our valve cover gasket had been reused after the last valve adjustment and had begun leaking at the front corner. Over-tightening the valve cover nuts to compensate for a worn gasket may distort the valve cover.

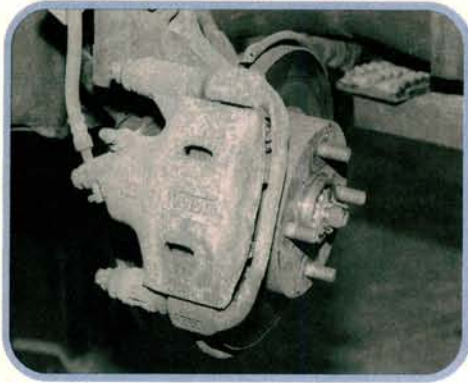
15

Rotor thickness variations may cause brake pulsations on some Corolla/Nova models. Thickness variations shouldn't be confused with rotor runout, although there is a cause and effect relationship. Excessive rotor runout leads to uneven pad contact and rotor wear, resulting in rotor thickness variations.

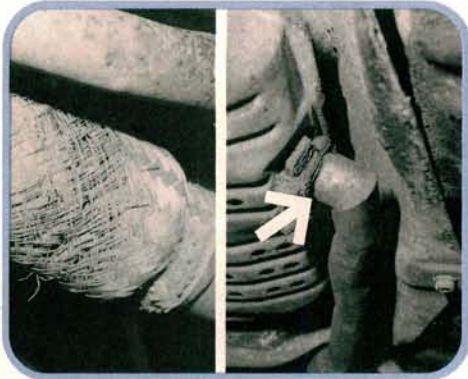
17

Ohio winters have taken their toll on the exhaust system of this low mileage car. The stainless steel webbing has torn away on the front flex pipe, revealing the accordion tubing (left photo). Further back, the small air inlet fitting at the catalytic converter also looks rather shaky (right photo).

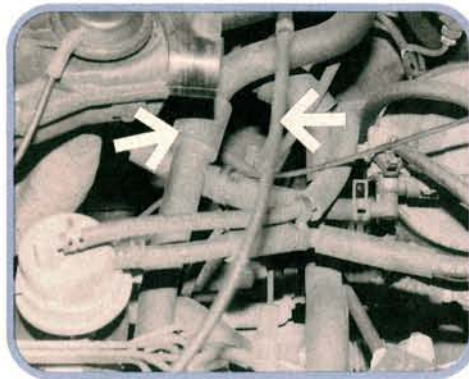
20

Mismatched counter gears may cause a high pitched whine at highway speeds on automatic transaxle models. Different versions of this transaxle are used in Camry, Celica, and MR2 models. These transaxles may also have similar noises. For a detailed look at this transaxle family, consult the May 1988 and February 1991 issues of *Import Service*.

The transaxle counter gears can cause a high pitched whine at highway speeds or a speedometer cable noise on 1985-88 automatics. A two piece speedo cable is available to correct this problem. Tie wrap the two piece cable to the heater hose. If the noise continues, replacement counter gear sets are available.

The factory came out with a two piece speedometer cable for the 1986 Corolla/Nova that was designed to isolate the counter gear noise from the passenger compartment. This cable can also be installed on early models. If cable replacement doesn't successfully isolate the noise, matched sets of replacement counter gears are also available.

The two piece speedometer cable may cause an entirely different rattling noise in the instrument cluster area if the cable isn't properly installed. To eliminate the noise, tie wrap the speedometer cable to the thick reinforced section of the heater hose, near the brake booster. To properly isolate the rattling noise, the center connection of the two piece cable shouldn't contact the thick section of the heater hose after the tie wrap is tightened.
