TURBOCHARGER PARTS CLEANING

TOYOTA WIRING HARNESS REPAIR

VOLVO DIESEL NO-START

DIGIFANT FLOODING

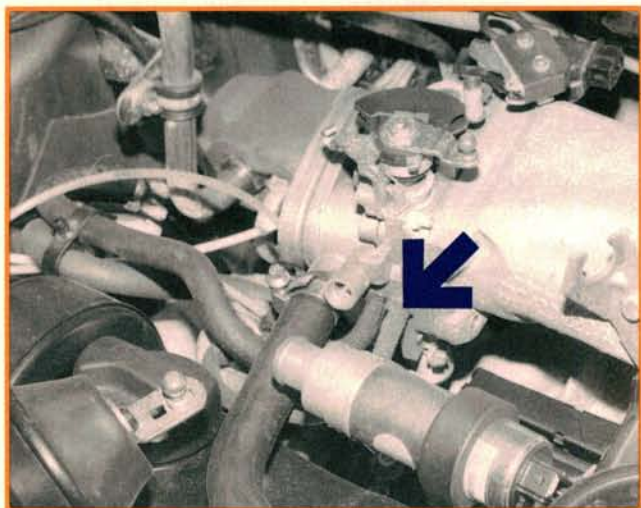
A leaking fuel pressure regulator may cause flooding in number 1 and 2 cylinders on Volkswagen models equipped with Digifant fuel systems. I repaired a Jetta with this problem. The car kept running, even after the fuel rail wiring harness connector was disconnected.

Don't assume that stuck fuel injectors are causing the problem. Remove the fuel pressure regulator vacuum line and check for fuel in the line. The vacuum line is attached to a vacuum port that's very near to the number 1 and 2 intake runners. Engine vacuum and fuel pressure force the fuel through the vacuum line from the leaking pressure regulator to the vacuum port. The extra fuel leaks into the intake manifold and causes number 1 and 2 cylinders to flood.

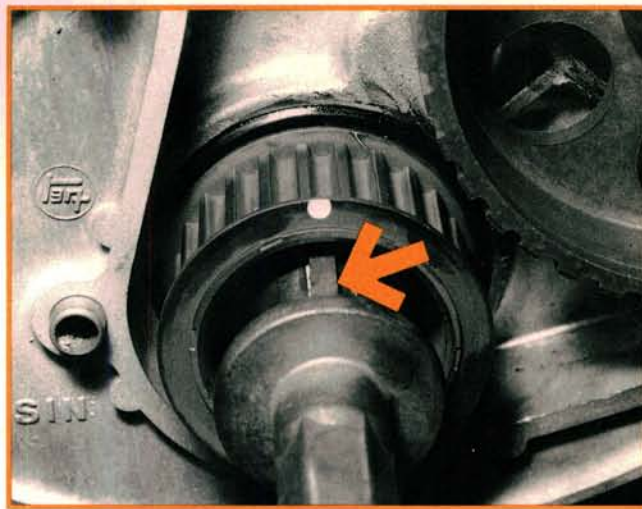
CRESSIDA CRANKSHAFT TIMING GEARS

A severe power loss on 1982 and later Toyota Supras and Cressidas equipped with 5M-GE engines may be caused by a sheared crankshaft timing sprocket key. The valve timing may or may not appear to be correct because the broken key allows the crankshaft timing sprocket to rotate on the crankshaft without disturbing the timing belt.

If you suspect that the crankshaft sprocket key has broken, the only way to check it is to remove the crankshaft timing sprocket. The sprocket may seem to fit tightly on the crank, and may lead you to believe that the key is okay. Remove the sprocket, then replace both crankshaft keys and the crankshaft seal.
