— By Karl Seyfert

# Saab 9000

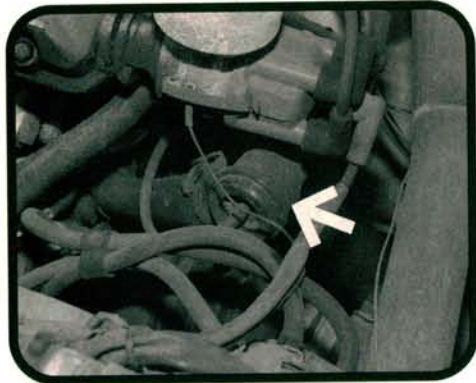
1

Turbo models use a vacuum controlled air bypass valve to redirect unneeded turbo boost to the turbo suction inlet during deceleration. A broken vacuum diaphragm inside the plastic valve can cause stalling problems during decel or an irregular idle speed. The plastic hose clamps may also break.

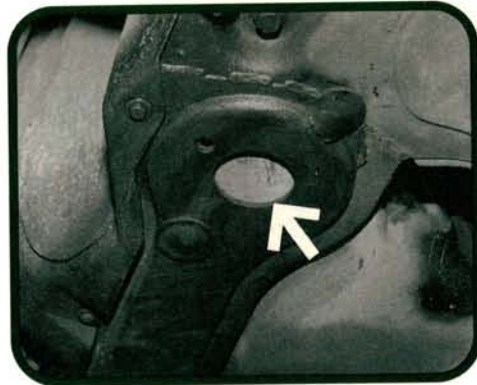
2

Both lower motor mounts at the right side of the engine bay are oil filled. The rubber mount seals may crack over time. The oil leaks out, causing extra engine vibration. A leaking front mount will lubricate the underside of the frame rail. The rear mount is fully exposed and easier to check.

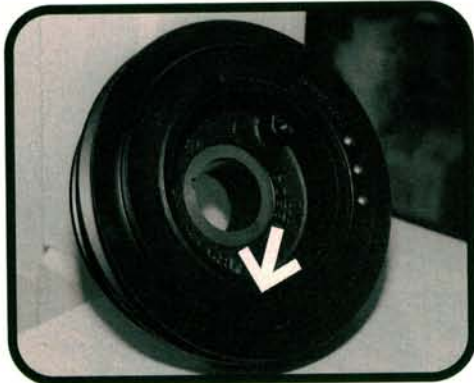
3

A squealing noise during cold starting probably means the rubber center has torn out of the crankshaft pulley. On early models, an outer pulley bolted to the main pulley. This kept the damaged main pulley from walking off the crank. Later pulleys and all replacement parts are a one piece design.

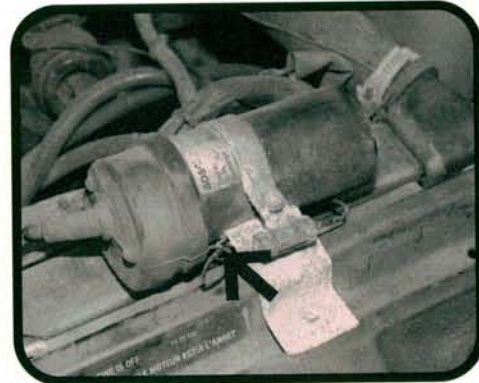
4

The ignition coil on pre-Direct Ignition models is mounted on top of the radiator core support. A broken radio noise suppressor wire on the positive side of the ignition coil may ground against the body, blowing the ignition fuse. Cut the broken wire at the coil terminal or replace the suppressor.

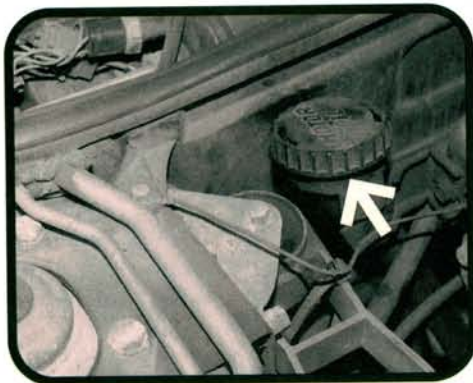
5

The combination remote oil filler neck/dipstick is located near the firewall. Be careful when filling the crankcase. The alternator is located directly below the filler. Spilled oil ends up inside the alternator. Starting the engine will cook the alternator faster than you can say "What's that smell?"

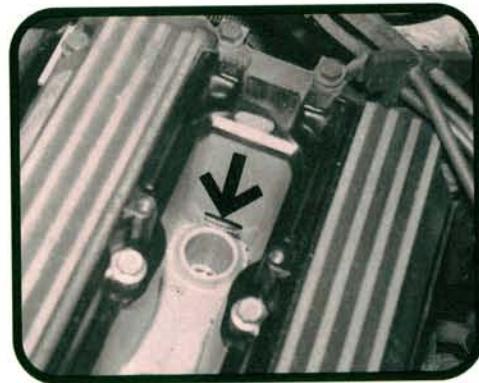
6

The valve cover is sealed by an inner and an outer o-ring. Oil from inner cover o-ring leaks will accumulate in the well between the DOHC valve cover. Saab made allowances for this problem by thoughtfully providing a drain (arrow) at the transmission end of the head.

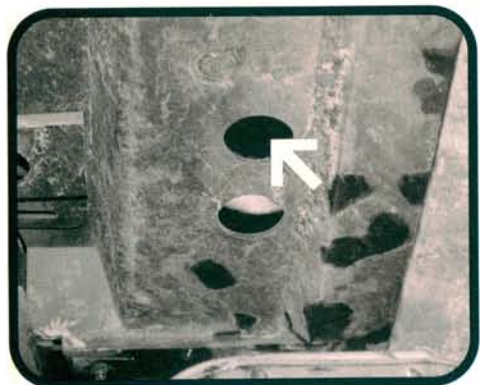
## 7

Look real hard and you might see the radiator drain plug in this photo. The plastic plug discourages overtightening but can also get brittle with age and may break if it's disturbed. To prevent an embarrassing leak a few days after a coolant flush, install a new drain plug or metal bolt.

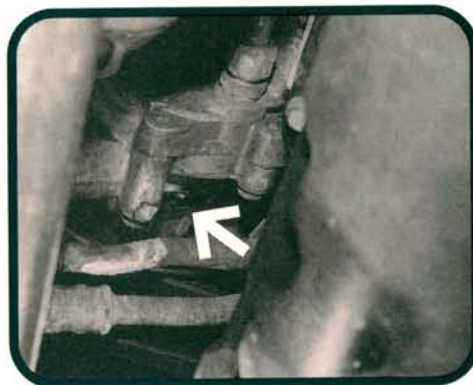
## 8

A chalky dried antifreeze deposit on the underside of the water pump may be misdiagnosed as a coolant leak. Even brand new water pumps may seep slightly to lubricate the pump seal. Watch the fluid reservoir level. The seepage should equal about a quart of coolant per 60,000 miles.

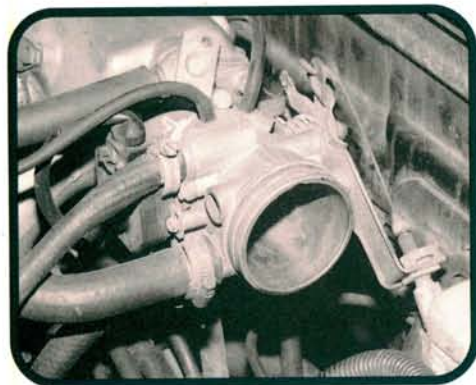
## 9

Throttle housing carbon deposits can affect the throttle switch operation. Remove the air inlet hose to clean the deposits with a rag and carburetor cleaner. Check the throttle switch and throttle stop screw for proper adjustment. Someone may have adjusted these to compensate for the deposits.

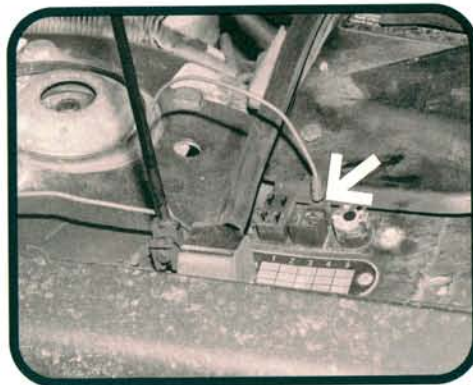
## 10

On early 9000s, ground the diagnostic terminal shown, then adjust the base idle speed. Always switch the automatic climate control to ECON before adjusting the idle speed. The climate control reverts to AUTO each time the engine is started and the compressor load will affect your idle speed adjustment.

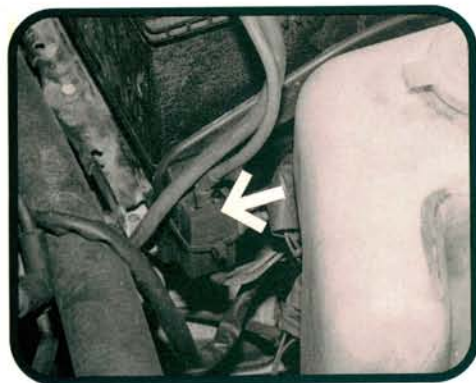
## 11

Check the ground connections next to the battery during a battery service. Many unshielded wiring harness grounds attach to the body behind the battery. Spilled battery acid and general corrosion can cause electrical problems. The positive junction below the battery (arrow) is shielded.

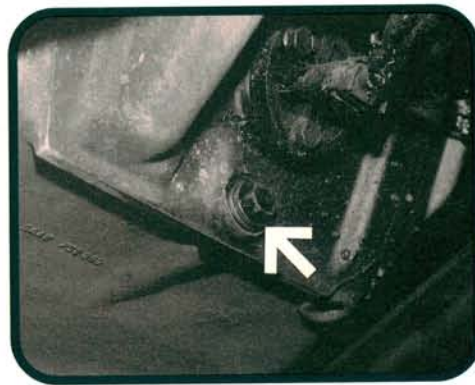
## 12

Don't overtighten the oil drain plug. The aluminum oil pan has a steel thread insert for the drain plug, so the oil pan may crack long before the threads strip from overtightening. The correct torque for the engine drain plug is 29-39 Nm (21-29 ft-lb).

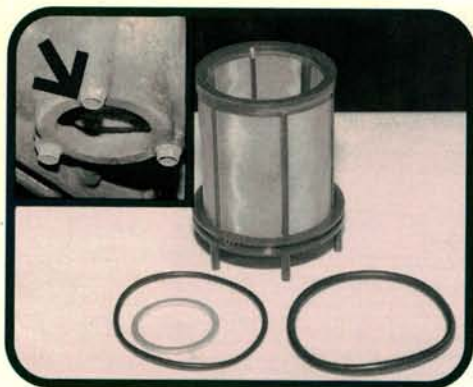
**13**

To prolong the automatic transmission life, change the fluid at least once every 30,000 miles or whenever it smells burnt. Remove these three bolts, then lower the cover to replace the round filter. The filter slides up into the transmission. Always use the new seals supplied with the new filter.

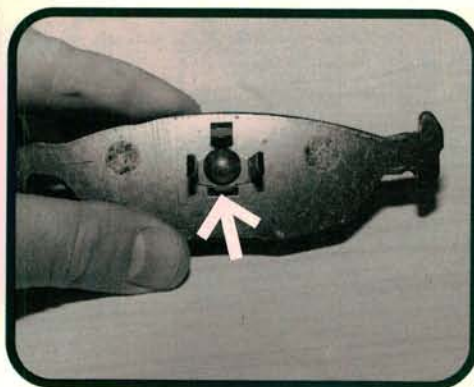
**14**

A rusted or broken anti-rattle spring clip on the inside of the inner rear brake pad will cause the pad to rattle over bumps. The clip is riveted to the pad and isn't available separately, so the pad set must be replaced if the clip breaks.

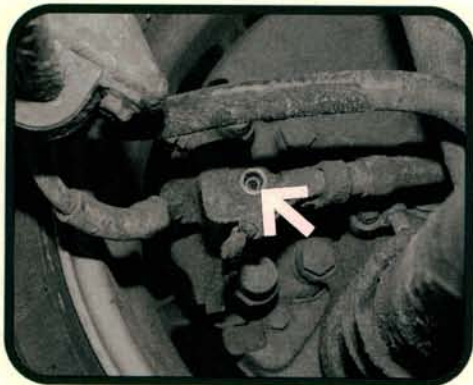
**15**

Don't retract the rear caliper piston with a C-clamp. Remove the access cover on the inside of the caliper. Then retract the piston by turning the internal hex while pushing the piston inward. With the new pads in place, tighten the screw until the brakes lock, then back off the screw about a quarter turn.

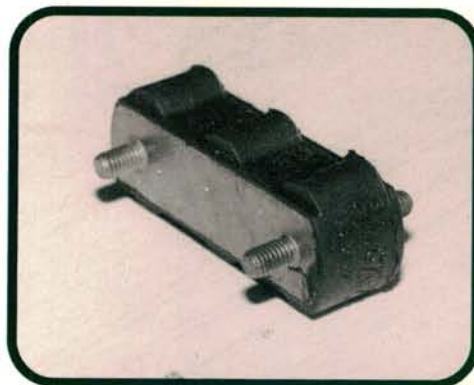
**16**

This rubber coupler provides a flexible connection between the manual shift linkage and the manual transmission gear selector shaft. One side bolts to the linkage, the other to the selector shaft. A coupler that's worn or broken on either side will make it difficult to shift into some or all of the gears.

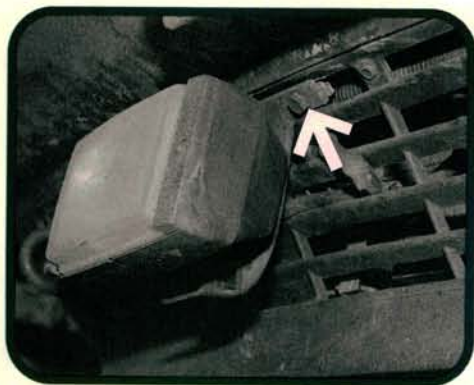
**17**

The mounting bolts for the factory fog light brackets can cause electrical problems either sooner or later. The bolts extend through the bumper and can damage the wiring harness that runs through this area. Repair the wiring, then secure the harness away from the bolts to prevent damage.

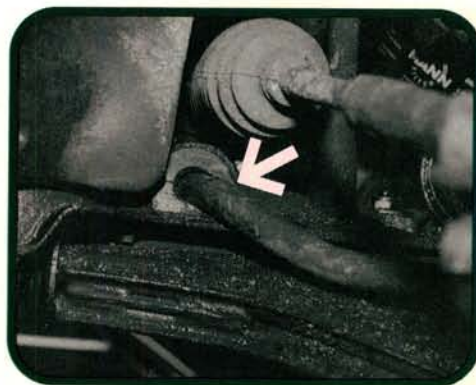
**18**

A clunking front suspension noise may be caused by a broken stabilizer bracket bolt. The broken bolt can be difficult to see when the car is in the air with the weight off the suspension. Pry on the bracket to see if one side is loose. Remove the broken parts, then secure the bracket with a new nut and bolt.

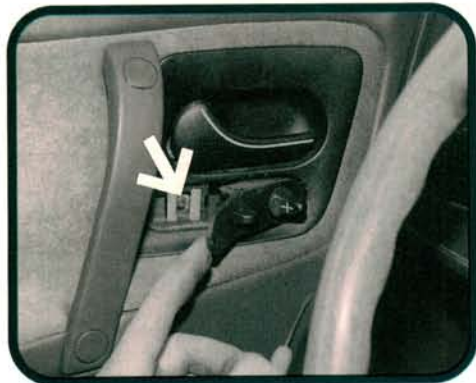
## 19

Removing the front door trim panel can give you fits if you don't know where all the hidden screws are located. Most of the screws are easy to find under plastic plugs. The last screw on the driver's side is behind the mirror switch. Pry the panel forward from the rear to remove it.

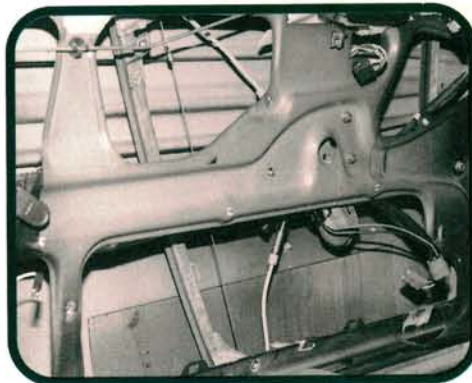
## 20

We removed the door trim to repair the window regulator. The cable operated regulator is easily damaged if the regulator mounting bolts loosen. If you catch it in time, tightening and thread locking the bolts will save the regulator. Once the cable slips off the pulleys and tangles, the 300 dollar assembly is toast.

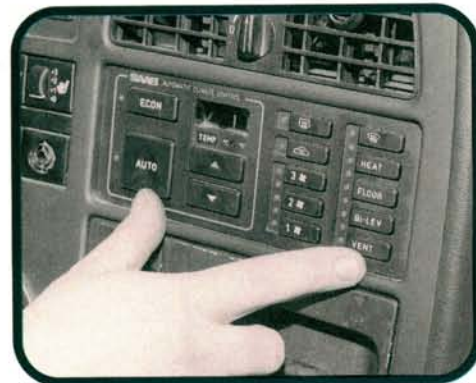
## 21

Failed servo motors may affect automatic climate control operation. To review diagnostic codes, press the AUTO and VENT buttons. The LED flashes 88 during self diagnosis, then the total number of codes is displayed. Press VENT once to see the first code number, then repeat for additional codes.

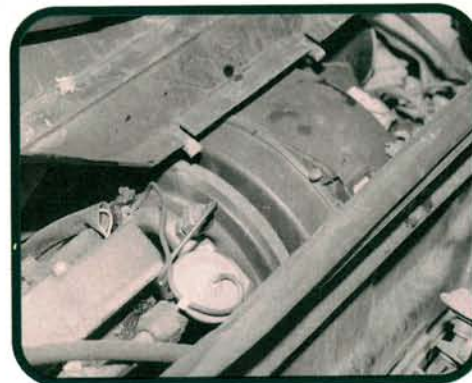
## 22

An incorrectly positioned or blocked evaporator drain pipe can cause water to blow out of the center dash vent or flood the driver's floor. Water may also cause the fan motor to drag during right turns and eventually seize. Clogged cowl drains will cause the cowl area to fill with rain water.

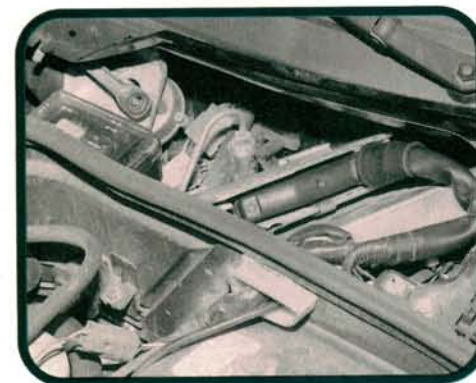
## 23

The blower motor runs even when the A/C system is shut off. The constant use has caused some motors to fail. The upper section of the bulkhead and most of the parts that surround the motor must be removed to access the worn out motor. We'll come back at another time for a detailed look at this procedure.

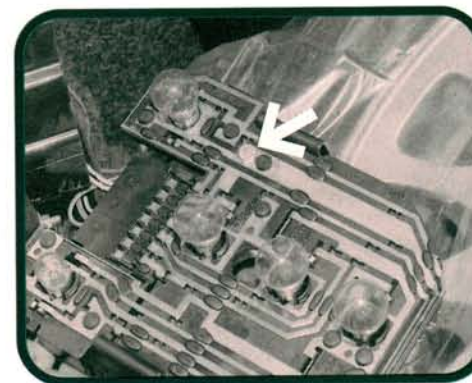
## 24

A poor tail lamp ground may light the bulb failure pictograph on the dash. All of the bulbs for both tail lamp assemblies ground through the same wire. Drill a small hole in the printed tail lamp ground circuit, then bolt an extra ground wire between the body and the tail lamp assembly.
