TOYOTA TECH TIP TREASURE TROVE

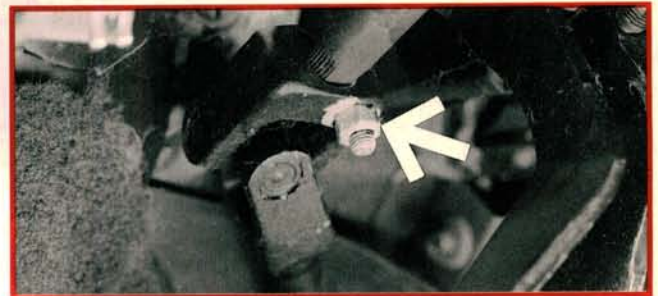
VOLKSWAGEN KNOCKING NOISES

If a customer with a Volkswagen diesel Rabbit or Golf complains of a knocking noise while driving over bumps, don't be too quick to inspect the under-car suspension components for wear. Check the pinch bolts on the steering column universal joint for looseness first.

The universal joint is located at the bottom of the steering column, near the brake and clutch pedals. I suspect that over a long period of time, the extra vibration from the diesel engine can loosen the universal joint and cause these knocking noises. It's a quick check to make and can save a lot of problems.
