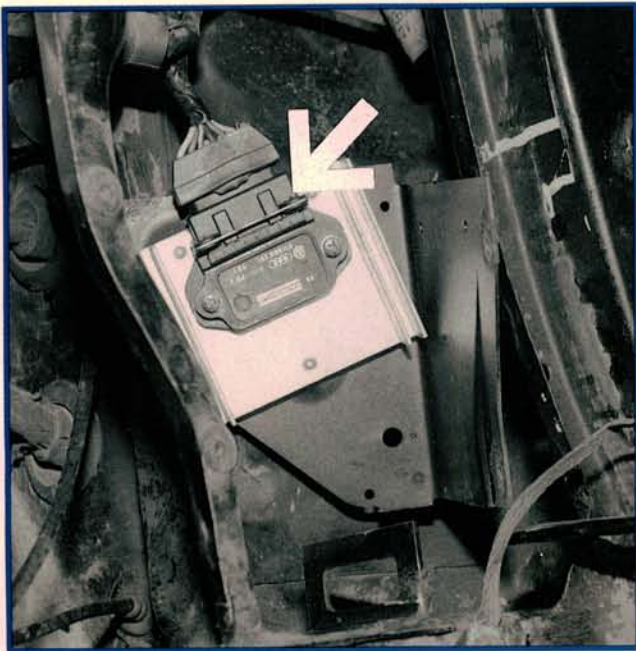
Many water cooled Volkswagen models (Rabbit, Scirocco, Jetta, Quantum) mount the ignition module, fuel injection control unit, and frequency valve control unit in the air plenum area under a plastic water drain tray. As these cars age, corroded electrical connectors are a frequent source of trouble in this area. Problems including poor starting, erratic idle,

and no-starts can often be traced to these corroded connectors.

Applying either silicone dielectric or white grease to the grommets and connectors on a regular basis will ensure good electrical connections and fewer problems. If the terminals inside the connectors are already corroded, clean them thoroughly and replace any badly damaged terminals before applying the protective grease.

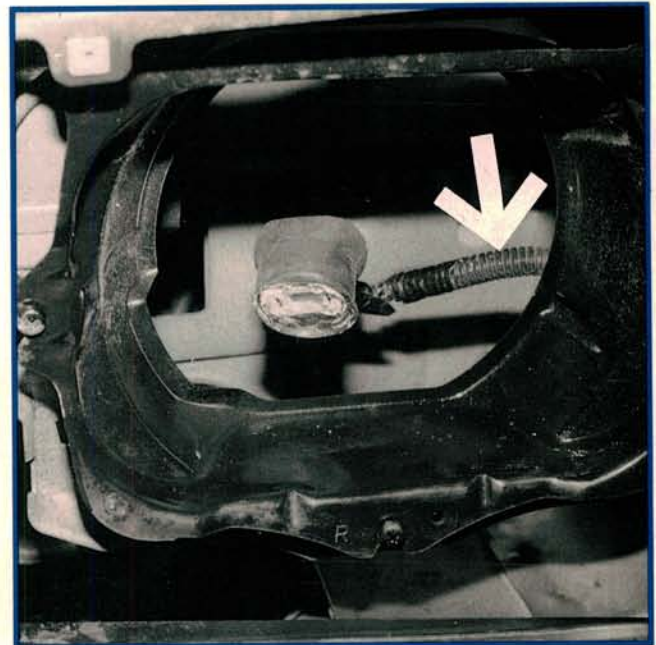
Chafed or broken wires inside the wiring harness to the headlamps may cause problems with the pop up headlamps on 1986-89 Honda Accord models. Symptoms may include inoperative headlamps, failure to change from low to high beams, blown fuses, and other peculiar symptoms.

Raise the pop up headlights, then open up the protective outer wiring harness sheath below the headlights. Opening and closing the headlights hundreds of times eventually causes the wires to crack and break. Repair any damaged wiring, insulate the repair, then close up the wiring harness sheath. Route the headlight wiring harness so the headlights can open and close without pinching the wiring harness.
