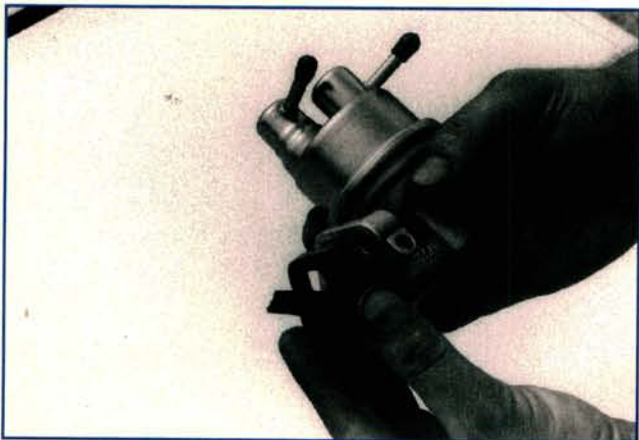
**When you've finished checking the obvious potential sources for oil leaks (oil pressure switch, valve cover gaskets, missing oil fill cap, etc.), don't forget to check the plastic insulator between the fuel pump and the engine block.**

I have found this insulator to be a common source of oil leaks, either because it has cracked or the gaskets on either side have failed. I never replace a fuel pump without replacing the plastic insulator and its gaskets.
