Dim the lights please. We're almost ready to begin our Audi-O-Visual presentation. Our subject this month is electrical troubleshooting on Audi vehicles.

Audi-O-Visual

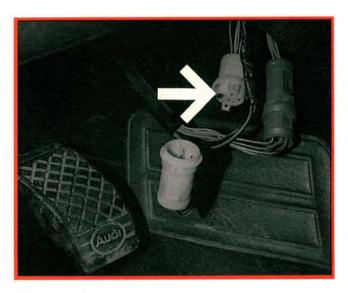
If the automatic climate control has developed a mind of its own or has quit working entirely, pull the connectors down from the left side of the center console. Loose terminal connections may cause a voltage drop at this automatic climate control connector. Separate the connectors and look for blackened, melted plastic. These terminals were previously repaired by bypassing the connectors. The preferred repair method is to replace the damaged terminals, then install new connector plugs.

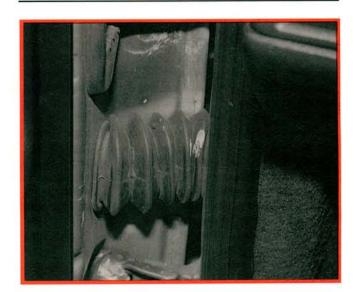
Repeated opening and closing of the driver's door may cause the power seat wiring to break. This can cause some bizarre malfunctions of the seat memory system. The driver's seat may automatically head for the full reclining position when the car is first started. Peel back the accordion pleated wire boot and locate the broken wire(s). If you're going to splice in a new piece of wire, start the splice inside the door on one end and under the dash on the other end. Solder and heat shrink all joints.

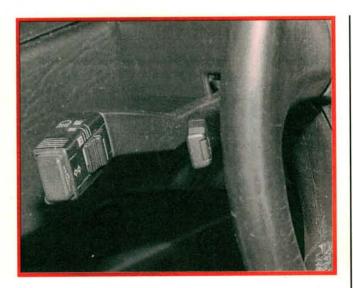
The steering column combination switches can cause problems on later model Audis. Replacing the switch isn't difficult as long as you remember a few important safety precautions. Since you'll need to remove the steering wheel to replace the combination switch, the air bag system must be disarmed first. Remove the steering column cover, then locate and disconnect the orange air bag connector. After the air bag is removed, place it out of the way with the horn pad facing upward.

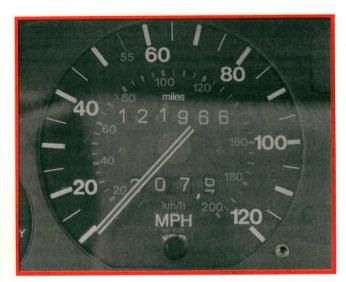
A cracked dashboard printed circuit board may cause intermittent speedometer operation on 1989 Audi 100 and 200 models. This may also cause engine stalling when coming to a stop. The fuel system control unit loses the speed sensor signal input, so it doesn't know that it needs to adjust the idle speed control. Tap on the instrument panel. If the speedo needle jumps, the circuit board is damaged. Don't use a soldering iron that puts out more than 30 watts to repair the circuit board.

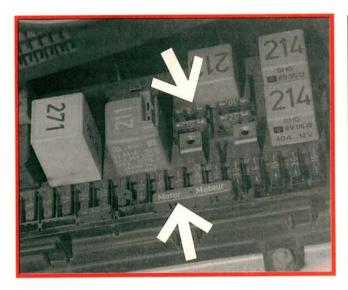
If you're working on an Audi with strange running problems, check the fuse box. The owner may have removed one of the wrong fuses, thinking it was a spare. The fuses that run along the outside edge of the fuse box are not spares. The spare fuses are mixed in with the other fuses, near the center of the fuse panel. Later models have better labeling but it's still possible to grab the wrong fuse if you aren't paying attention. Pulling the wrong fuse on some models will kill the distributor advance.

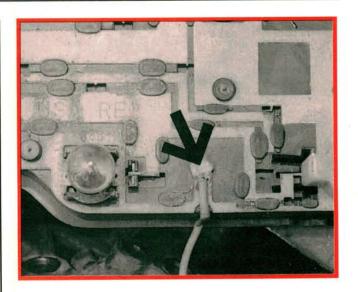
The tail light grounds on first generation 5000 models are a notorious problem area. Both tail light assemblies share a ground that's located a long distance away from both assemblies. The tail and backup lights will quit working if enough corrosion has built up at the ground connection or the tail light harness connectors. Poor grounds can be repaired by soldering a length of wire to the tail light ground circuit, then grounding the wire on a threaded body stud a little closer to the housing.

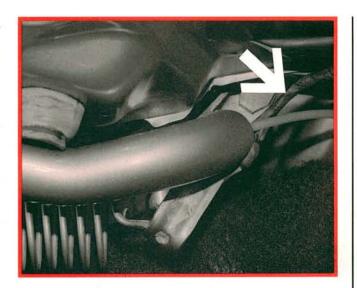
Just like the driver's door, repeated opening and closing of the trunk may cause the wires inside the trunk lid harness to break. Inoperative tail, brake, backup and license plate lights may be caused by broken wires inside the harness. Blown fuses may be caused by two broken wires shorting against each other. The wires may break at either end of the trunk lid tube, but seem to break more frequently near the hinge. Cut the damaged section out of the harness, then fish the new wire into place.

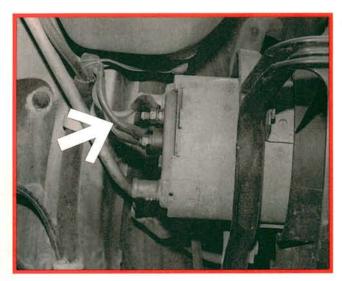
A seized radiator cooling fan may burn up the wiring harness between the fan motor and the firewall. This happens more often on turbo models because the fan runs more often. The fan circuit is not fused and is powered at all times. Heat from the fan wiring often damages the wiring for other circuits along the way. The harness can be repaired if you have the time to find all of the damage. Better yet, check the fan motor operation and add an inline fuse before damage occurs.

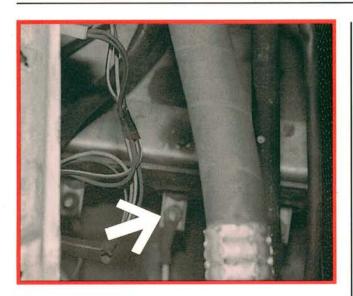
The cooling fan resistor block is usually to blame if the radiator cooling fan on a second generation Audi 5000 runs at high speed at all times and sounds like an airplane taking off. Remove the upper radiator shroud at the front of the radiator to reach the resistor block. The resistor is located in front of the bottom of the A/C condenser. This area is not very well sealed from the outside, so the resistor receives more than its fair share of road salt and slush.

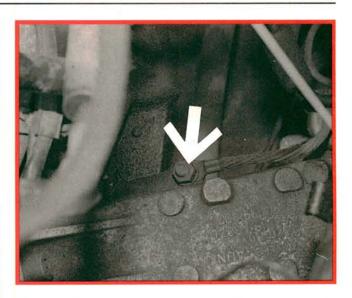
Poor engine grounds may be the root cause of many electrical problems. On 5000 models, clean and tighten the main engine ground connections at the left motor mount. The ground wire between the cylinder head and the firewall is often left dangling during valve cover gasket replacements. The main ground connections for the fuel system are located on the right side of the engine, near the throttle housing. The battery is under the rear seat, so all connections must be clean and tight.
