Mirage/Colt Service Information

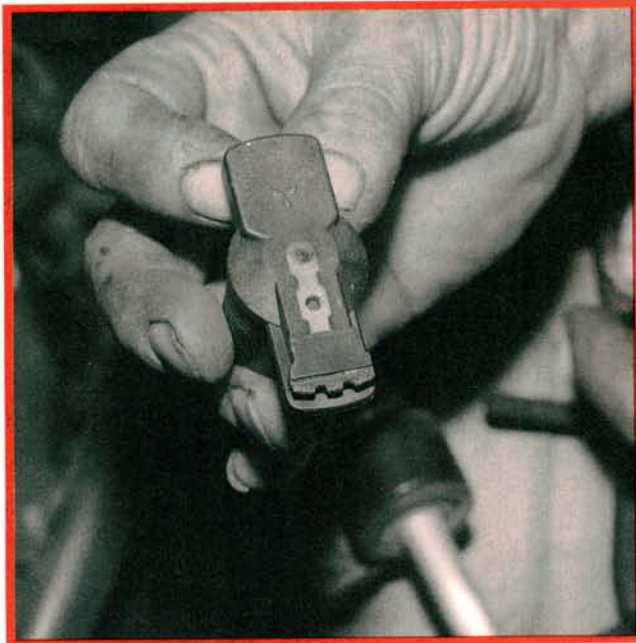
1 Electronic ignition can make you careless about secondary ignition components. High secondary resistance in other parts of the system may cause the secondary spark to burn holes through the distributor cap as it looks for an easier path to ground. Check for deposits on the tip of the rotor, too.

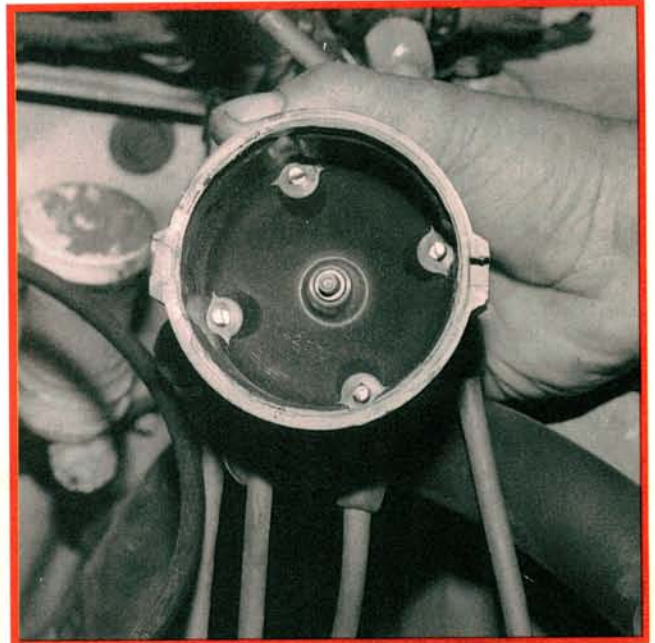
2 Flip the distributor cap over while you've got it off. Look for chalky deposits at the electrodes that can increase secondary resistance. On models equipped with a vacuum advance, check the unit with a vacuum pump. This is a common failure that may cause acceleration problems.

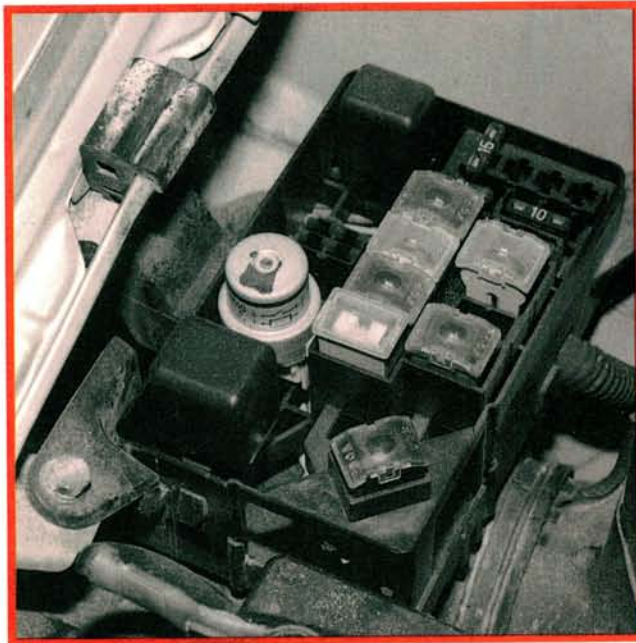
3 Have you ever seen a fuse that sags in the middle? This is a sign that the fuse has passed current close to its rated limit, and lived to tell about it. Check for sagged fuses in the main underhood fuse panel. These could indicate higher than normal current draw caused by corrosion or loose connections.

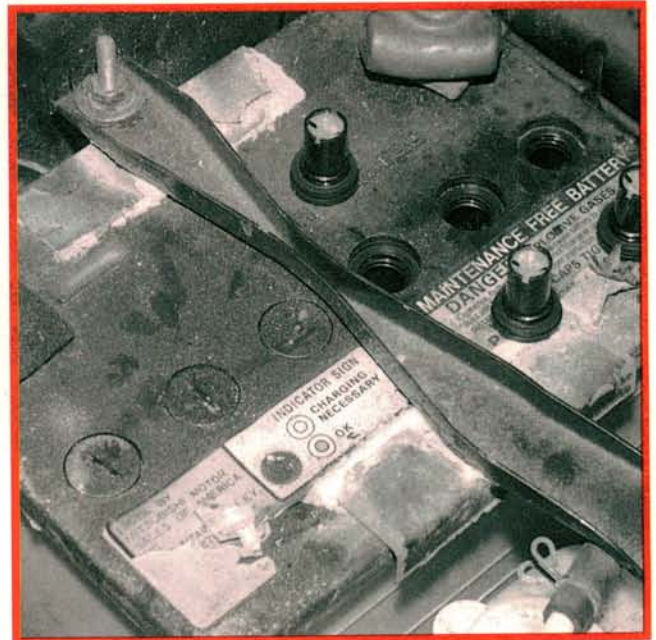
4 Battery maintenance is another often overlooked service. Mirage and Colt batteries are low maintenance, but not maintenance-free. Remove the battery caps to check the electrolyte level. A specific gravity test will show the battery's health and give advanced warning of battery failure.

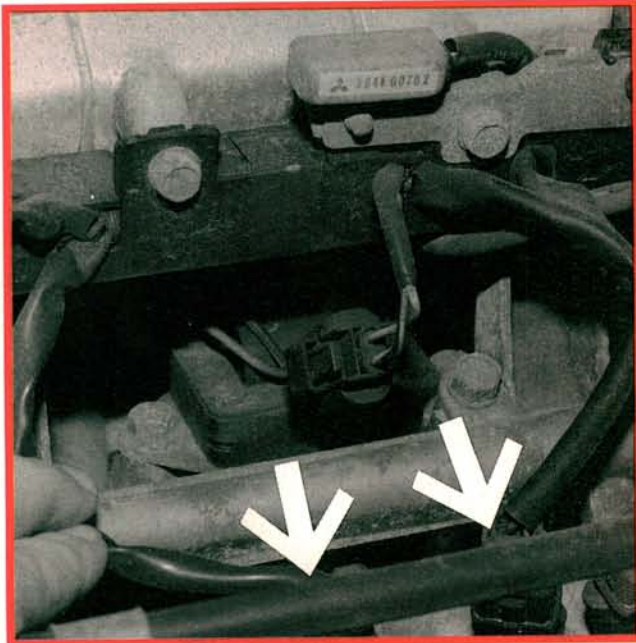
5 Corroded terminals in the injector harness connectors on port injected models may cause a stumble on acceleration that can be hard to diagnose. Remove and clean the connector terminals and the pin terminals on the injectors. Replace the harness terminals if they're too far gone to clean.

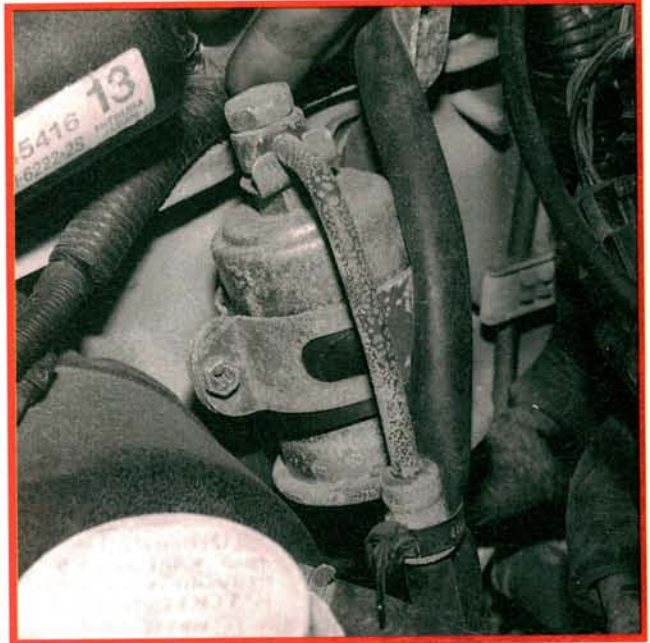
6 The oxygenated winter fuels used in some areas have been known to loosen fuel tank deposits. These deposits can work their way forward and clog the fuel filter, causing stalling or other driveability problems. Frequent fuel filter replacements may be necessary to prevent these problems.

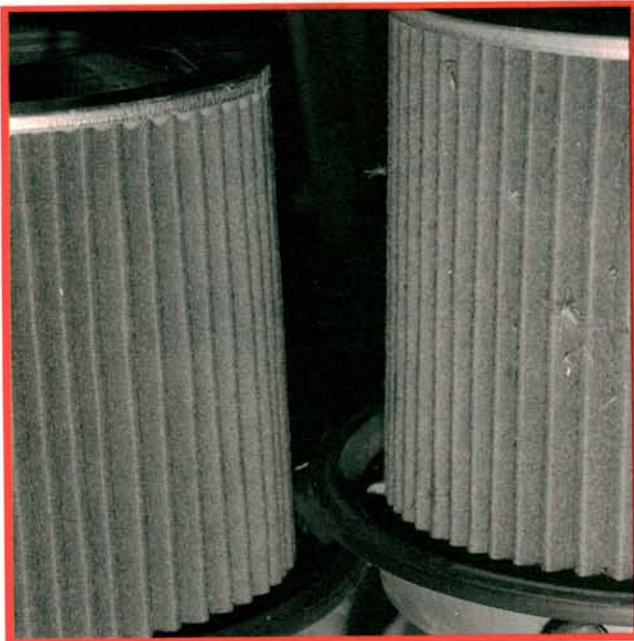
7 Replace air filters at recommended intervals, and more frequently in dirty conditions. The large surface area of a canister air filter can hide a lot of dirt and may not look dirty. On carbureted models, watch for poor fitting replacement filters. They may allow dirt to slip past the filter.

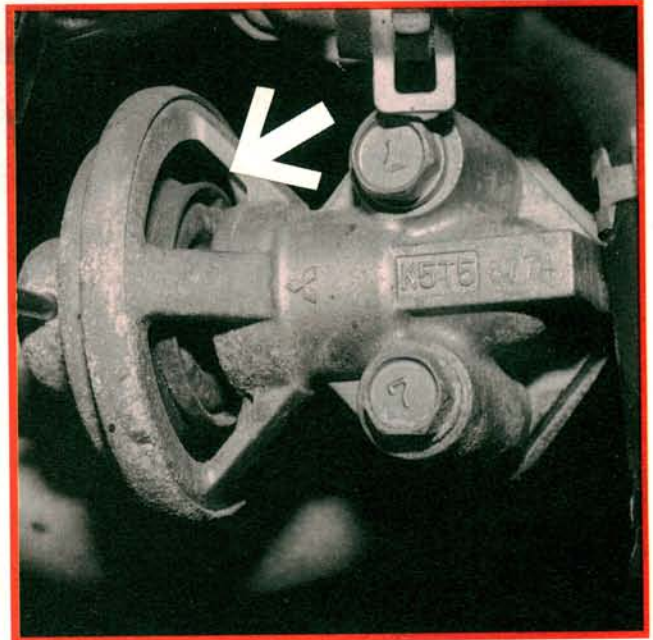
8 The open design of the EGR valve may prove inviting to our four-legged friends. Unusual driveability problems may result when they leave nuts or other debris in the valve. Reach behind the intake manifold with your hand to check for a stuck EGR valve if diagnosing a rough idle condition.

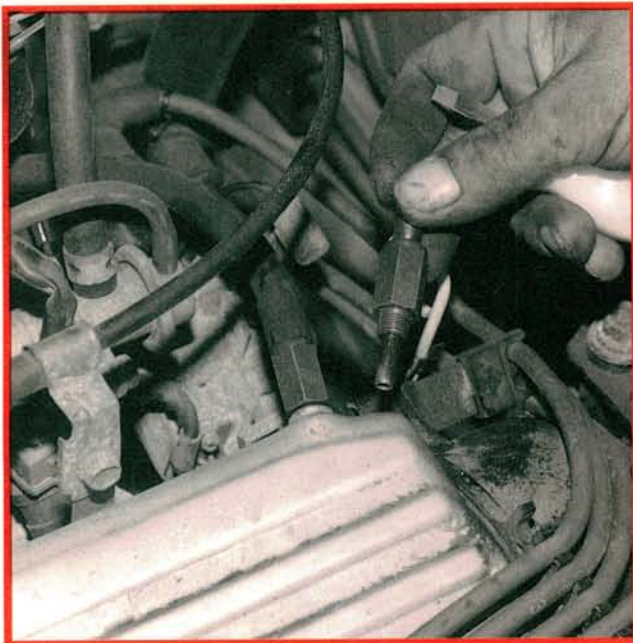
9 The metal PCV valve threads into the valve cover. These valves should be replaced during a major maintenance to prevent crankcase ventilation and oil consumption problems. You probably won't be able to tell that the valve needs to be replaced by looking at it. When it's time, it's time.

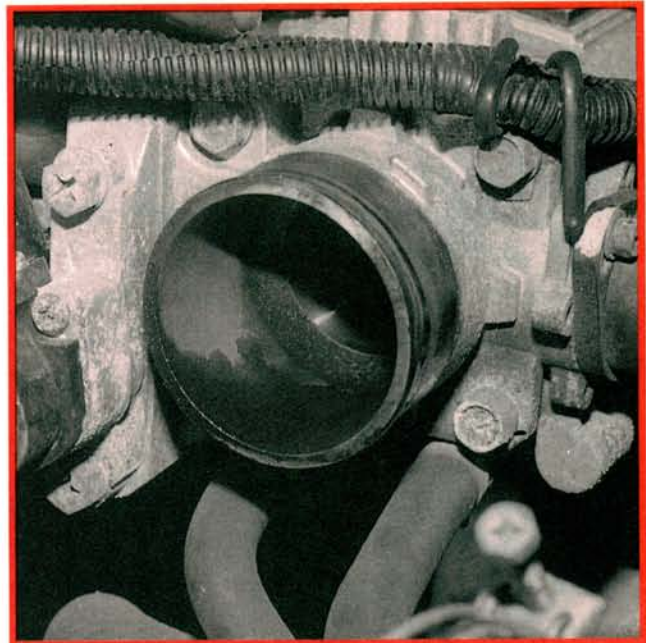
10 Crankcase fumes and fuel deposits cause a build up on the inside of the throttle housing. If these deposits get thick enough, they can cause the throttle plate to stick or hang open slightly at idle. These deposits also throw off the throttle position sensor adjustment, causing driveability problems.

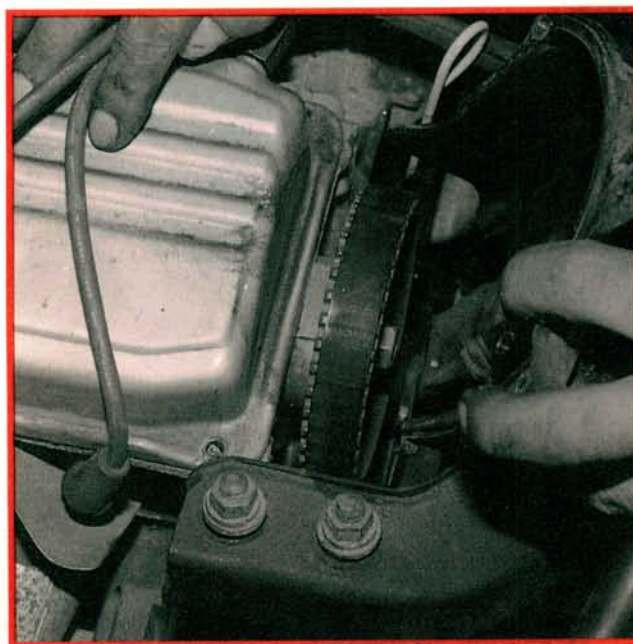
11 Some technicians remove the valve cover without removing the upper timing cover. The valve cover may come off okay, but it can be difficult to reinstall without damaging the gasket and causing an oil leak. With the upper cover removed, the timing belt can be inspected at the same time.

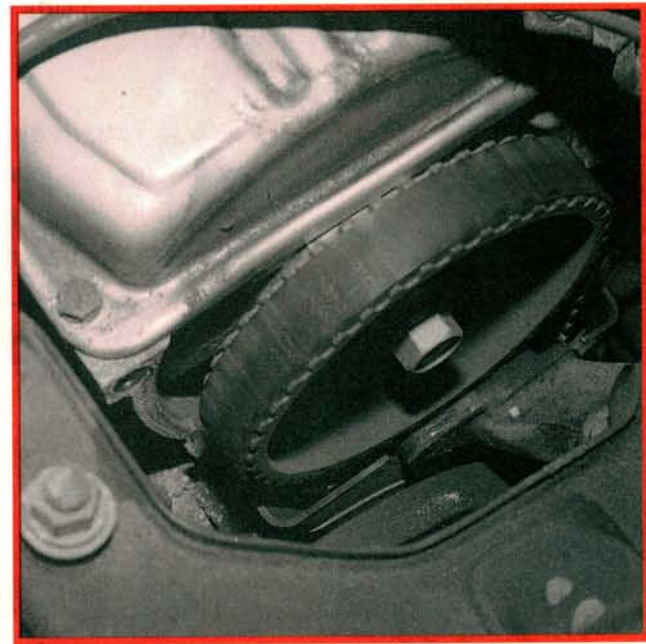
12 While you've got the upper cover off, check the timing belt for signs of wear and proper tension. Timing belt replacement is recommended at 60,000 mile intervals. Belts on SOHC engines usually make it to this interval without difficulty. The DOHC engines put more strain on the belt.

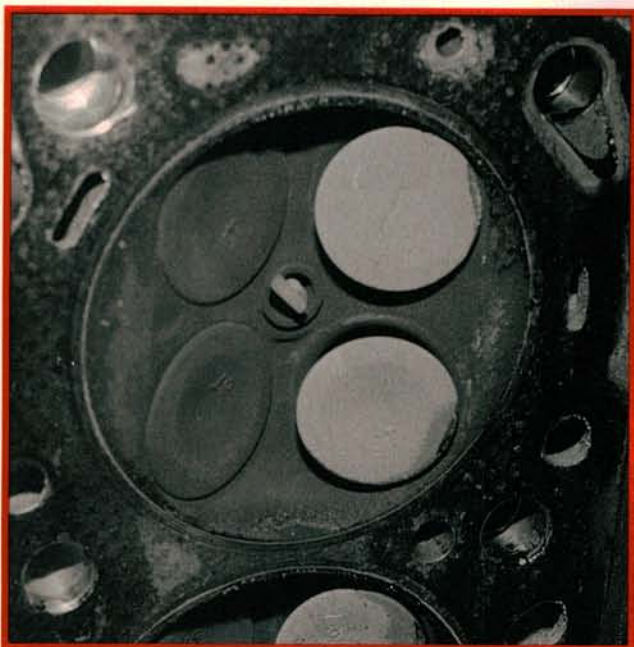
13 The owner of this DOHC engine decided to wait a few thousand more miles before replacing his timing belt. He made it all the way to 68,000 miles. The DOHC engines are valve benders, so this one clipped all eight exhaust valves, plus a few intakes. An expensive lesson in deferred maintenance.

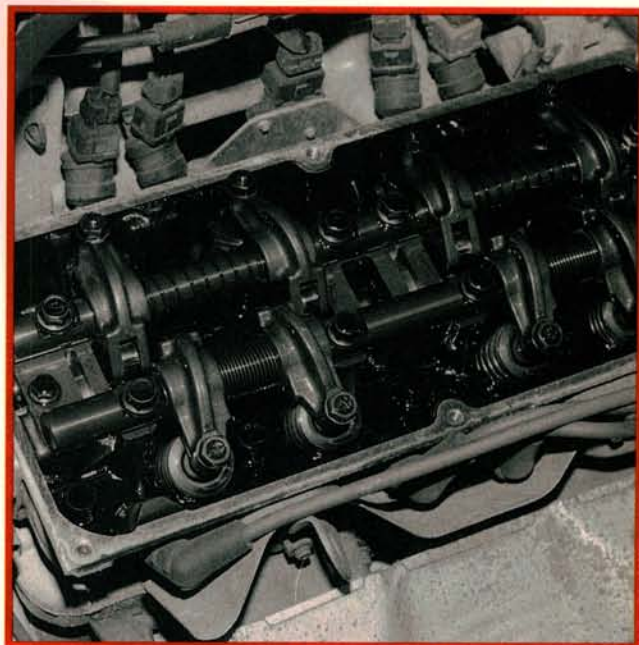
14 All single overhead cam engines require periodic valve adjustments. Adjustment on this two valve 1988 Mirage engine is normal. The smaller "jet" valve spring pressure on 1989 and later three valve engines is very light. The feeler gauge should slip past the valve stem with light resistance.

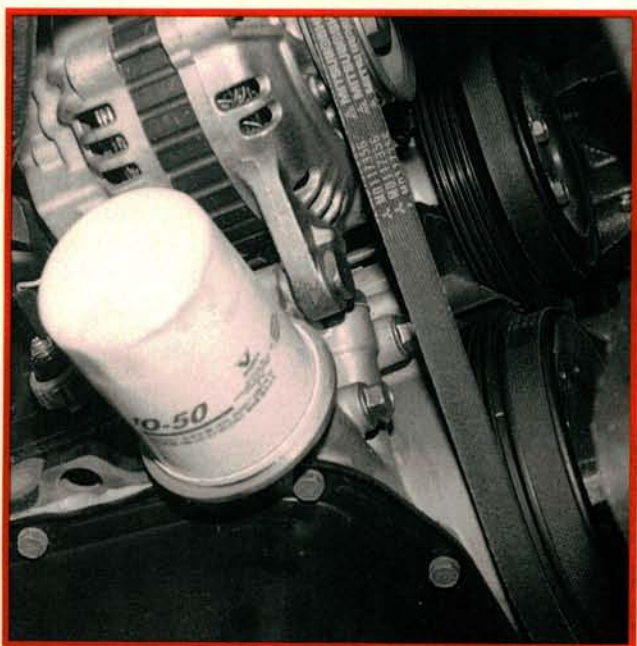
15 The v-ribbed drive belts used on all Mirages and Colts since 1985 will normally last a long time, and may get neglected for the same reason. As the outside of these belts normally stays in good condition until the bitter end, look on the inside of the belts for signs of age or cracking.

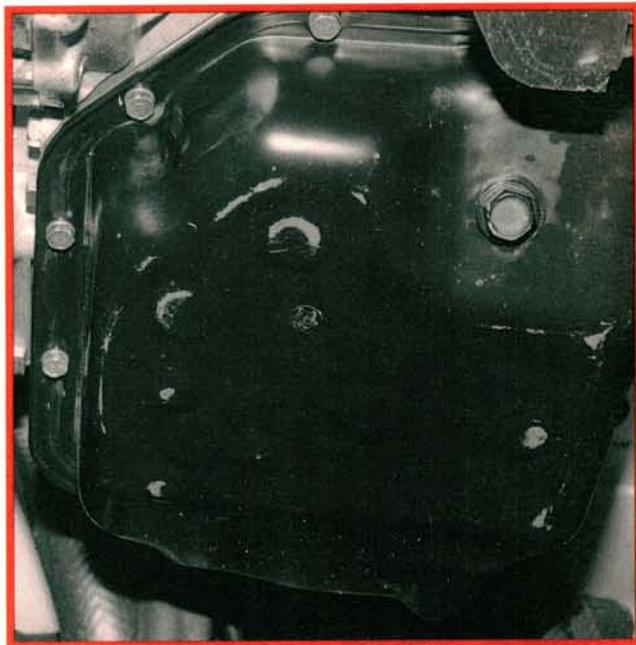
16 This seems obvious, but it did happen. The engine and automatic transmission pans both have drain plugs. This car's transmission was damaged when the ATF, not the engine oil, was drained by an inattentive lube jockey. The engine got four extra quarts; the transmission was four quarts low.

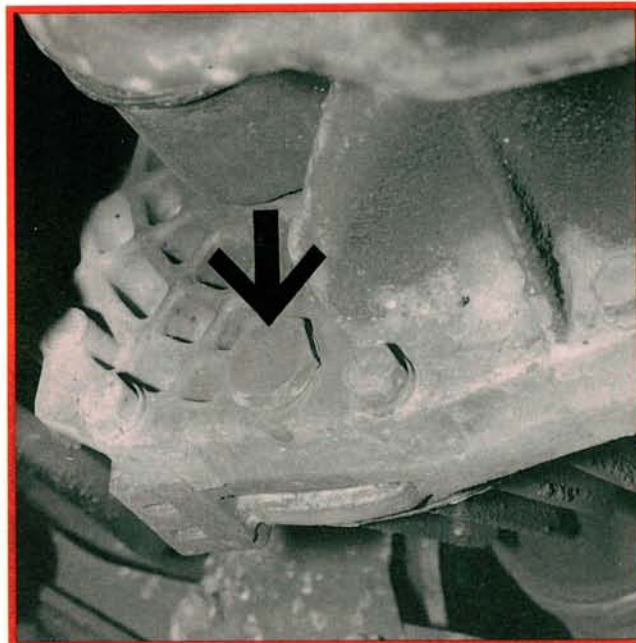
17 The manual transaxle gear lube is an often neglected fluid change. Remove the large drain plug (arrow) after the transaxle has reached operating temperature. See a service manual for the recommended lubricant type and grade. Some models require ATF rather than straight gear lube.

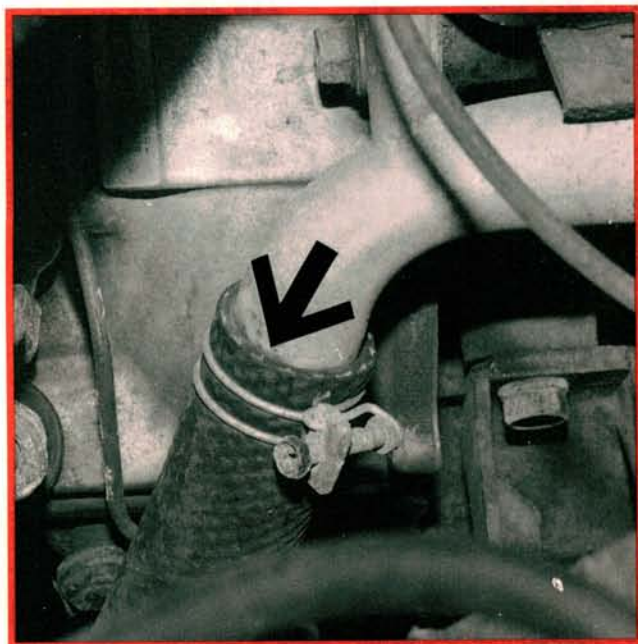
18 Cooling system hose clamps can lose their grip on hoses over time. A coolant leak from a loose clamp may be too small to notice on the ground, but can gradually empty the cooling system. Pressure test the system. Also look for spots of dried coolant deposits around the hose connections.

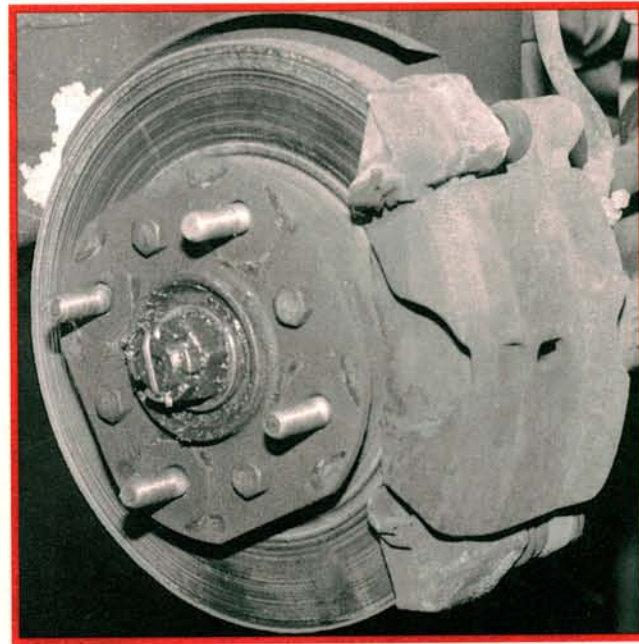
19 The front brake rotors on this 1988 Mirage are "captive." Resurfacing requires either hub and bearing removal or an on-car brake lathe. Rotor resurfacing isn't mandatory during every pad replacement if the rotors are in good shape. Check surface finish, runout, and parallelism before deciding.

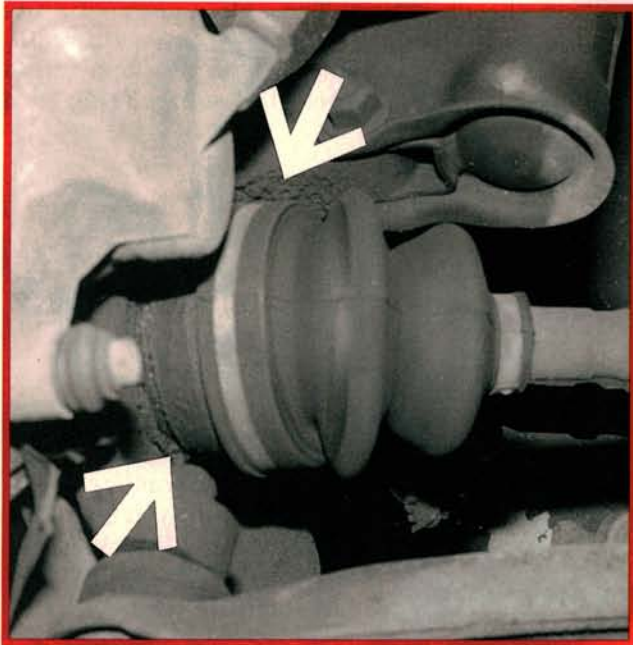
20 Check the inner and outer CV joint boots during any servicing. The grease buildup on the inside of the steering knuckle (arrows) indicates that the inner wheel bearing grease seals are leaking. A wheel bearing repack and seal replacement during a rotor refinish will prevent a costly repair.

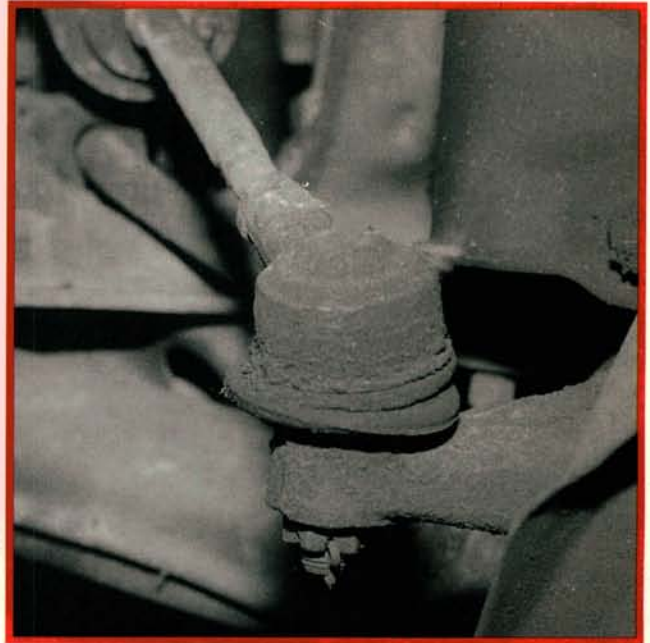
21 Mirages and Colts have a simple strut front suspension. Toe is the only adjustable front alignment angle. Service technicians tell us these vehicles normally hold an alignment for many miles. They watch for unusual tire wear or handling problems, then align problem vehicles when needed.

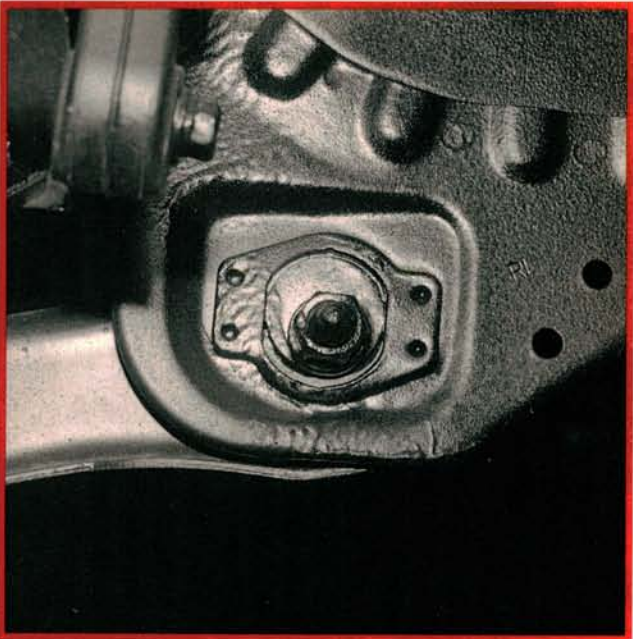
22 Colts and Mirages built before 1989 have a beam axle rear suspension, so no rear wheel alignment is possible. An independent rear suspension is featured on 1989 and later models. Eccentric adjuster bolts on the front and rear control arms permit camber and toe adjustments.
