TransPlant

This month, he's taking us on a guided tour through a common transaxle used in many Mazda and Ford vehicles. With the constant cross pollination of vehicle brands increasing, it's getting harder and harder for

The G4A-EL on the bench today is an electronic unit used in 1988-92 Probe, MX-6 and 626 models. Its valve body contains five solenoids, although a conventional throttle cable is used to control line pressure based on throttle position.

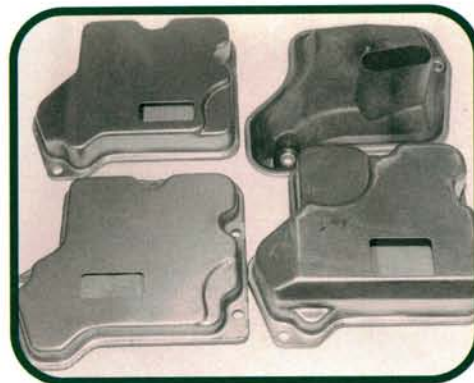
Filter and fluid changes became more important when they started using solenoids in valve bodies, so you'd better know the four filter options. Reading clockwise from top left: 1988-92 regular and turbo models; the new plastic-bodied filter used in 1993 versions; all hydraulic trannys; and 1986-87 versions.

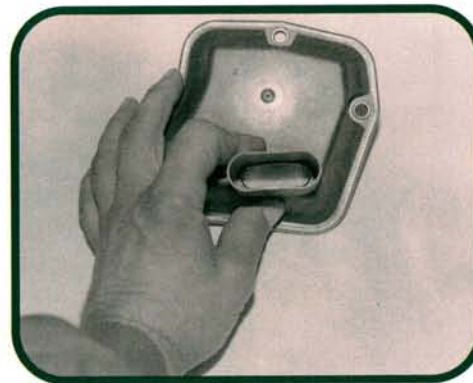
The filter used in 1993 versions incorporates an "American" style filtering element. Earlier versions used a screen-type filter we've seen on Japanese transmissions for years. But the screens weren't always fine enough to keep tiny bits of metallic debris out of the electro-magnetic solenoids.

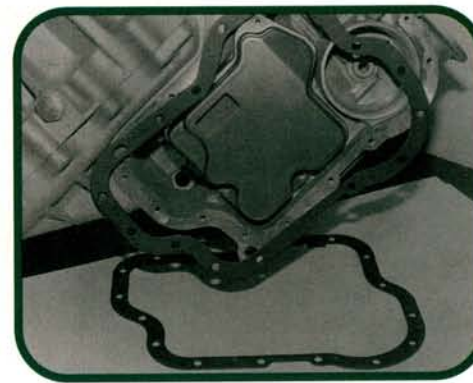
Pan gaskets on turbo and non-turbo applications are slightly different. There are two pans on each trans, one for the valve body and an access pan for filter changes. You probably wouldn't get the wrong gasket installed since some of the holes don't line up, but who wants to return an oily gasket?

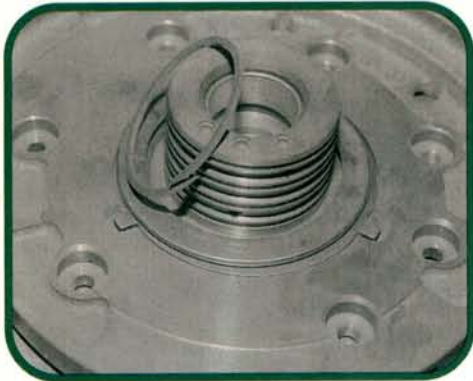
4

This brings us to some internal sealing problems which have resulted in failed 3/4 and reverse clutches. There are several possibilities to consider which may cause "cross-over" leaks between clutch fluid feed lines. Leaking seal rings on the pump are one possible cause of cross-over leaks.

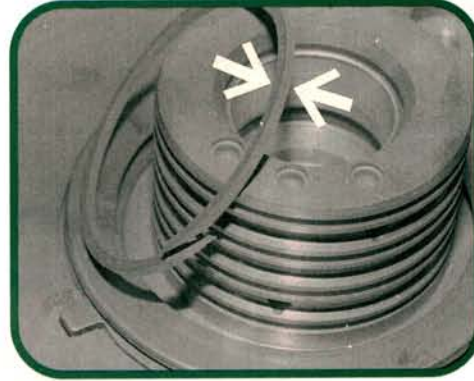
5

One thing John emphasized during our meeting, was the importance of using OE seals on the pump. Tolerances are critical here, and some aftermarket seals may leak. If you buy an aftermarket gasket set, make sure the pump seals in the kit are OE, or purchase them individually from either Ford or Mazda.

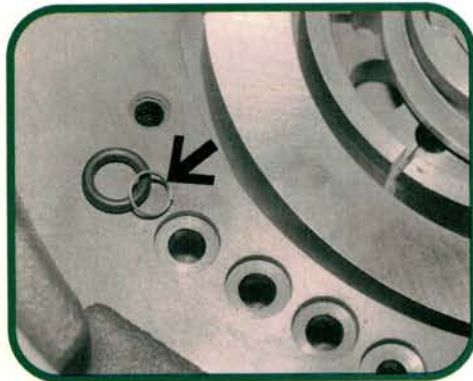
6

Another possible cause of cross-over leaks can be found at these o-rings between the case and pump body. Each of the tiny rings has a metal spreader which must be installed. These seals were enlarged on 1988 and later models to reduce the possibility of cross-over leaks.

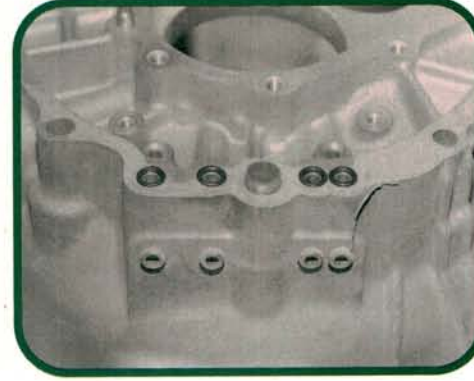
7

If you're splitting the case for any reason, always replace the o-rings between the case halves. Then seal the rest of the case halves with an approved sealer. This is one more place where cross-over leaks can occur. Don't let the cake decorator in the group apply the sealer. Excessive sealer can clog the ports.

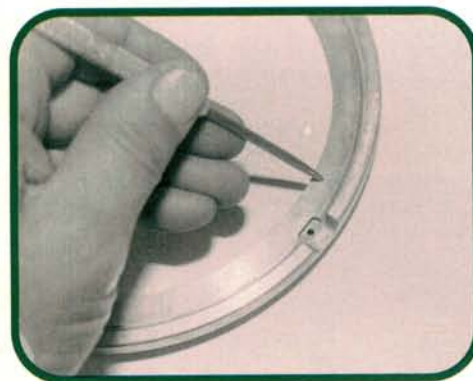
8

Cross-feed pressure problems caused reverse clutches to apply just far enough to drag when forward gears were selected. This caused overheating and premature reverse clutch failure. Some enterprising trans techs drilled a .030 hole in the reverse piston (pointer) to vent any cross-over pressure.

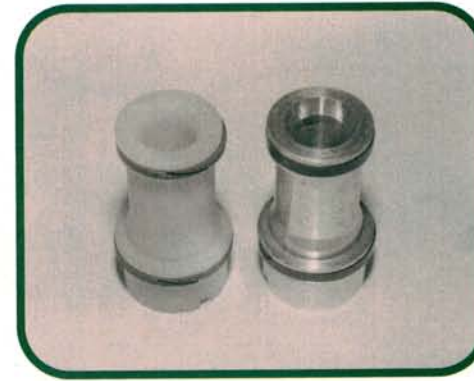
9

The original aluminum accumulator pistons were pretty, but they had a tendency to stick. You have two repair options here: either reuse the old pistons with new seals; or replace them with improved accumulator pistons and seals. We strongly suggest that you choose the latter option.

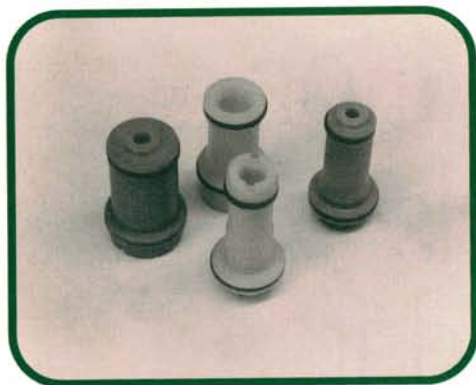
10

The valve body contains four separate accumulator pistons. These new, improved pistons come in four different designer colors! But be careful, the width of the scarf cut sealing rings for the plastic pistons is thinner than those used on the original aluminum pistons. Don't mix and match.

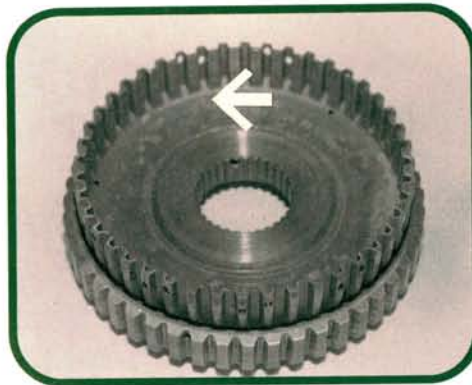
11

If you see a trans that won't move unless you select manual 1st or 2nd gear, suspect a bad input sprag. Be careful when you install a new one — it's possible to install it upside down. The sprag should freewheel in a counterclockwise direction (arrow) when it's properly installed.

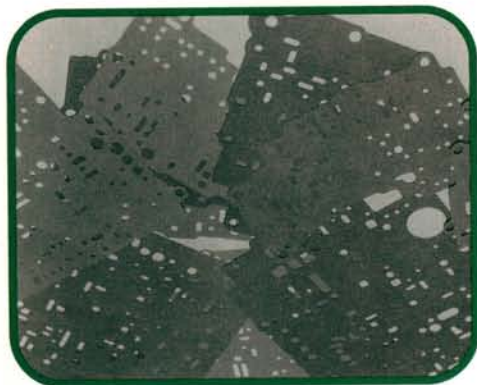
12

This stack of valve body gaskets is another possible cause for confusion. Each valve body uses six separate gaskets. You'd need a total of 24 gaskets to cover all applications. Some kits will have enough gaskets to cover more than one application, so be sure you have an exact match!

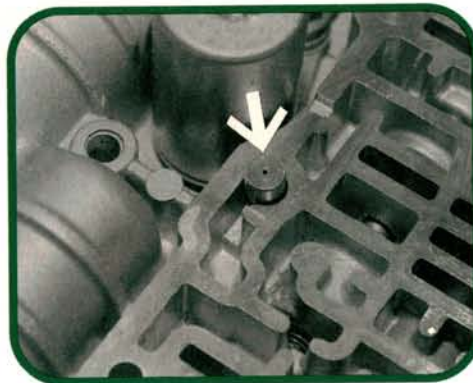
13

Those of you accustomed to seeing the pressure metering orifice holes in the valve body separator plates may find this wrinkle interesting. Tiny orifice cups on springs (arrow) have taken the place of precision drilled orifice holes in the separator. Don't lose, mix, or relocate these caps.

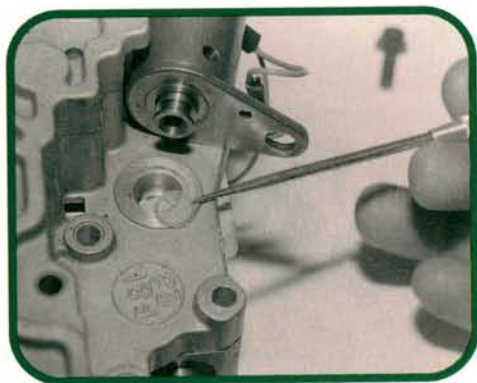
14

We mentioned plugged solenoids. The windings in the solenoids act as small electro-magnets, and attract any wandering metallic debris. When servicing or replacing solenoids, remove, clean, and reinstall the tiny filters in the bores where the solenoids fit and install new o-rings on the solenoids.

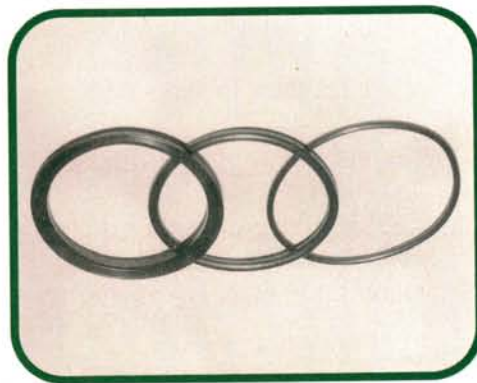
15

The 3/4 clutch piston inner seals can also cause confusion and an embarrassing comeback. This photo shows the different seal options, and a kit may contain all three. Choices include a lip seal and two o-rings. Use the wrong one, and you'll burn up the 3/4 clutch pack when it starts slipping.

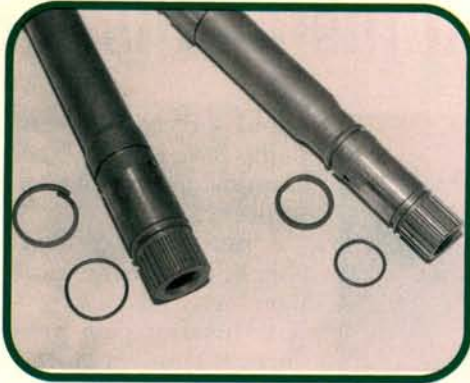
16

Another design change has to do with the input (turbine) shaft design. The early style shaft was meatier than the revised shaft. A Ford bulletin suggests that you always check the shafts for breakage, and replace the shaft and seals on any transaxle built before VIN#161020.

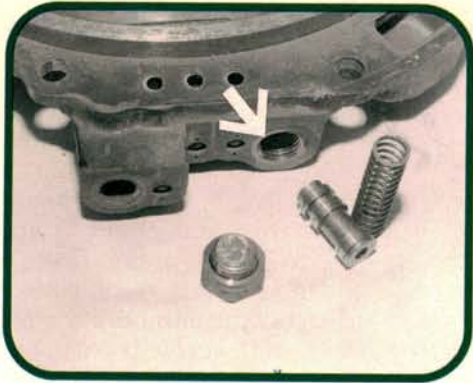
17

This is the early spool-type pressure control valve. It had a tendency to stick in the bore in the oil pump housing. The spring/piston assembly would stay open, causing erratic pump output pressures, even though the pump was just fine. A modified piston with a centering snout is available as a fix.

Line pressure is very important to shift quality. A slip or flare in the 2-3 shift may be the result of uneven oil pump delivery pressures in 1988-90 versions.

Repeat the test, only this time, pull the cable in a smooth, even motion to the midpoint of its travel and watch the gauge. The pressure should increase smoothly and evenly as you pull the cable. If the pressure rises, drops off, and then rises again, the

spool valve in the oil pump may be sticking. It should be removed and inspected.

A new valve is available to correct this problem. (See Photo 17.)

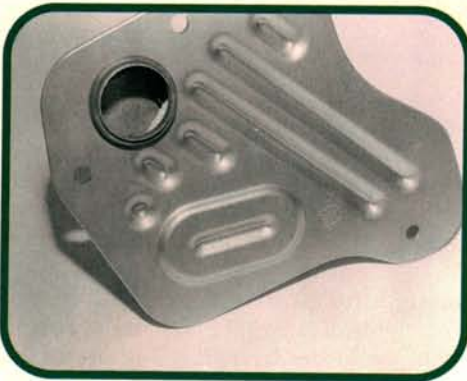
18

Even if you don't do automatic transmission internal repairs, this article should convince you and your customers of the importance of regular transmission maintenance. Your customer may have ignored the old Jatco in his '84 Mazda 626 for 200,000 miles, but fresh fluid and a clean filter mean more now.
