TECH TIPS

BLOWN HEAD GASKETS

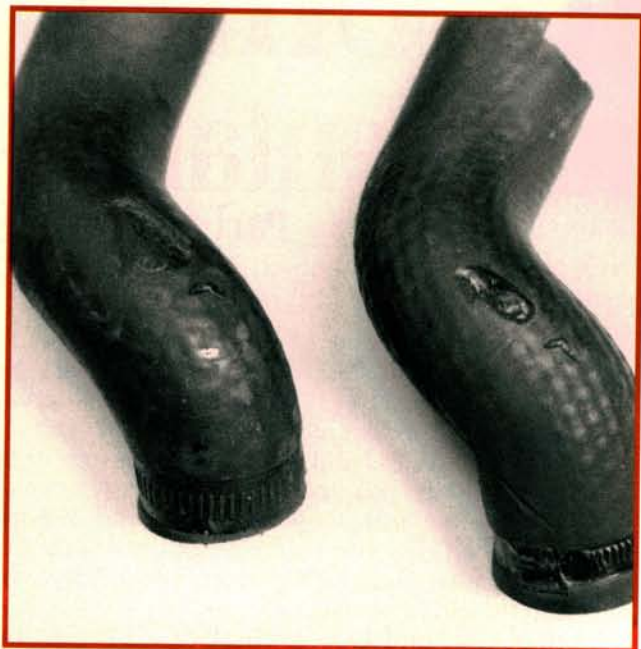
Whenever you have an air conditioned BMW 320i in your shop, be sure to check the lower radiator hose for abrasion damage caused by contact with the top of the air conditioning compressor. To check the hose, run your finger along the bottom of the hose where it passes near the compressor.

You're looking for damage similar to what is shown in the photo on the next page. The hose on the left had not started leaking yet, while the hose on the right would leak for a while after the engine was shut off (just like a failing water pump).

There are a couple of things that you can do to prevent a recurrence of this problem:

- First, replace the hose with an OEM component. Some aftermarket hoses don't seem to fit properly and are even more likely to rub against the compressor, resulting in abrasion.
- Second, cut out a section of the old hose and secure it between the new hose and the compressor with a couple of wire ties.

- Finally, check the motor mounts to make sure they are not allowing excessive engine movement. Weak mounts can also cause hose abrasion.
