Top to Bottom

Part Two

Welcome to the second half of our top to bottom look at a 1987 BMW 535 iS engine overhaul. We thought we had finished our top end coverage last month, but it turned out we were just getting started. This elevator is going to be stuck at the penthouse a little longer.

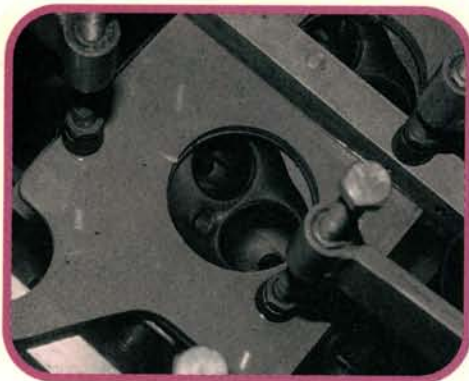
We didn't suspect that the head was cracked or porous, but a quick pressure test seemed like good insurance. We clamped this plate over the bottom of the head to block the cooling passages. After submerging the head, we pumped compressed air into the head. No bubbles, no leaks.

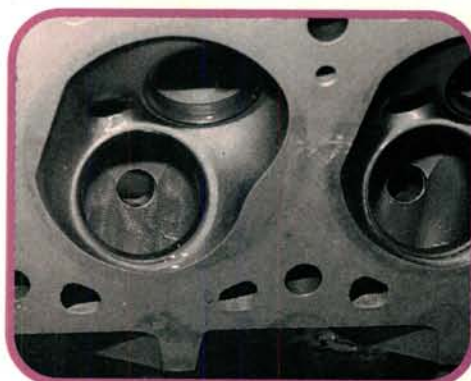
The new valve guides were oversize (14.1 mm), to compensate for any damage to the holes during guide removal and installation. Ray assured us that if the head was heated before removal and installation, standard diameter guides (14 mm) could be installed. The holes looked fine after guide removal.

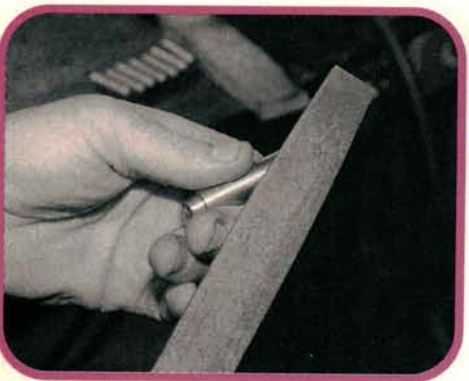
This extra step assures a tight guide fit with minimum damage to the guide holes. Even though the new guides are tapered, a few minutes spent with a file will remove the rough edge at the end of the taper. This keeps the guide from picking up any aluminum and broaching the hole as it is installed.

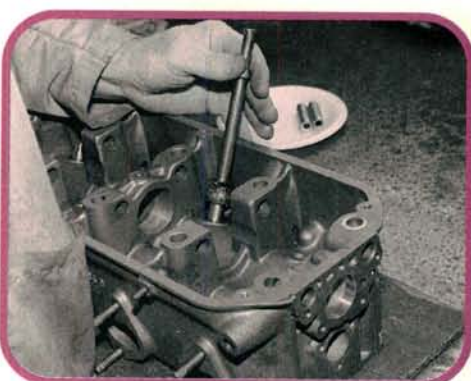
Before installing the new valve guides, chill them in a freezer and reheat the head in an oven. Ray prefers to install the guides by hand - no air tools. This homemade tool installs each guide to the correct height. The tool's recessed head directs the impact to the guide shoulder, preventing mushrooming.

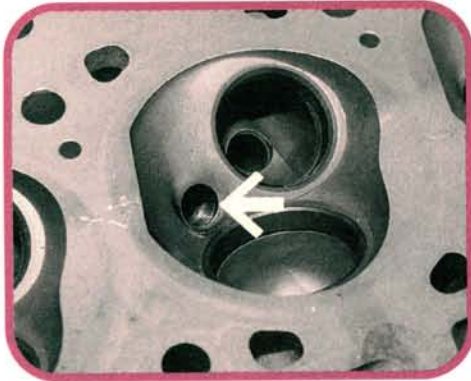
5

Damaged spark plug hole threads had caused the engine to spit out its number two spark plug a while back. The threaded insert that was installed at the time didn't reach the combustion chamber. We removed the insert, prepped the hole, reinstalled the insert, then machined the spark plug seating surface.

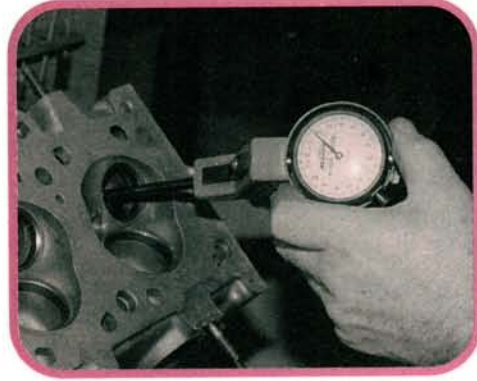
6

Careful installation had prevented any damage to the interior diameter of the valve guides. A few strokes with a diamond hone brought the guides to the specified clearance. Using a new valve as a guide, we set up this dedicated inside diameter dial indicator to measure the clearance.

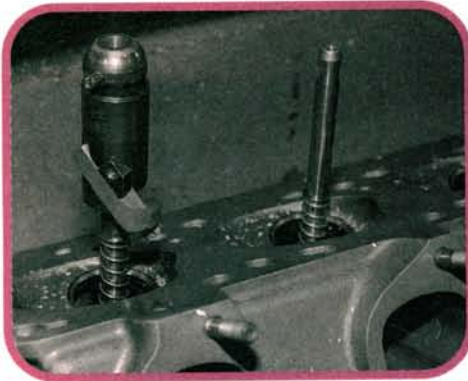
7

The job is always easier when you have the right tools. This valve seat refacing tool cuts all three valve angles, adjusts the seat width, and sets the seat height; all at the same time. Very little material was removed. Valve installed height remained within specifications.

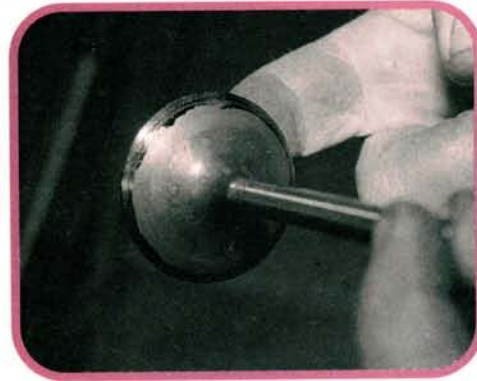
8

After placing a thin coating of machinist's bluing on the face of a new valve, we checked the results of our seat refacing work. The valve is making even contact with the seat. However, to our eyes the valve appeared to be sitting low in the seat. Ray assured us that this is the correct contact point.

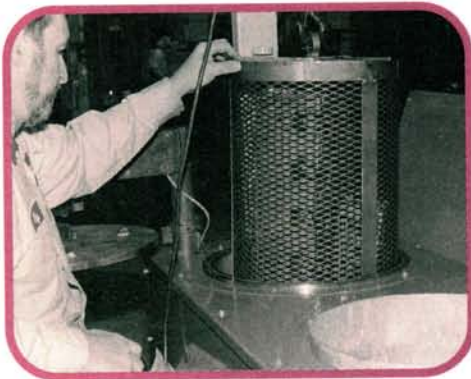
9

Baking the head in an oven destroys the factory's original resin coating. Aluminum castings are naturally porous, so it's necessary to reapply the coating to prevent oil or coolant leaks once the head is reinstalled. This machine uses a three-step process to force a special resin into the pores of the aluminum.

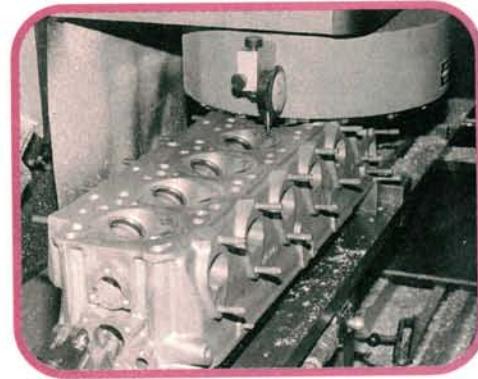
10

A straight edge revealed that the head was unwarped. Even with a flat head, Ray recommends a very light cut to provide the proper surface finish for the new head gasket. The maximum cut for this head is only 0.4 mm. A 0.3 mm thicker head gasket is available from BMW for use with machined heads.

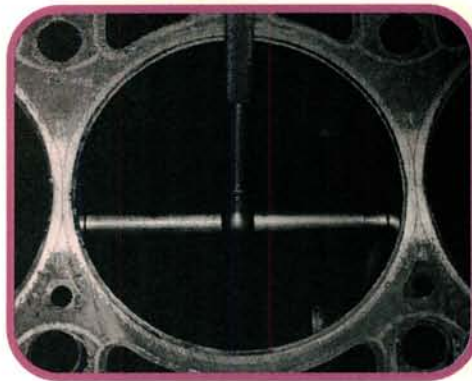
22

We didn't have a bore gauge, so we used a telescoping gauge to determine the extent of the cylinder wall wear. We checked at several depths and positions to check for taper, barrel and other cylinder distortions. Piston thrust had caused the greatest wear at 90 degrees to the crankshaft centerline.

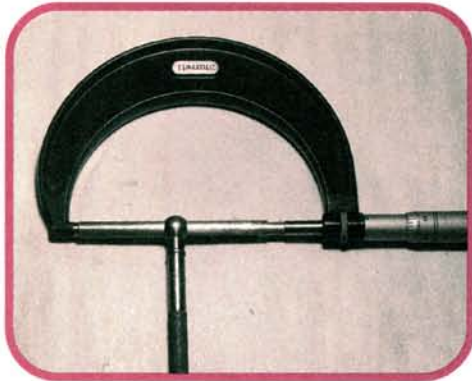
23

We transferred several telescoping gauge readings to an outside micrometer. Measurements ran 92.014-92.024 mm. Maximum out of round and conicity for the 92 mm bores is 0.01 mm (0.004 inch). Our gauge readings indicated that a 0.25 mm oversize bore would clean up our wear problems.

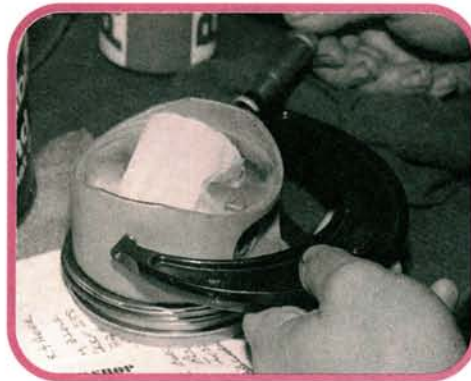
24

The box says these pistons are for a 92.25 mm oversize bore, but Guy at Gable Machine and Engine Shop wasn't taking any chances. Recommended piston-to-cylinder wall clearance is 0.02-0.05 mm (0.0008-0.0020 in). At the prescribed measuring height, our new pistons measure 92.22 mm — just right.

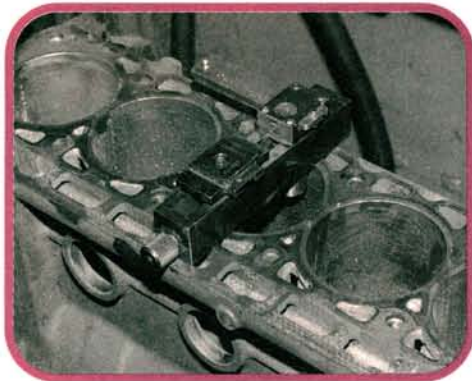
25

Guy double checked our bore measurements while setting up the machinery to hone the cylinders. We're enlarging the cylinder bores a relatively small 0.25 mm (approximately 0.010 inch) beyond their original diameters, so we can skip an appointment with the boring bar.

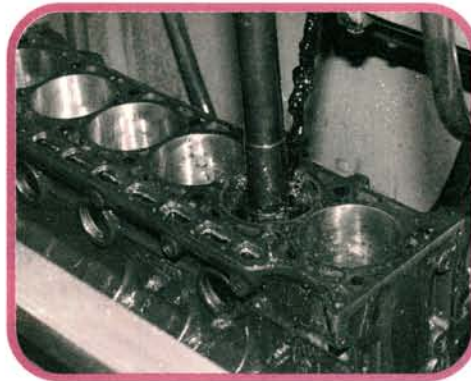
26

The block was honed in a three-step process. Starting with a diamond hone, we took the bores half way to their ultimate size. Progressing to a medium, then a fine hone, the bores were gradually enlarged to their finished dimension. Guy stopped several times along the way to check his progress with the bore gauge.

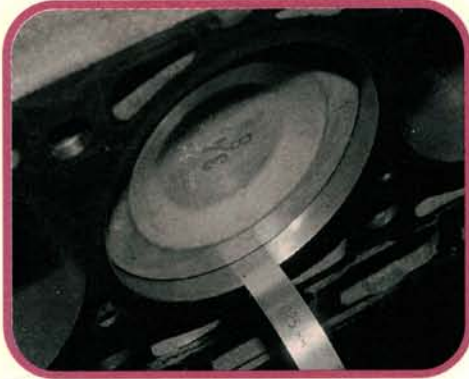
29

As a final bore check, lower a new piston into the freshly honed cylinders to measure piston-to-cylinder bore clearance. Hold the piston steady while inserting a feeler gauge between the piston and cylinder bore. If the bore has been properly honed, nothing bigger than a 0.03 mm feeler gauge should fit.

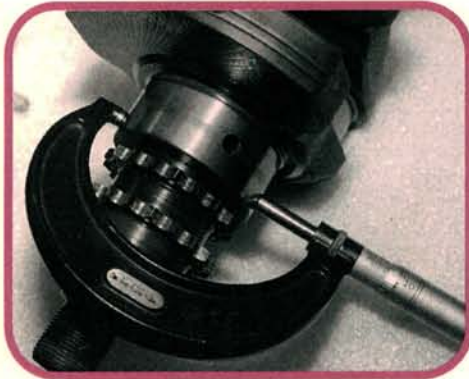
30

The crank looked relatively clean and undamaged. We used an outside micrometer to measure each of the journals at several different points to check for wear, taper and out-of-round. The rods showed a little wear, but were still in the middle of the recommended specs. The mains were even better.

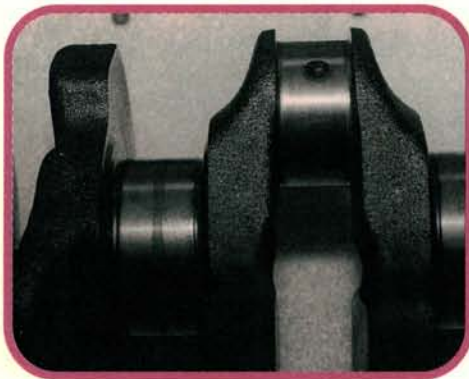
31

BMW uses a colored paint dot classification system to identify the original dimensions and clearance specifications for their crankshaft main bearing journals. This crank has red dots next to the journals, so we used the red classification chart when selecting bearings and measuring clearances.

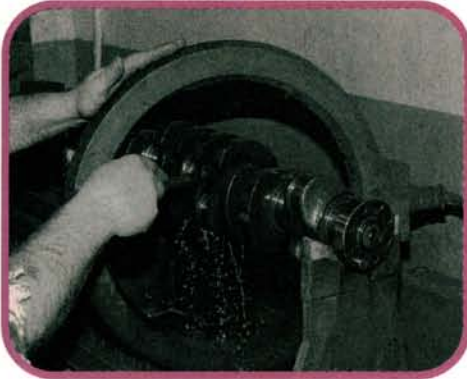
32

As a safety measure, Dale at Gable Machine magnafluxed the crank. After bathing the crank in a special fluid and magnetizing it with the ring shown here, he checked for cracks using a black light. Cracks usually appear near the connecting rod pins. Our crank received a clean bill of health.

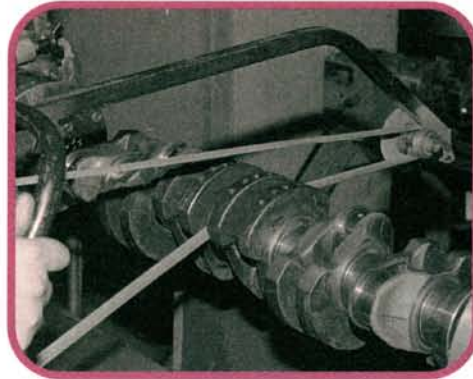
33

BMW doesn't recommend regrinding their crankshafts to repair damaged or undersized journals. As our earlier measurements indicated that the crank was still within acceptable limits, we settled for a simple polishing job. Measurement after polishing indicated we were still within specs.

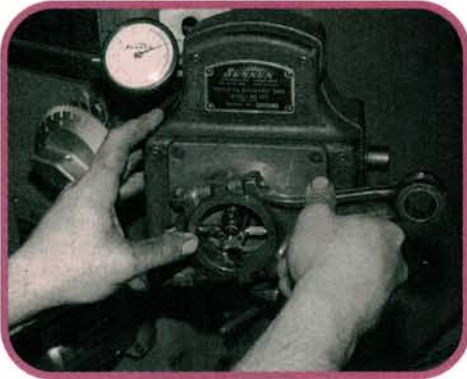
34

After 200,000 miles of pounding, the big ends of the connecting rods weren't as round as they used to be. This would cause uneven wear and clamping on the new bearings. After removing a small amount of material from the rod caps, we honed the rods until the original inside dimension was reached.

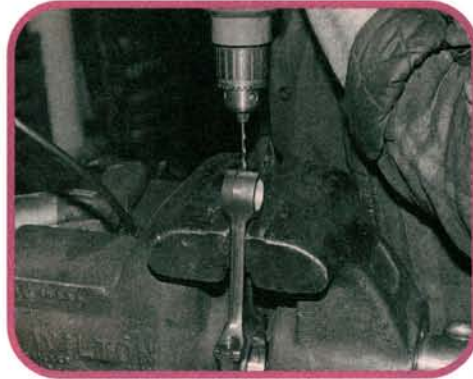
35

We can't forget the little ends. These are full floating pistons, so piston pin bushing clearance is especially important. After driving out the old rod bushings, we pressed new bushings into place. A small oil lube hole must be drilled in the top of the bushing before honing the bushing to size.

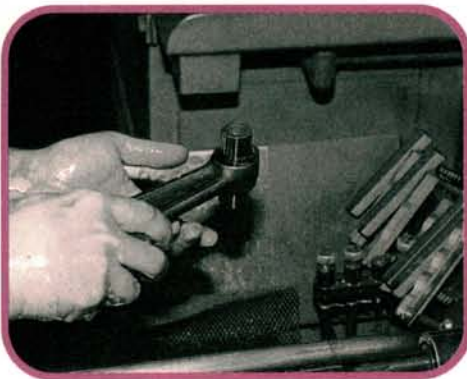
36

Guy transferred his new piston pin micrometer measurement to the hone gauge. Even though we had this sophisticated equipment to measure our progress, there's still no substitute for the human touch. When properly honed, the lubricated pin just barely slid through the bushing under its own weight.

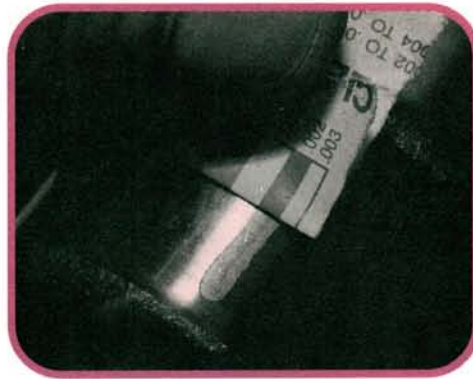
37

The crankshaft journals measured good, but we measured the rod and main bearing clearances with Plastigauge™ as a final quality check. Allowable clearances are listed according to the classification system. Our "no classification" rod journals called for a clearance of 0.030-0.070 mm (0.0012-0.0028 inch).
