Welcome back inside the friendly confines of Fort  $NO_X$ ! As you may recall, last month's issue featured a Honda which had failed the I/M 240 test for excessive  $NO_X$ . This month's car, a 1988 Volvo 240, was also an I/M 240  $NO_X$  failure. While the owner of last month's car had insisted there were no driveability problems, and had blissfully ignored the car's persistent pinging, the Volvo's owner readily acknowledged a lack of power. He also told us that his car pinged badly under all conditions unless he used high octane fuel. Even on high-test, the Volvo still pinged mildly on acceleration.

## Fort No<sub>x</sub> Part Three

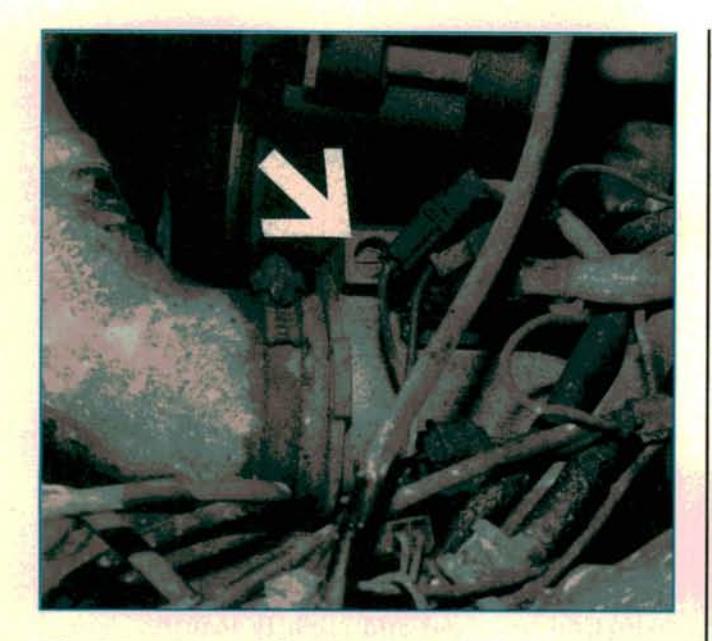
The CO section of the I/M 240 printout traces indicated a very lean condition. Most Volvos don't use EGR for  $NO_X$  control. Could it be something as simple as a mixture adjustment? It seemed unlikely, so we continued our step-by-step analytical routine. Refer to the subhead in last month's article for an explanation of I/M 240 trace analysis.

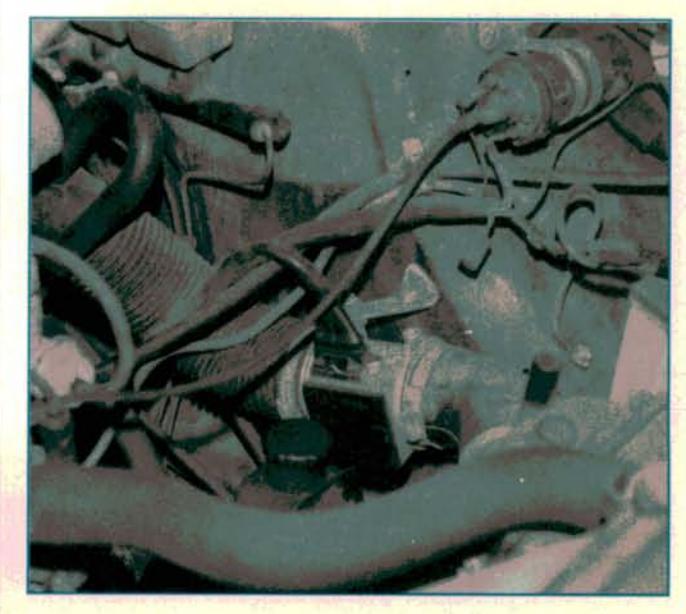
With last month's Honda still fresh in our minds, we took a few minutes to check the Volvo's preheat system. It uses a wax-pellet type system to control intake air switching. Our trusty heat gun confirmed that the preheat control door was cycling appropriately. Well, we really hadn't expected it to be that easy to find the problem.

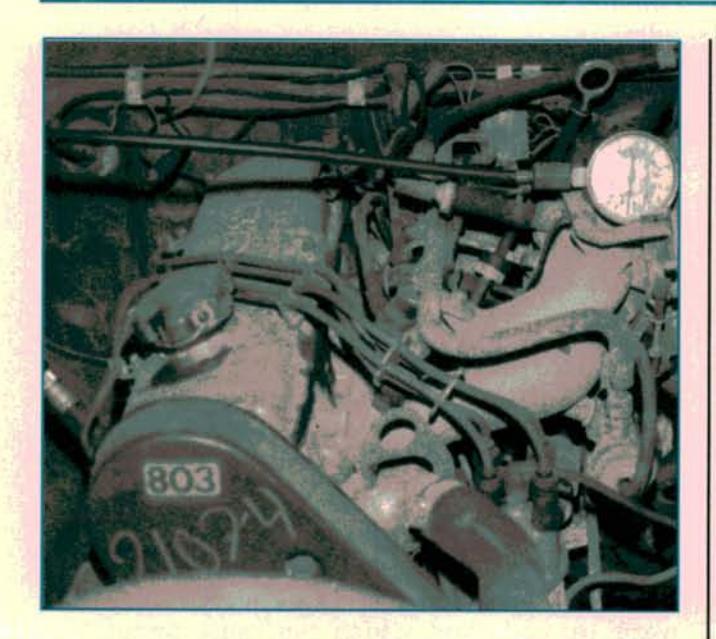
A road test confirmed the presence of a light ping under load and a lack of performance. The temperature gauge read normal. A compression check would rule out a valve timing or carbon buildup problem. A reading of 185 PSI on all cylinders seemed high for this engine. We rechecked ignition and valve timing. They were right on the money.

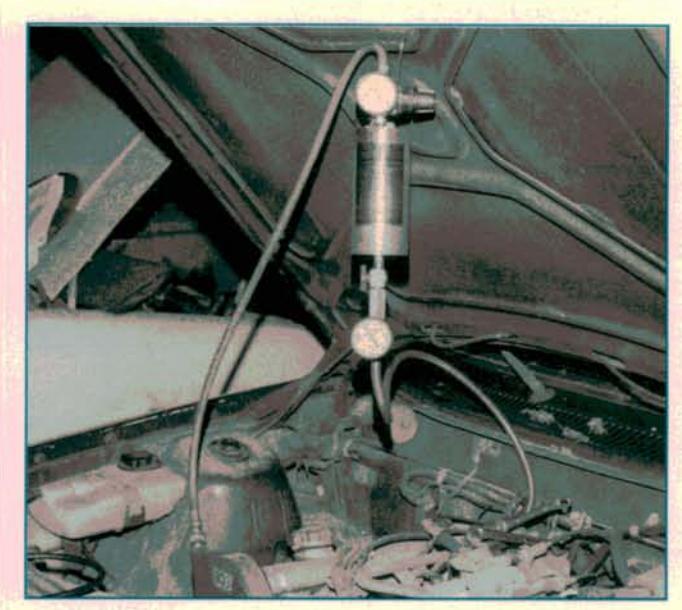
The next logical step was a thorough carbon cleaning. Clogged injectors could account for the lean running condition and the combustion chambers might be carboned up. We pulled off the fuel feed and return lines, looped them back onto one another, then started up the engine with our cleaning apparatus supplying the fuel.

The engine sounded dramatically better soon after we started it up. This seemed like an opportune moment to check  $O_2$  sensor function, so we pulled out our trusty lab scope, attached it to the sensor lead with a 10:1 probe and looked at the results. Not only did the motor sound fine, the  $O_2$  traces were those of a good-running engine.

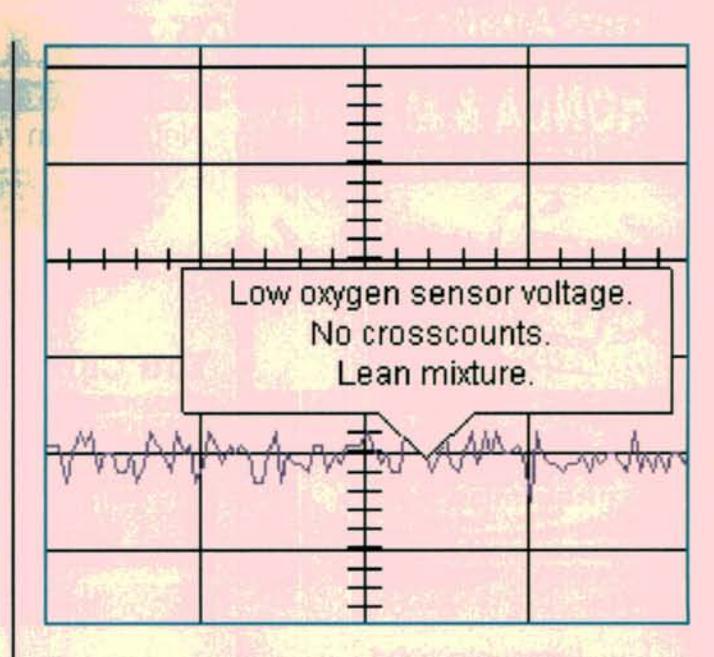
As soon as we restored the car to its own fuel system,  $O_2$  sensor activity ground to a halt and the engine was running lean again. It looked like the Volvo wasn't getting an adequate fuel supply. We pulled the return line off the regulator and measured a flow of about 750 ml in 30 seconds—more than enough volume.

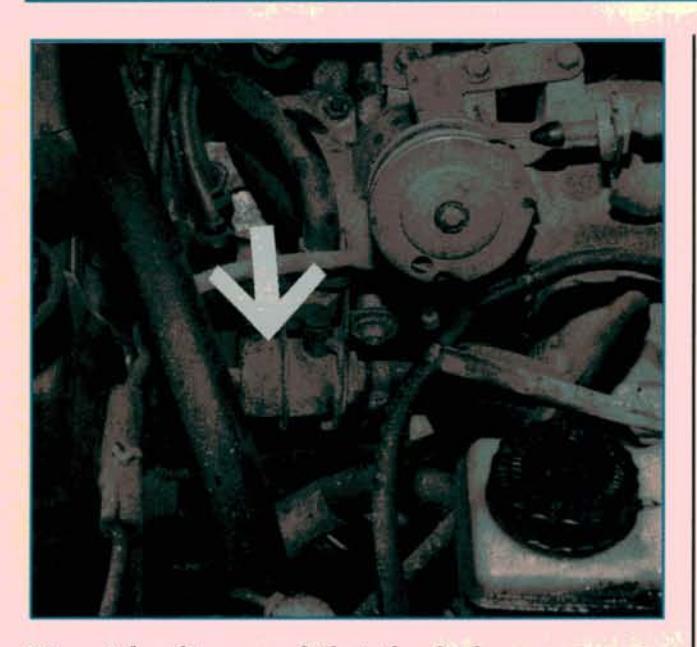
We quicky discovered that the fuel pressure was just 1.5 bar (20 PSI). With the gauge attached, we slowly clamped down on the return line until the pressure reached 2.5 bar (36 PSI).  $O_2$  sensor activity also returned to normal as pressure increased. We ordered a new pressure regulator and kicked ourselves for neglecting to check fuel pressure first.
