Subaru Emissions System Service

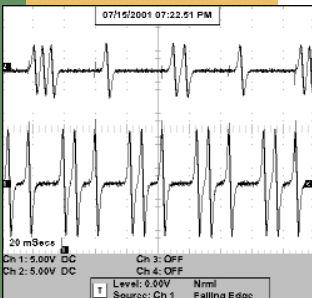
Camshaft sprockets may be damaged in a front end collision, necessitating replacement. Installation of incorrect components *should* result in a no start condition. However, we have received at least one report from the field of a vehicle that had the wrong camshaft pulley installed by a body shop during accident repairs. The engine ran, but very poorly. The Check Engine light was on, and a P0341 DTC (camshaft position sensor range/performance problem) was stored in the control unit's memory.

Both camshaft sprockets have the same number of teeth for the engine timing belt. However, they have a different number of reluctor teeth for the camshaft position sensor to read. Installing the correct camshaft sprocket corrected the running problem and eliminated the DTC.
