FACTORY SERVICE BULLETINS

These suggestions and solutions for technical problems come from service bulletins and other technical information published by Mercedes-Benz, selected and rewritten for independent repair shops.

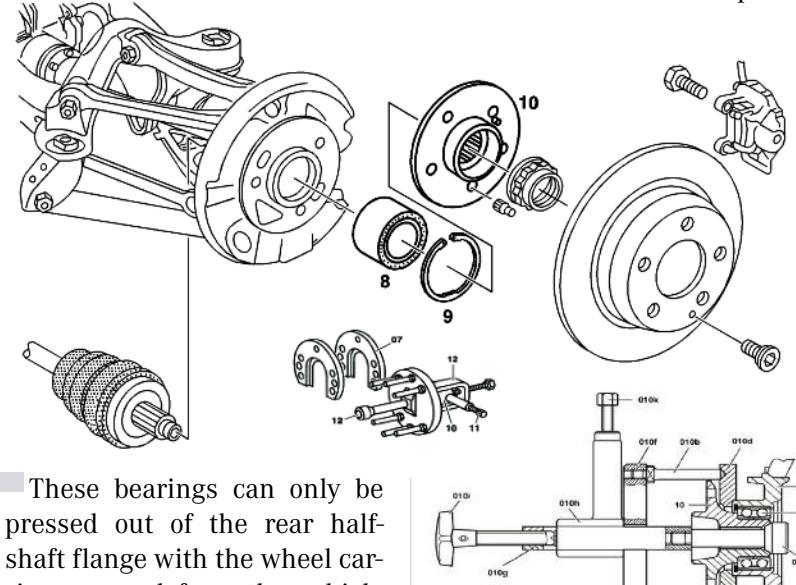
Removal of Rear Axle Halfshaft Flange with Double-Row Tapered Roller Bearings and Modification of Special Tool – Models 300TE, 300TE 4 Matic, 300TDT and E320 Wagon used on other models. The puller special tool number 202 589 04 43 00 is not designed to handle such forces.

These double row tapered roller bearings require extractor force three times that of the force required to pull the double row tapered ball bearings a spare part under the following special tool part number: 202 589 04 43 11.

The special tool puller should be modified with a shear pin, which is installed at the pressure screw of the hydraulic press. The pin will shear at a force of 40Nm, thus preventing any further pressure build-up at the hydraulic press, making the application (except on Model 124.090/092/193/290) of this tool safer on all vehicles. The modified pressure screw is available with the shear pin as

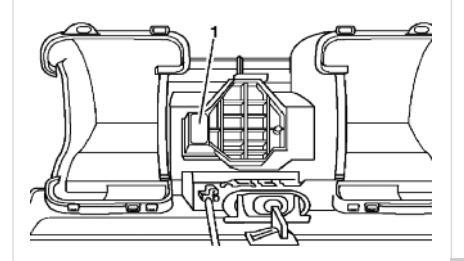
Effective with March, 1996 production, the overall dimensions of the blower motor have been changed. The overall length of the new blower has been shortened, so if the newer blower motor is installed it will shift due to not being seated. That is, unless an adapter around in the blower housing is used.

Note: The blower motor used prior to 3/96 production is approximately 12.5 mm longer than the newer blower motor. The longer unit can be used in vehicles made after that date if the end stop is removed using a suitable tool.

The adapter piece is supplied with the new blower motor, and must be inserted as shown for the new blower motor to properly seat in the blower housing.

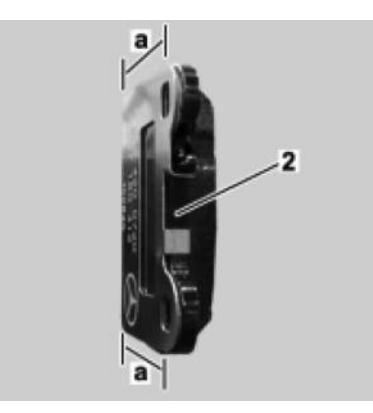
Although squealing brakes are not the problem they once were, the condition still shows up from time to time. It may be aggravated by cool, damp weather in combination with light braking effort. Besides switching to improved friction material, it's been found that the judicious application of brake paste to the ends of the pad backing plates as shown can reduce the noise. If you receive customer reports in the above model vehicles of brake squeal emanating from the front of the vehicle, please order the improved brake pads available from your local M-B dealer's parts department, and perform the following procedure:

2. Apply brake pad paste to the ends of the replacement brake pads' backing plates as shown. Reference WIS document AR42.10-P-0161-01GH

Note: Do not allow any paste to contact brake pad friction surface or apply paste to any other areas besides those specified. Immediately remove any excess paste that contacts pad front or
