MINIMUM OVERDRIVE: ALTIMA SHIFTING CONCERNS by Kerry Jonsson

Mid-'90s to early 2000 Nissan Altimas didn't have the most complicated transmission control system, but you should still look at it first before pulling the transmission.

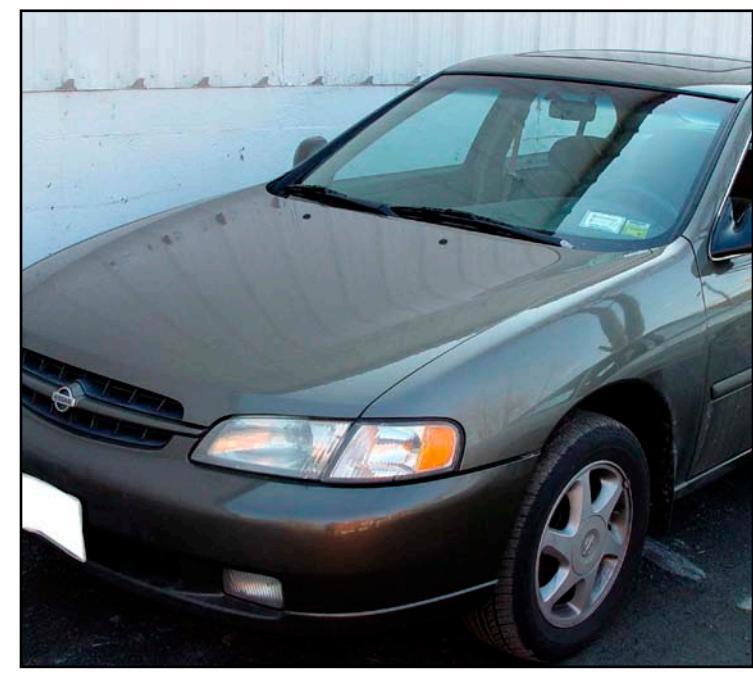
This Altima's trans was rebuilt, but it still shifted way too hard.

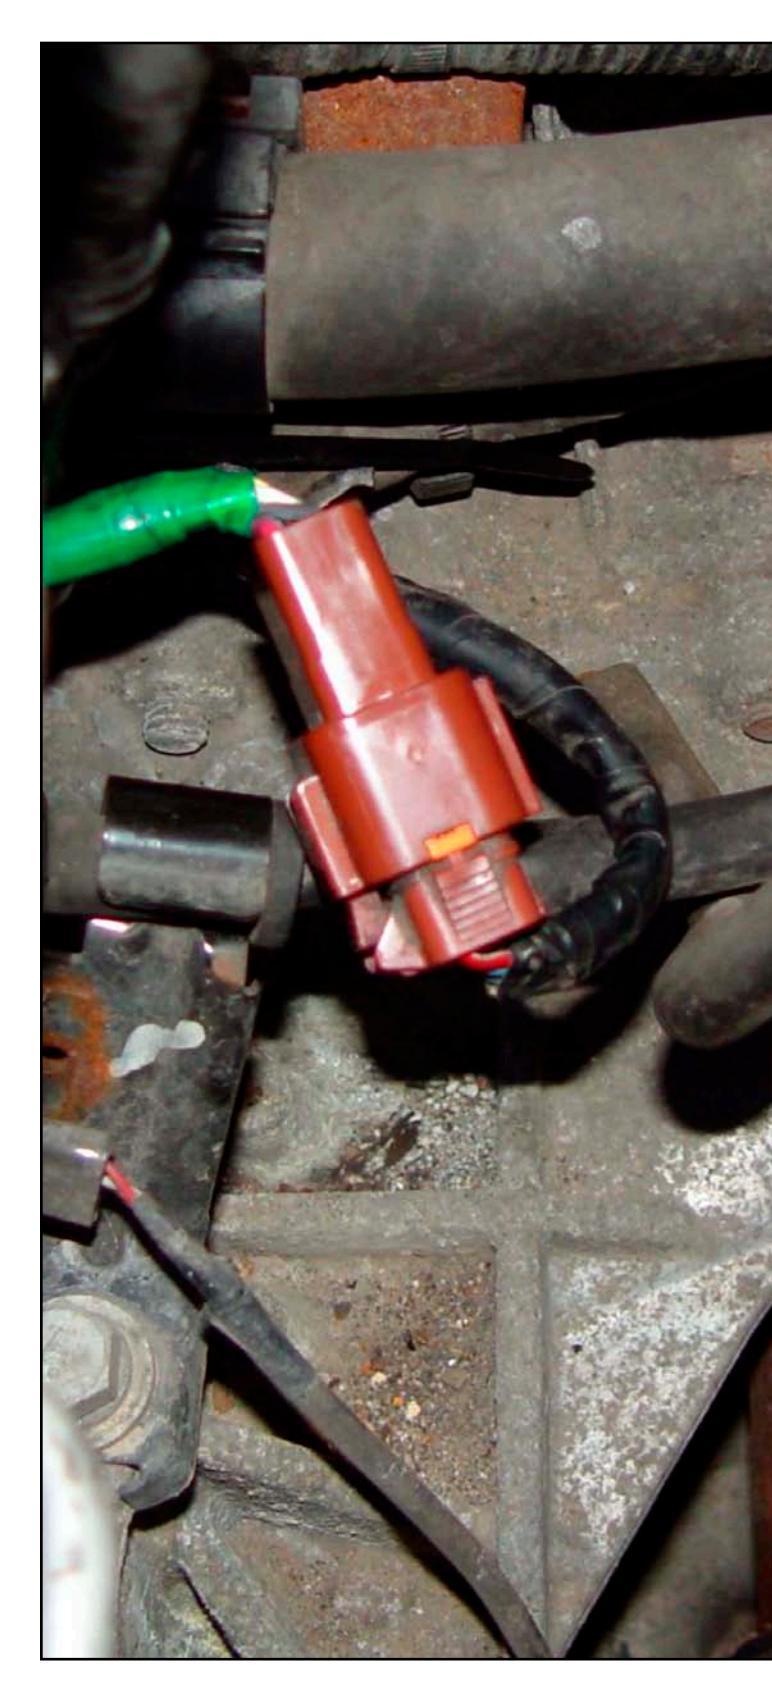
The transmission connector was easy to get to.

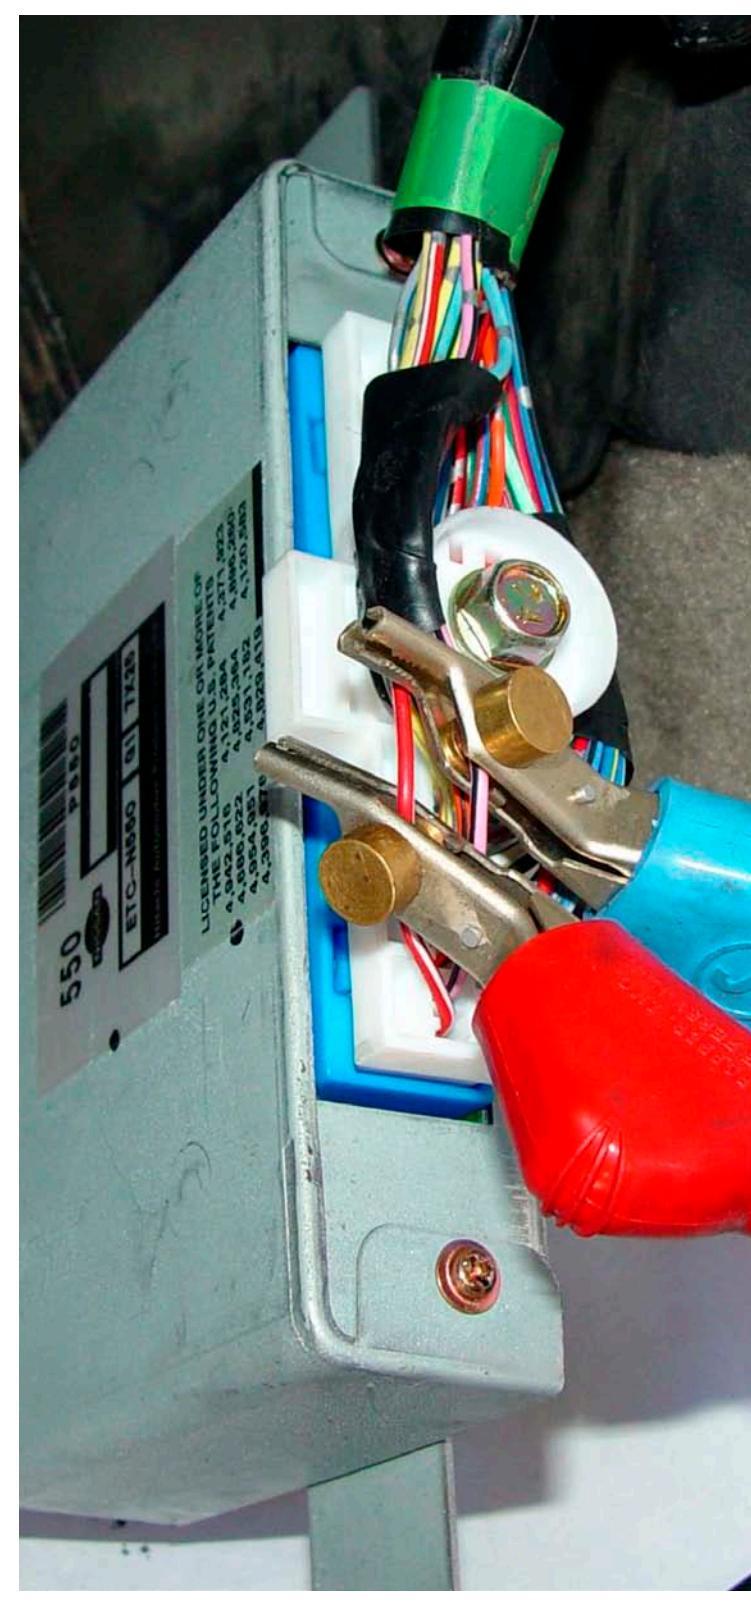
The lab scope leads tapped into the line pressure solenoid wires.

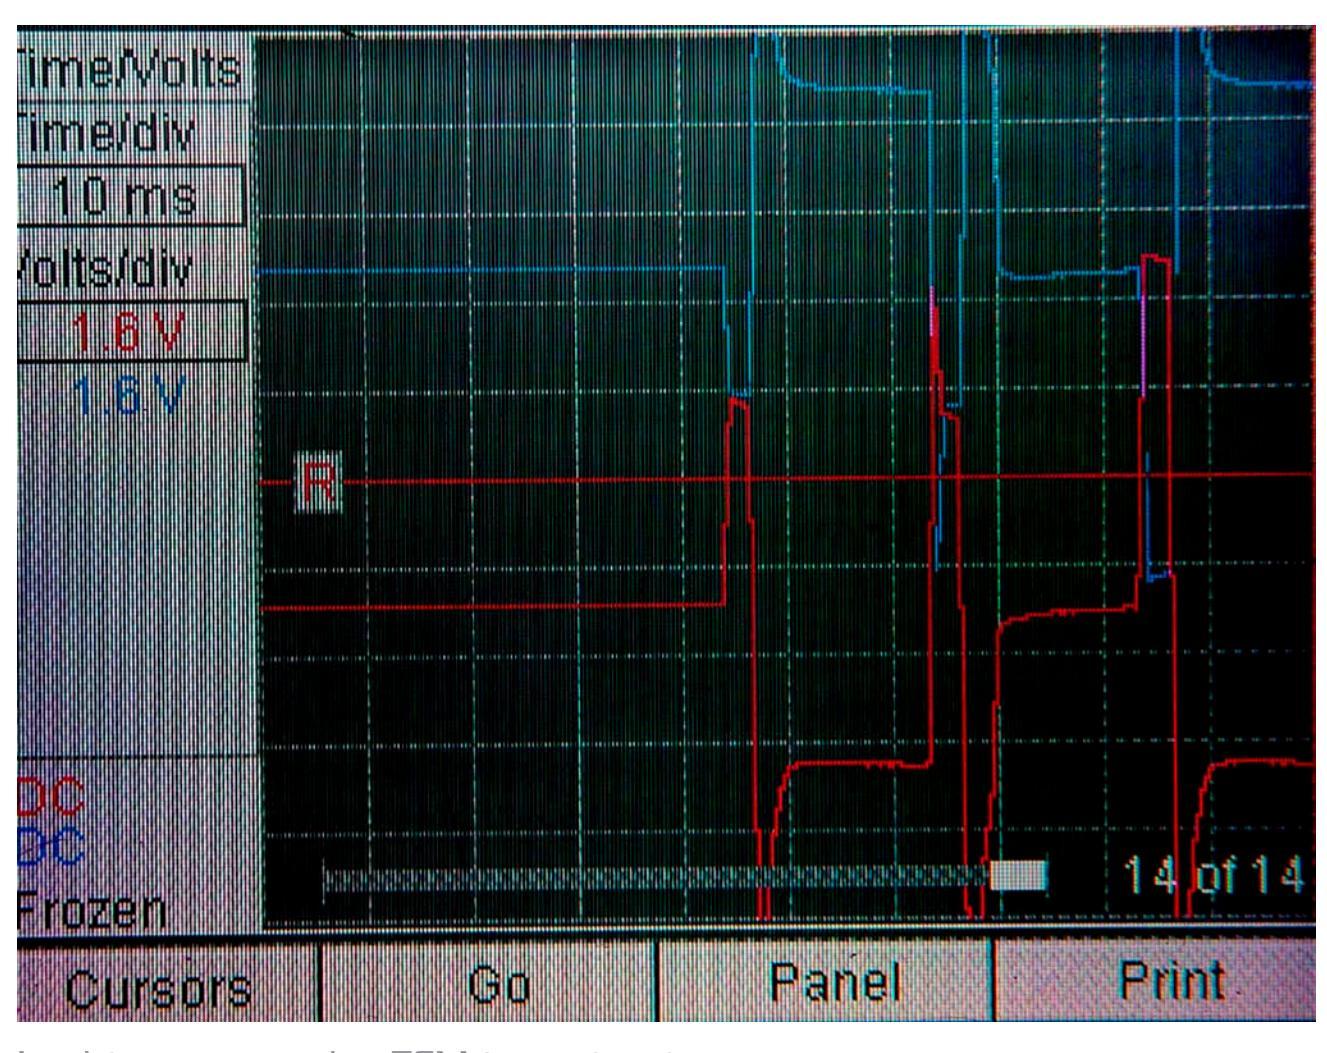
In this screen, the TCM is activating the line pressure solenoid.

Something strange happened on this car. After checking the dropping resistor, the TCM set a Code P0745, which wasn't present before. Now, at least we had something to hold onto and diagnose. Look at the scope pattern with the ignition switch turned on and right away you'll see the TCM activate the line-pressure solenoid through the dropping resistor and the direct line. The TCM activates the solenoid three times when you turn the key on. This is the circuit test for the solenoid. If it fails the test, Code P0745 will be set. In the scope pattern, the pink/blue wire through the dropping resistor is the blue trace, and the red wire is the red trace. Advanced scope users will notice that the patterns go below ground. None the less, you can still see the line pressure solenoid being activated. Now, look at what happens when the dropping resistor is unplugged, tested with the DMM, and plugged back in. Notice the blue trace. This is new! By the way, this was when the TCM started flagging Code P0745.

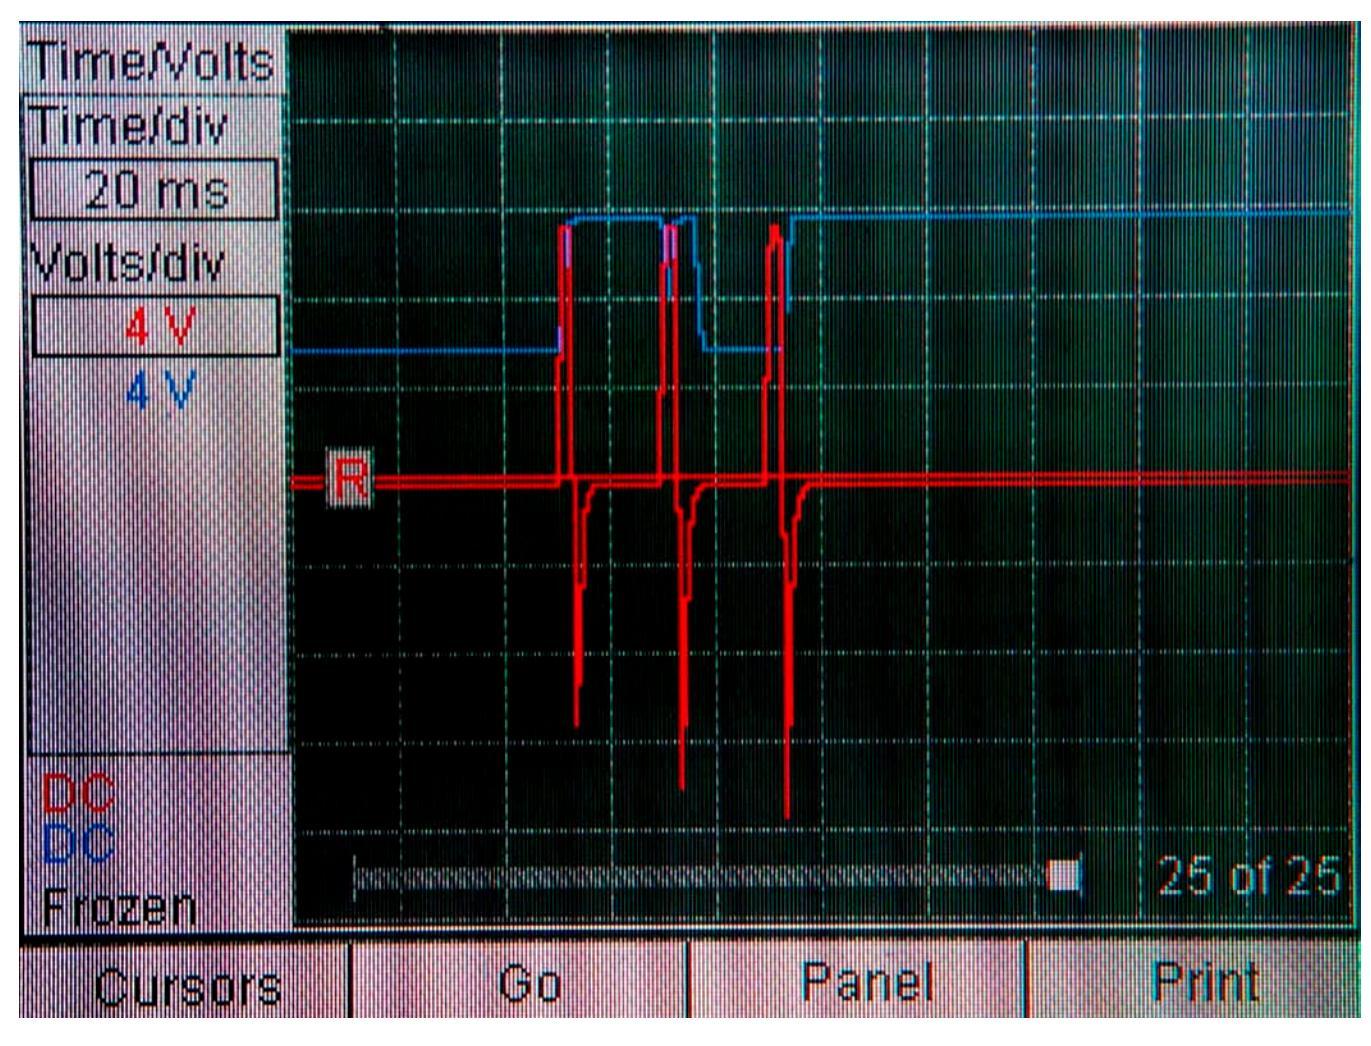
But wait! What happened?

from the transmission plug to the negative battery terminal and compared that reading to the resistance checks from the TCM to the negative terminal. They should be very close since only a few feet of wire would be added to the circuit. However, checking the resistance on the pink/blue wire with the dropping resistor reinstalled, we found an open circuit. We know the solenoid is not the problem because the resistance check on the direct wire is still 3.8 ohms. At this point, we assumed the dropping resistor had failed. The first time it was tested it indicated about 16 ohms (20 ohms overall circuit resistance minus the 3.8 ohms of the solenoid), but later it indicated open. The second scope pattern shows what happens when that circuit goes open.

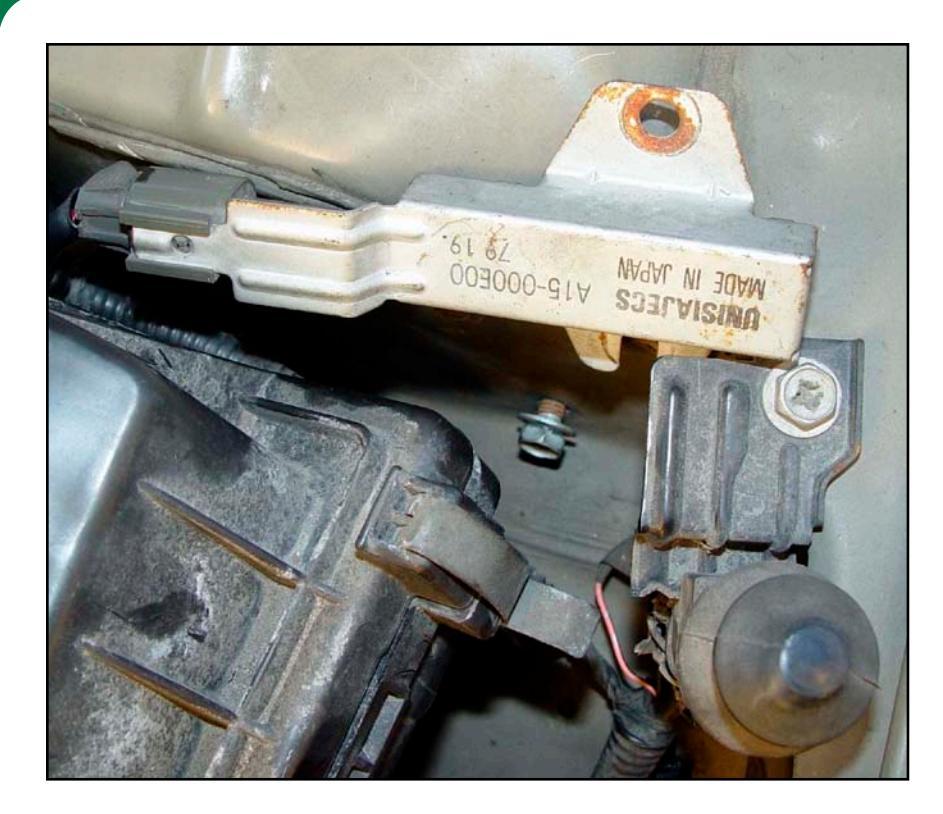
The offending component itself was inexpensive, but crucial.

the solenoids. Now that we know what was wrong, we realize that that would not have fixed the car. We now know to check the line pressure solenoid resistance and amp draw to determine if the solenoid is functioning. The transmission shop had the right equipment to test the solenoids properly, and that's why they didn't get replaced. We now know that the TCM pulses the solenoids three times at start-up and watches the voltage drop. If it doesn't like what it sees, it will flag the code. In the beginning, the solenoid passed the ground resistance test, but after testing the dropping resistor, and probably bending or breaking the wire in the process, we saw the resistor fail. We learned to go over the electronic/electrical components of the transmission, and saved the headache of R&Ring the transmission and replacing the solenoids for no good reason. Now, with a new, relatively inexpensive resistor in the car, we can return it to the customer confidence with that the job was finally done right.
