# 2015 Golf trunk floor replacement

*To help minimize potential weakening of adjacent panels, reinforcements, corrosion protection, and other critical body elements, Volkswagen recommends partial replacement of the Golf luggage compartment (trunk) floor pan if it has received collision damage. Here you'll find detailed examples of steps in the sectioning and replacement procedures for a 2015 Golf.*

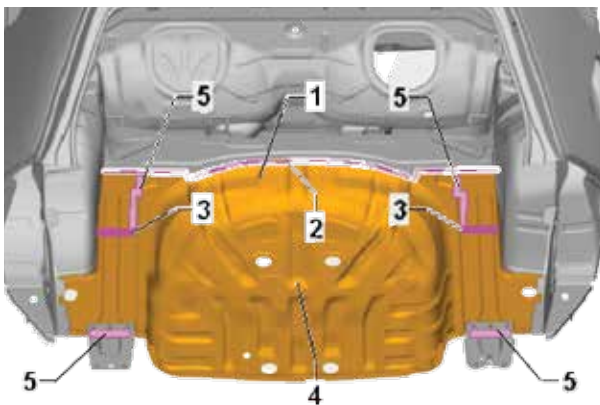
*Right: Volkswagen allows a separating cut at the dashed pink line (2) across the front end of the spare tire well (1). On each side there is a cavity containing a molded structural foam insert at (3), which you must inspect and replace if necessary. There is bonding adhesive joining the trunk floor to the frame rail and to the end plate or bumper impact bar bracket at (5), which must be replaced during floor pan reassembly. The spare tire retaining bracket (not shown) is mounted at (4).]*
