# Camshaft Control Systems Part IV: Timing Chain Guides & Tensioners

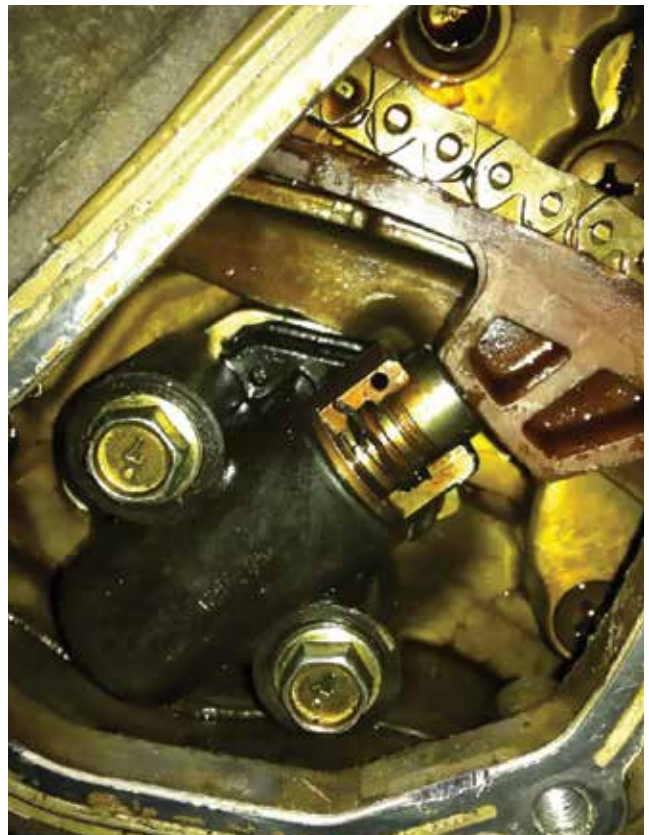
Here we see the tensioner contacting the correct portion of the guide, but the guide has broken and started to slide down the frame.

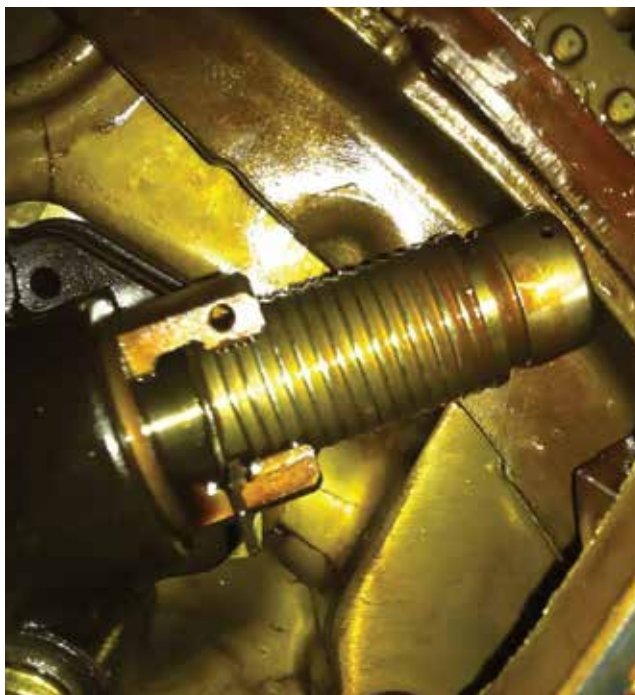
There is no TSB released from Nissan regarding slack guide breakage. It can be identified by a hard rattle on startup, typically after cold soak, from beneath the timing cover. Typically, the noise changes tune when the engine speed changes. As engine speed increases the rattle frequency increases, but the volume and distinctness decrease. Usually, the noise will go away once the engine warms up a bit, but not always. The first step in diagnosing this failure requires only a stethoscope. Probe around the timing cover area with it, and if the noise is coming from the right side (towards the rear in front wheel drive applications) on the upper half of the cover, then it is likely to be a broken slack guide. Luckily, there is an access panel that

Here we see a broken slack guide has completely dropped, and the main tensioner plunger has fully extended. Notice how the plunger is contacting the metal frame of the guide. You can check for this relatively quickly by simply removing the main tensioner cover.

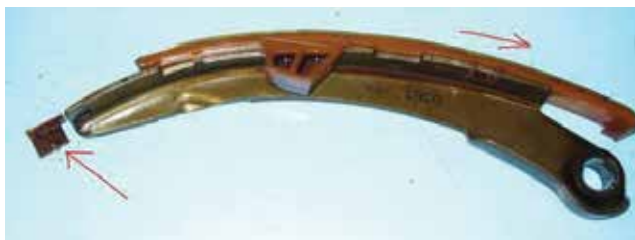
Typically the slack guide breaks near the top and the entire plastic portion slides down the metal frame.

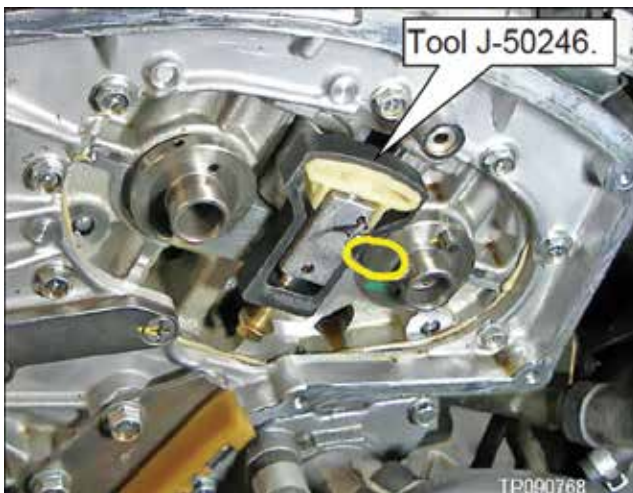
Another item on Nissan V6 engines is excessive secondary timing chain guide wear. This can be identified by a high pitched buzzing or whining from the secondary timing chain area. It increases in frequency as engine speed is increased. If it does not increase in frequency, then there is likely to be another problem and it should be diagnosed properly, per the service manual. The noise is caused by the chain rubbing through the secondary tensioner

shoes and thus riding on a surface that was not designed for this. This condition also makes it very difficult for the tensioner to properly tension the secondary timing chains. Nissan has released a TSB (NTB07-042d) detailing it, as well as upgraded tensioner shoes (P/N 13028-ZK01C) that don't wear out in this fashion.

This is a secondary shoe being replaced without removing the secondary tensioner. It requires special service tool J-50246.

The secondary tensioners themselves do not require replacement, as the worn shoes can be pried off of them easily. Special Service Tool J-50246 is required, however, to compress the new guide shoes into place

once the old ones have been removed. The tool can be ordered from Nissan's Tech-Mate authorized tool and equipment program website at [nissantechmate.com](http://nissantechmate.com).

The TSB also requires replacing both secondary timing chains, as they wear excessively due to lack of proper tension. All other components under the timing cover, including the secondary tensioners, will typically be reused, but they must be carefully inspected to ensure they are not worn.
