## Pre- and Post-Repair Scanning for Better Collision Repair Results

There is a surprisingly long list of ways in which failing to perform pre- and post-repair scans can ruin a collision technician's day. Read on for examples of how scanning for trouble codes can assist with diagnosis of both collision-related and repair-induced problems.

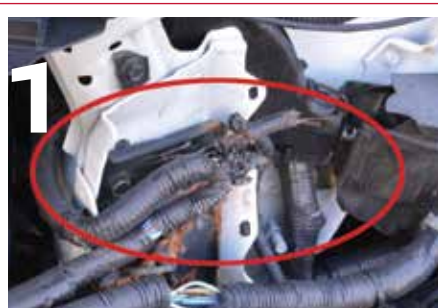
This front-hit 2015 Rogue® shows damaged wiring (red circle 1 – driver side) for the front crash sensor. Although the crash sensor itself shows no visible damage (red circle 2 – passenger side), it must be replaced because even minor impact-related internal damage can prevent proper sensor operation in a future collision. Pre-scanning would find a DTC (B0094, etc.) noting an issue in this sensor's circuit, and post-repair scanning would alert the technician to the need to calibrate the replacement crash sensor, or confirm that calibration had been successfully completed.

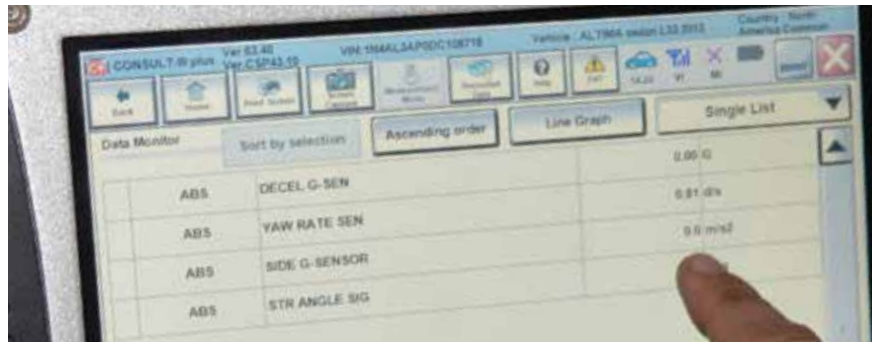
Nissan's CONSULT III Plus helps verify that sensors are functioning and that performance of the systems being monitored are within factory specification.

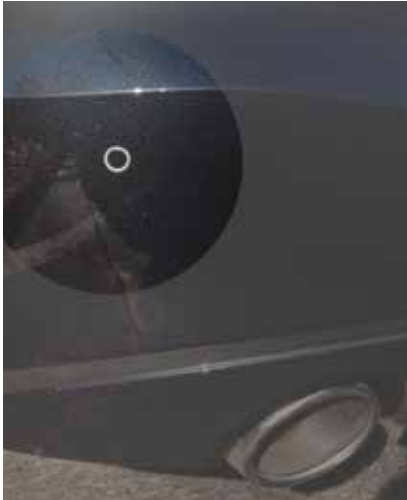
Electronic sonar sensors in Nissan front and rear bumpers are engineered to exact positions within the fascia. Aftermarket and recycled fascia may not meet the same specifications, and if the imaging technology cannot be properly located, may not function as intended.

Nissan has issued a Position Statement requiring that any replacement must be performed using only Genuine Nissan bumper fascia panels. Depending on the model, there is sonar or other imaging technology in Nissan bumper fascia.

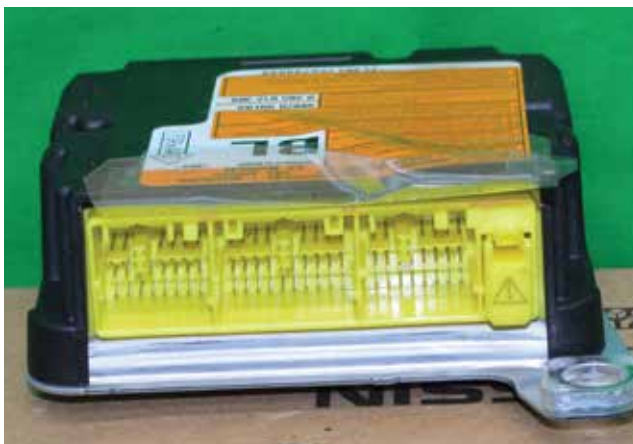
Tiny connector pins are fragile and easily damaged, even during removal and replacement of a module or component. Shown is the SRS diagnostic sensor unit for a late-model Nissan SUV.

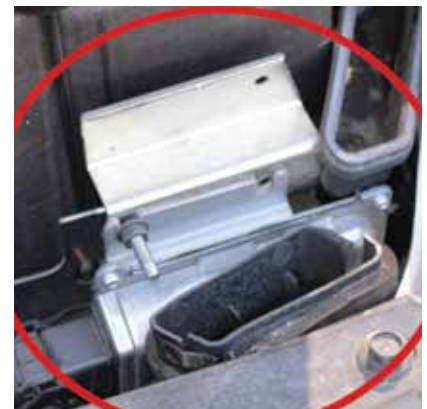
Pre-scanning for trouble codes may show that the ECM mounted in front of the battery on this 2015 Rogue® has suffered internal damage and must be replaced. Even if the ECM suffered no collision-related damage, post-repair scanning will detect if disconnecting and re-connecting any devices during the repair process has led to an inability to communicate properly with the ECM.
