HIGH MILEAGE VOLVOS

A LOOK AT SOME OF THE ISSUES THAT DEVELOP IN HIGH MILEAGE VOLVOS

850 AND S70/V70 SERIES (1993-2000) DOOR STAY REPAIRS

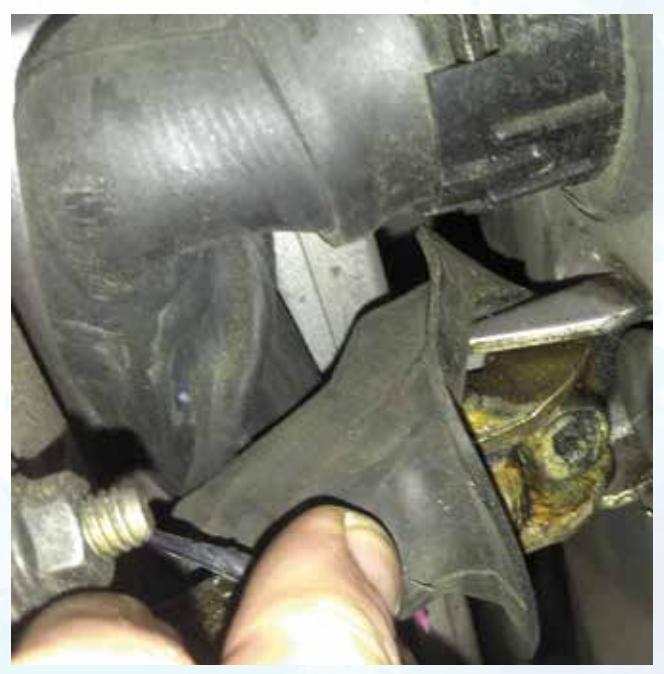
If you still see some of the good old 850 and early S70/ V70 series cars in your shop, you have probably opened a door or two to the sound of a loud crack or popping noise. In most cases the cause of the noise is damage to the part of the door sill that the door stay is bolted to.

Over time stress and metal fatigue take their toll on door sills and can crack. If you catch this problem in time it is relatively easy to repair, but if left unattended for too long the damage may become a larger issue that a body shop will have to attend to.

If you work on a lot of older Volvos, you have probably opened a door or two to the sound of a loud 'POP' or 'CRACK' noise, caused by cracks in the body where the door stay is attached. In most cases, this is a repair that can be done in house and, if done properly, can last for years to come. You will have to start this repair by removing the affected door from the vehicle. Luckily on these early Volvos, the engineers had mercy on the technicians and made the removal of the entire door assembly VERY easy to do.

A lot of shops will just grind down the paint around the door stay mounting and mig weld the cracks. This method usually only lasts for a couple of years at best because the area is already weakened and needs to be reinforced. Volvo's recommended repair procedure is to replace the mounting and weld the cracks around the door stay mounting.

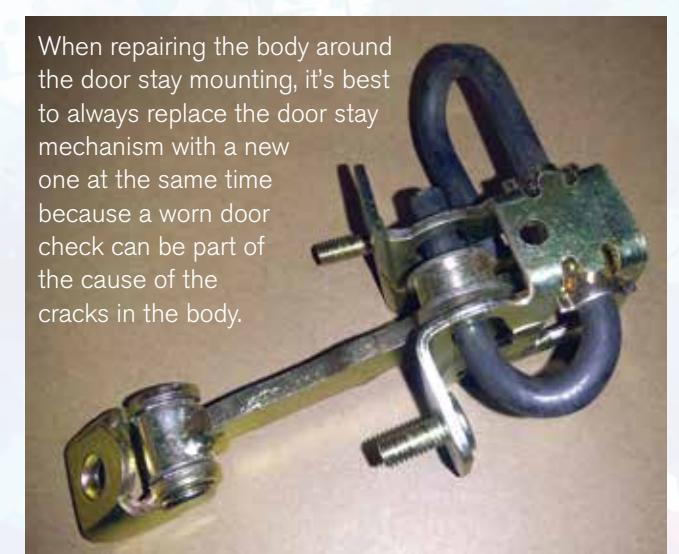
This service bulletin [TP 32395/2, Section 8 (81, 84) Body and Glass; 850 1992-] describes how to repair damaged door stop welds.

Door stop mountings are available as replacement parts if a mounting needs replacing.

Door stop mounting A-post is p/n 6817408-5. Door stop mounting B-post is p/n 6817409-3.

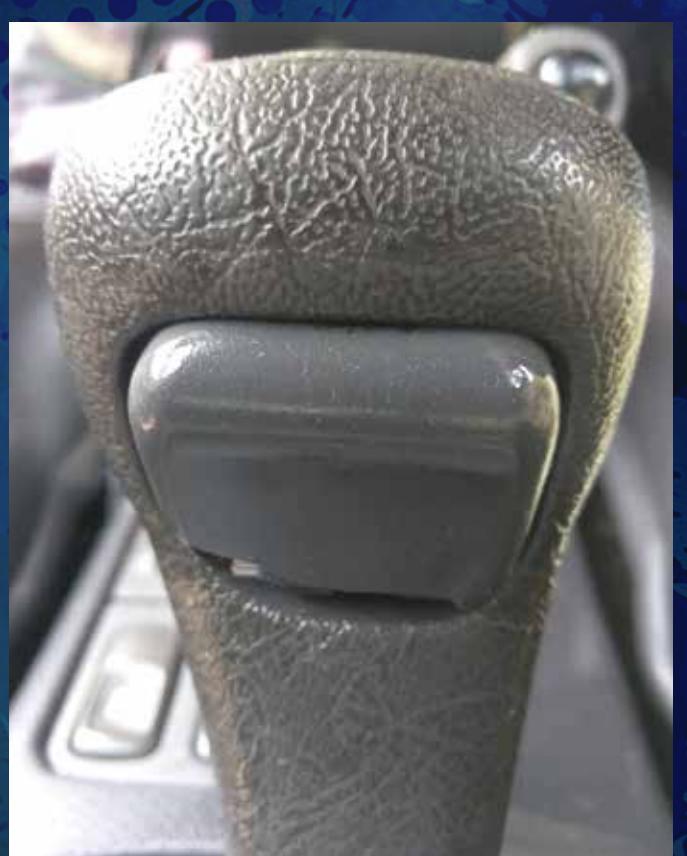
As Volvos age, some of the plastic components will become brittle and start to crack. In a lot of cases, this kind of wear is mostly cosmetic, but in the case of the plastic shifter button on Volvos with automatic transmissions, a cracked or broken shift button can turn into a problem.

If you are test driving a customer's Volvo and you feel a jagged edge on the lower part of the shift button, you should recommend replacement of the shift knob assembly before a sticking button causes a real problem for the customer.

Replacement of the shift knob assembly on most of the affected Volvo models is relatively easy. To remove the old knob, start by applying the parking brake so the car won't roll and turn the key to the first position so you can put the car in neutral. This is so the shifter is pointing straight up towards the roof of the car.

Now take a panel tool and loosen the boot at the bottom of the shift knob, grab the shift knob with both hands and pull straight up. This can take some force, so make sure you don't hit yourself in the face when the shifter comes off the stalk.

To install the new shifter assembly you got from your local Volvo dealership parts department, just slip the new knob onto the shifter stalk and press down until it clicks into place. This can also take some force. If necessary you can use some shop towels to protect the top of the knob and tap it into place with a rubber mallet. Test the function of the new shifter and re-install the boot into the bottom of the shift knob.

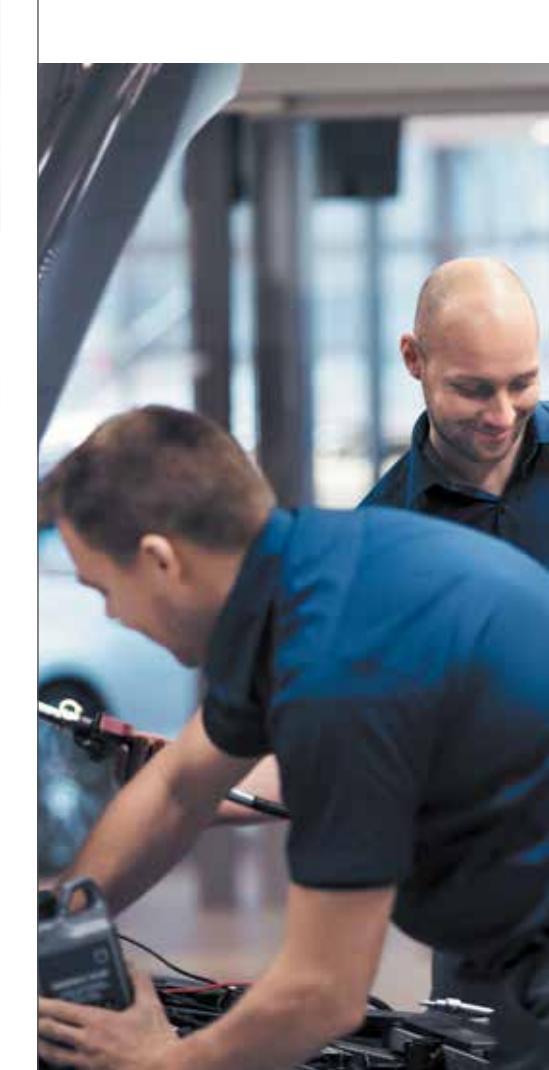
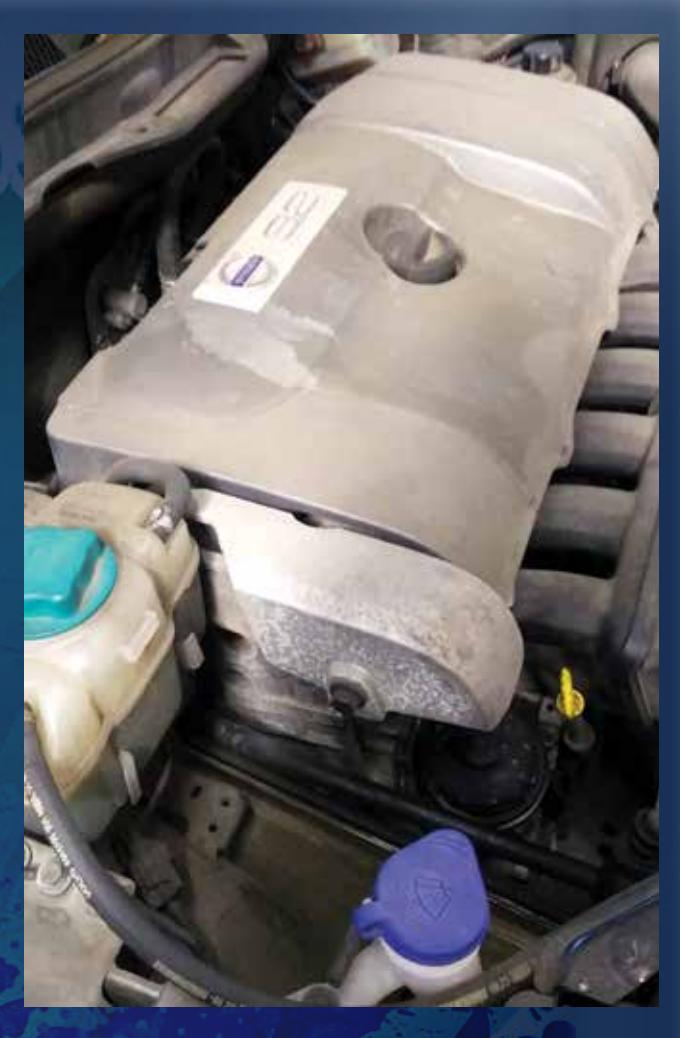
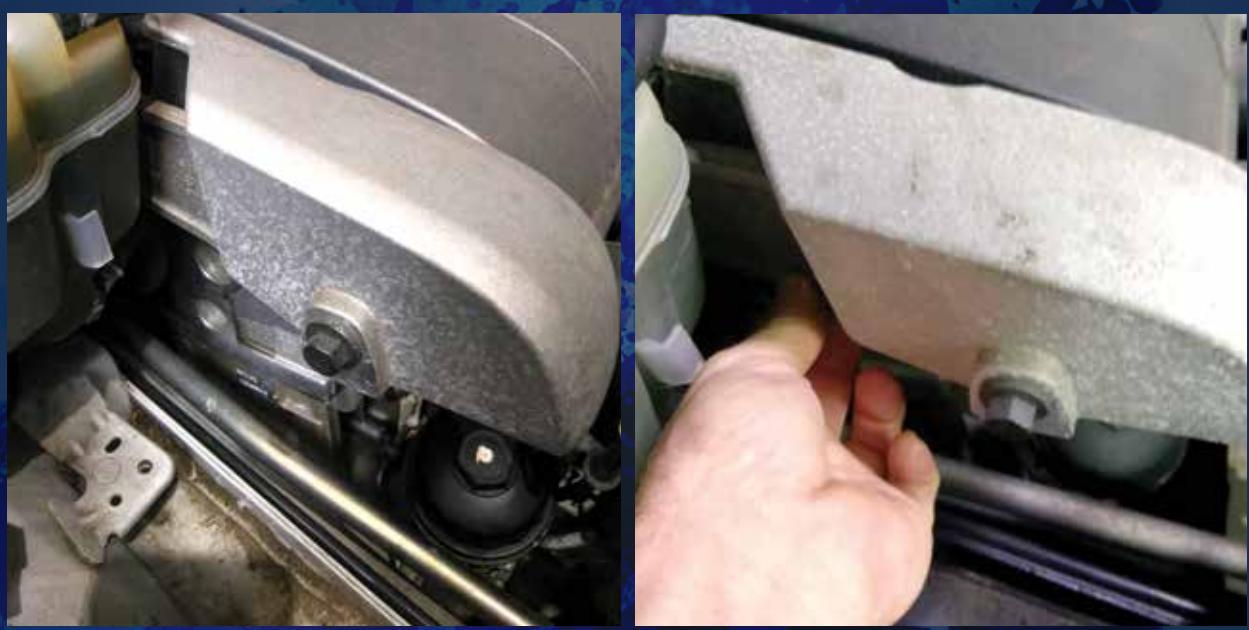
You may get one of these later XC90s in your shop equipped with the SI6 3.2L short six cylinder engine, with a customer complaint of an intermittent grinding or rattling noise coming from the engine area under light loads. The symptom usually happens more when the car is cold and can sound like there are rocks being ground up in the transmission or bevel gear.

If the torque rod is worn out, it will rattle around when you grab it from the bottom to check for play. When you remove the torque mount you will usually see the front bushing is cracked and shrunken.

When you are checking out a Volvo equipped with the SI6 3.2L engine, make sure you check the upper engine torque rod mount by grabbing it from the bottom and shaking it. If it rattles, replace it. These mounts can cause very strange noises while driving at low speeds, sometimes the noise sounds like a grinding transmission or angle gear.

When you replace the upper engine torque mount tighten the bolts to 80 N-m.

This sound is usually intermittent and can sound like the drivetrain is ready for the scrap pile, but before you break the bad news to the customer, you should remove the upper engine torque mount and test drive the car again.
