# VOLKSWAGEN GOLF TRUNK FLOOR REPLACEMENT

The sectioning and replacement procedures for the trunk floor of a 2015 and newer Golf differ from those for prior year models. The new procedures take into account Volkswagen design changes that improve trunk floor reinforcement and corrosion protection. Here you'll find our tips extracted from the factory-approved repair procedures.

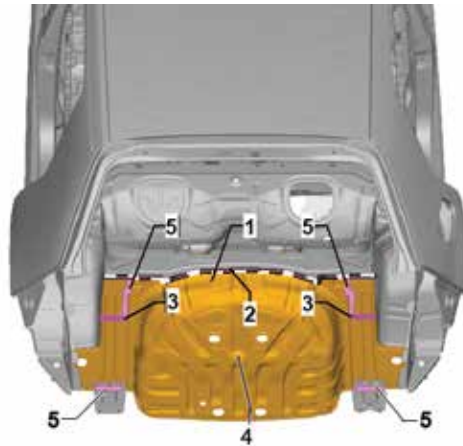
*The factory-recommended sectioning cut is represented by the dashed black line (2) across the front of the spare tire well (1). Cavities on each side contain a molded structural foam insert (3), to inspect and replace if necessary. You must also replace bonding adhesive which joins the trunk floor to the frame rail and to the end plate or bumper impact bar bracket at (5). A spare tire retaining bracket (not shown) is mounted at (4).*

Inspect the existing molded foam insert to make sure that it has not lost its shape or flattened out. If it is in good condition, save and re-use it when you install the replacement floor pan. If not, cut out a replacement insert from a universal molded foam closeout panel (part number 000 864 663).

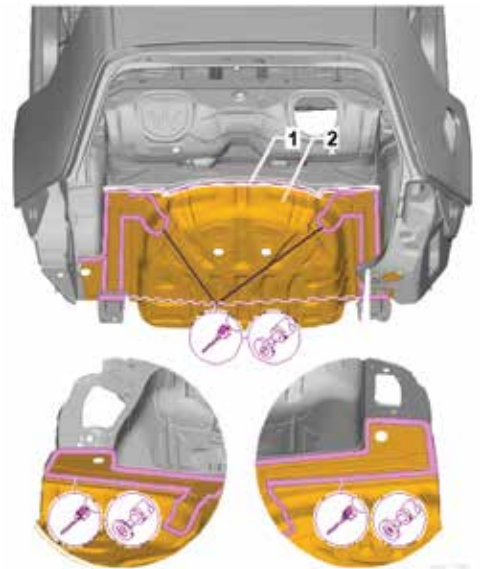
*Your separating cut (1) must allow room for overlap between the replacement pan and the remainder of the existing floor at the front of the spare tire well (2). Drill out any spot welds where the pan joined the frame rails, the reinforcement under the front of the spare tire well, and the sidewall support area for the tire well. Then remove the pan from the vehicle.*

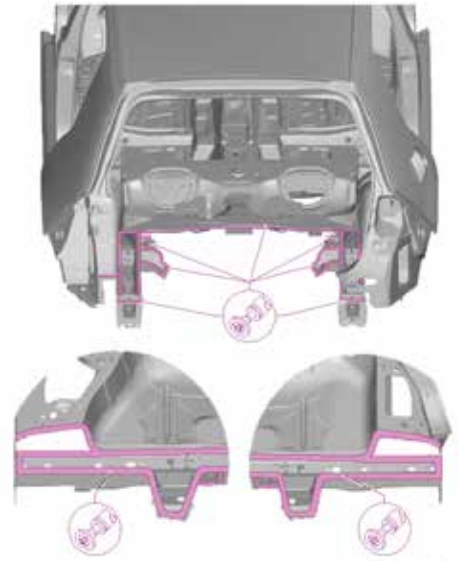
*After floor pan disposal, remove adhesive remains and grind welding surfaces down to bare metal.*

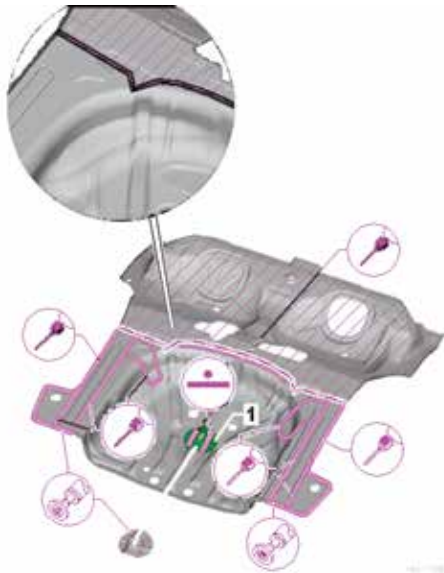
*Transfer the separating cut to the new trunk floor pan, then cut and remove the shaded area. This will allow overlap of the new pan with the old floor. Drill or punch 7 mm diameter holes for the MIG/ MAG plug weld seam. Weld the spare tire retaining bracket (1) to the trunk floor using a straight line spot weld seam on each side of the bracket.*

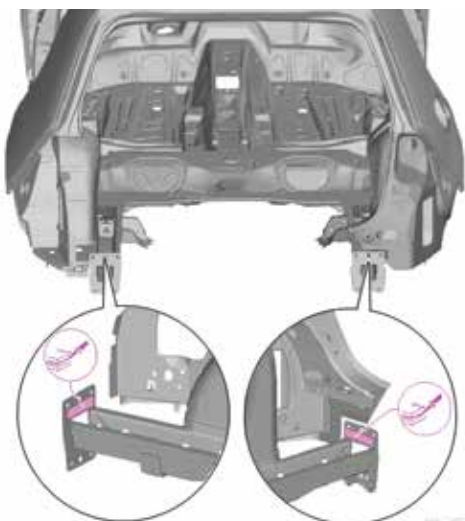
Apply two-part body adhesive (VW part number D 180 003 M2) to the side of the bumper bracket facing the rear seat. Fit the replacement floor pan with the vehicle secured to an alignment bracket set on a frame bench, or while it is standing on its wheels.

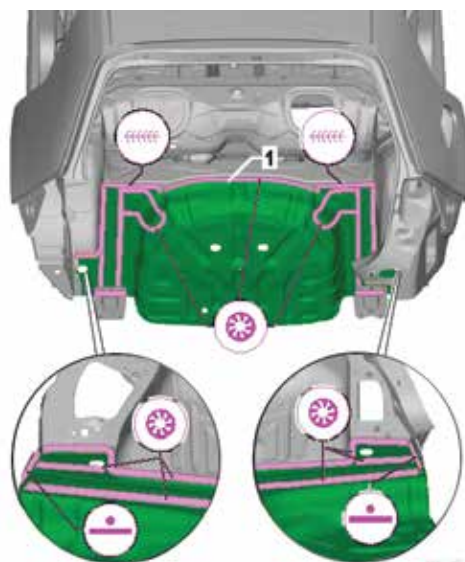
The Volkswagen repair manual shows use of MIG/MAG continuous seam welds for the left and right side front floor pan overlap. It shows MIG/MAG plug weld seams to weld the curved front (1), the vertical reinforcements that support the spare tire well sides as they curve toward the front, and the sides above the frame rail. A straight-line spot weld seam is used to weld the ends of each side.
