# derFIX<sup>®</sup>

Technical Knowledge for Volkswagen<sup>®</sup>, Audi<sup>®</sup>  
and Porsche<sup>®</sup> Service Professionals

**VW 01M  
SPEED SENSORS**

**2.0L BEV ENGINE  
WITH AUTOMATIC  
TRANSMISSION**

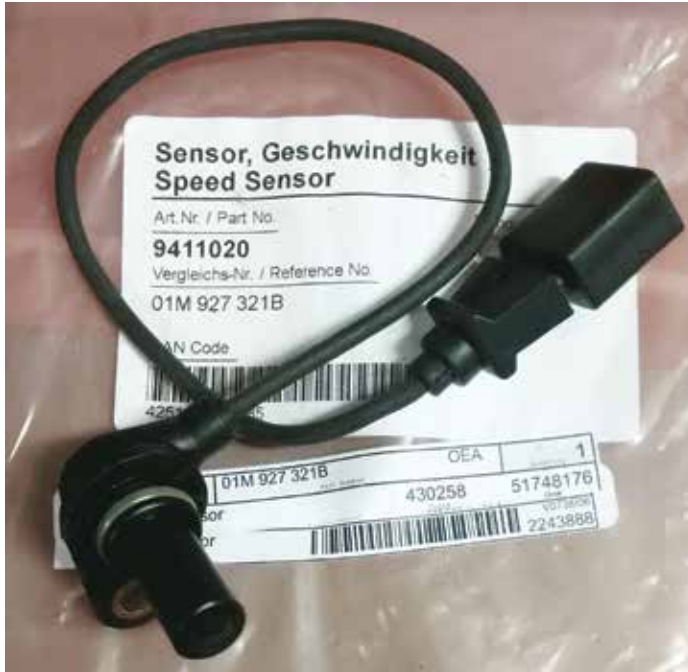
The fourth field is road speed. It is the output shaft speed at G68. With an open circuit and since the output shaft speed is not being read, the transmission sets limp mode, harsh gear engagement and starts out in 2H while in D with the wheels spinning at about 10 mph for a short period. The view is TCM group 004, field 4 and also found at TCM group 003 field 1.

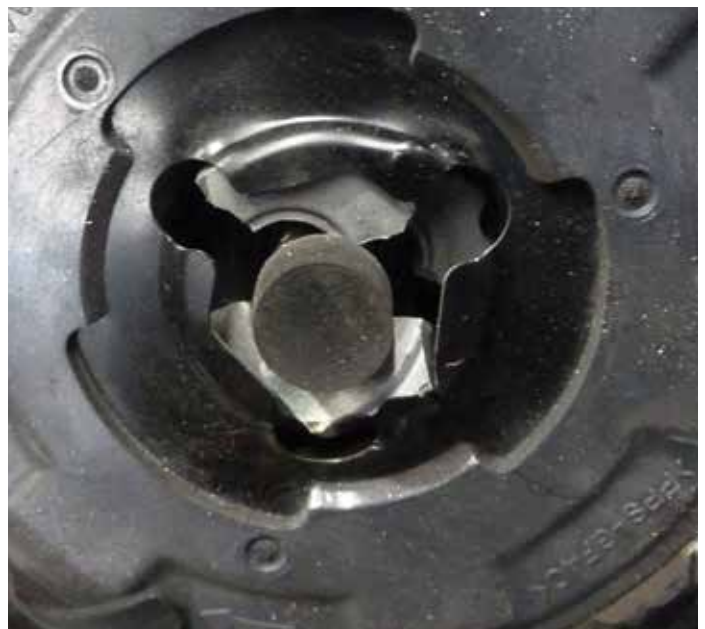
*This compressor was exhibiting a clunking noise.*

locking up if it becomes damaged. This pulley design also dampens the compressor from engine forces. Often, a low or empty refrigerant level can cause pulley failure. The refrigerant and oil normally act as lubricants, keeping the inside of the compressor spinning smoothly. Without them, overheating of the internals may occur, causing extreme drag and eventual pulley failure.

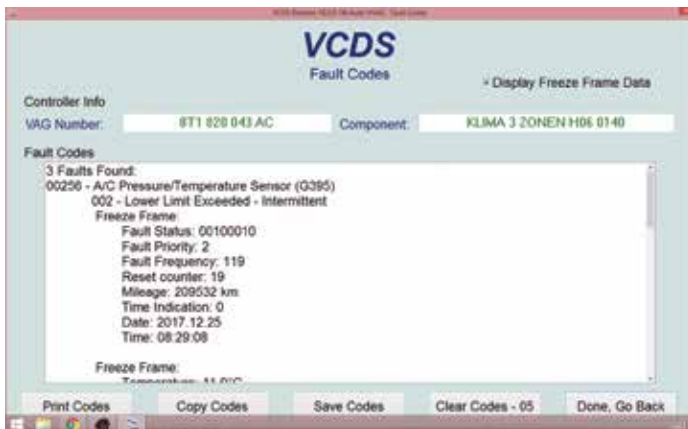
*This vehicle was low on refrigerant charge, setting the lower limit exceeded fault.*

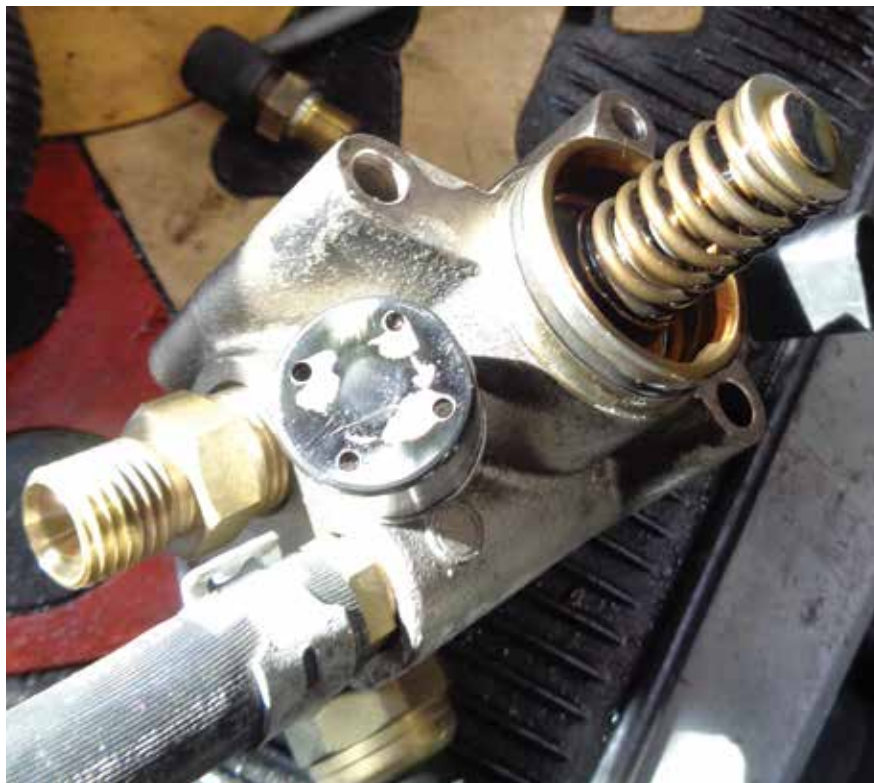
*This high pressure fuel pump shows signs of wear on the piston head as well as cam follower. It should be replaced.*

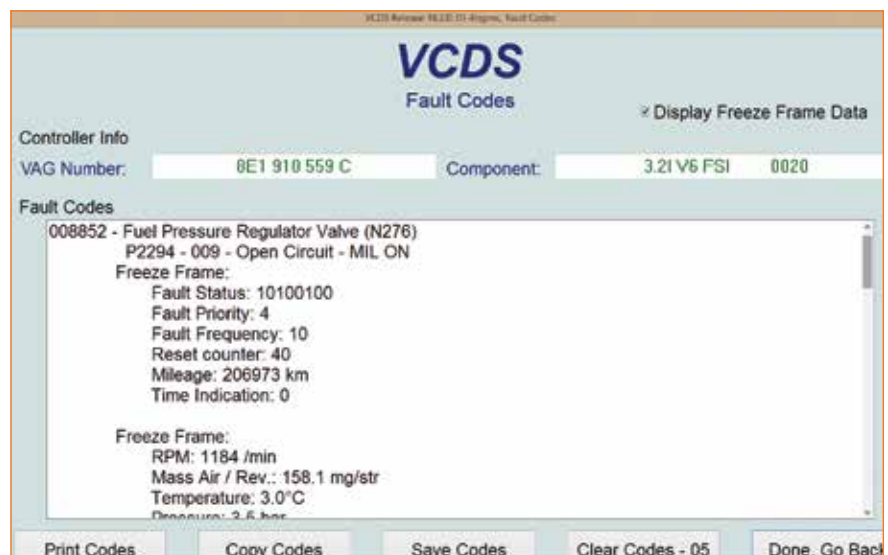
*After pulling this fault code and checking wiring connections, this vehicle was determined to need a new high pressure fuel pump. The regulator valve is not serviceable separately.*
