XENTRY

and OBD II
Go Deep

XENTRY at work on communication errors

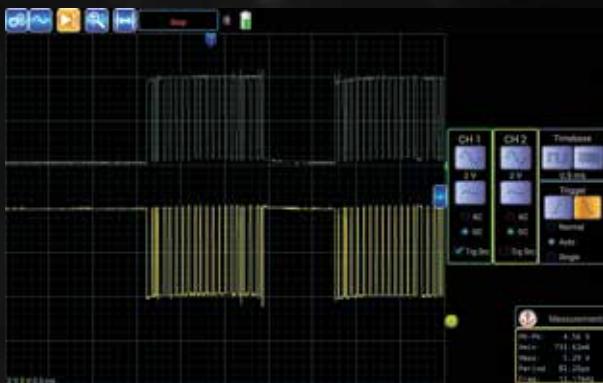
The oscilloscope used for this simple test is Bluetooth-connected to an Android-based tablet. The probes used are 10:1 switched and were set to the 10x position.

The image “CAN B expected” was captured with KOEO while connected between the CGW Gateway and the CAN B connector station. Wire colors are: Brown (CAN L) and Brown/Red (CAN H). The “CAN B expected” image indicates a normal and standard view of a CAN message. This is to be expected and follows the voltage rules on this network. Capture/Save the screen and leave the settings on the scope in the same state.

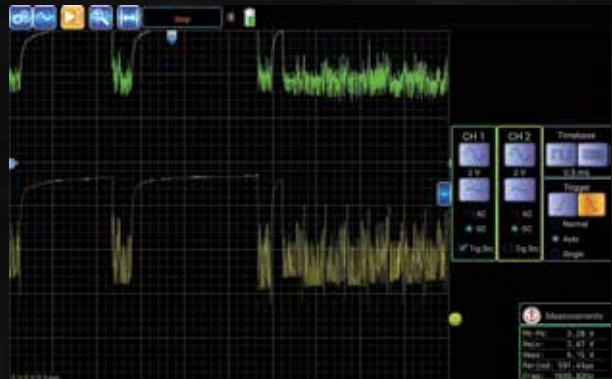
This is not the expected image and is part of the theory as to why there is a disturbance within the network and partial loss of communication. Capture/Save this and other screen images of importance. With the scope operating and leaving the probes connected, remove one connector at a time. If nothing changes, reconnect that connector and move on to the next one while viewing the oscilloscope image. If the image normalizes, leave the connection off and mark/band it for later tests.

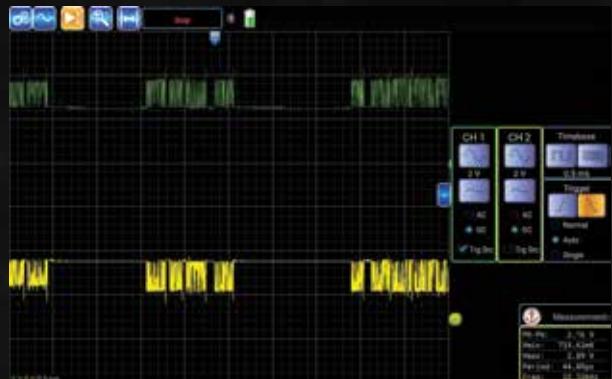
This image “CAN C expected image“ is what should be predictable following the voltage rules for this particular CAN system. What is not known currently is who the “bad actor” is after that connector was removed from the network station.

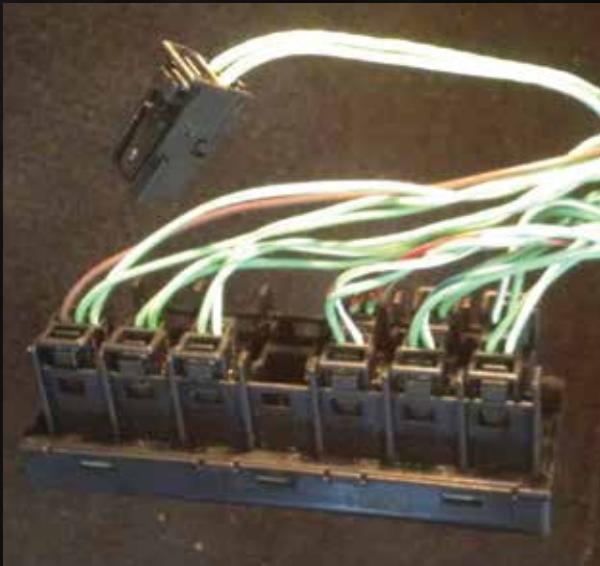
The defective controller unplugged.

The count now is 35 controllers with IRS-HLA - Outer left rear intelligent radar sensor system missing within the scan. Follow the fault for IRS-HRA and note the remaining fault. In total, this model will have 36 controllers active.

Vehicle	164.125	Control unit	IRS-HRA
Event memory			
Code	Text	No.	Status
552002	No CAN message received from component B2974 (Left rear bumper intelligent radar sensor)	0	Event CURRENT and STORED

Disconnect the harness at the station again and look for a normal oscilloscope pattern. Inspect both Blind Spot Monitoring modules and harness connections of the vehicle.

Choose either left or right, but disconnect one side and confirm with the oscilloscope. If the correct/defective module is disconnected, the oscilloscope reading the CAN pattern returns to normal and XENTRY will produce a final outcome. On the last Quick Scan, one controller is not recognized because it has been disconnected, but the network is back to normal.
