Technical Knowledge for Volkswagen®, Audi® and Porsche® Service Professionals

November 2019

This Audi Diagnosis Was Bad Timing for All

2005 Jetta 2.5L PCV/Vacuum Leak

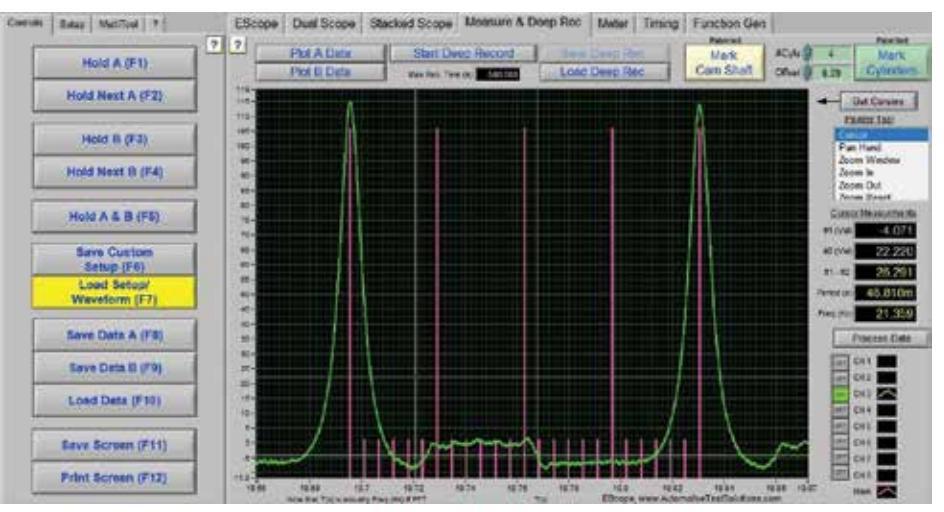
Bank 1 was measured for cam timing. The waveform proves a normal cam timing profile with the exhaust plateau appearing between the second and third large purple marks. Both intake and exhaust camshafts are within specification for proper cam timing.

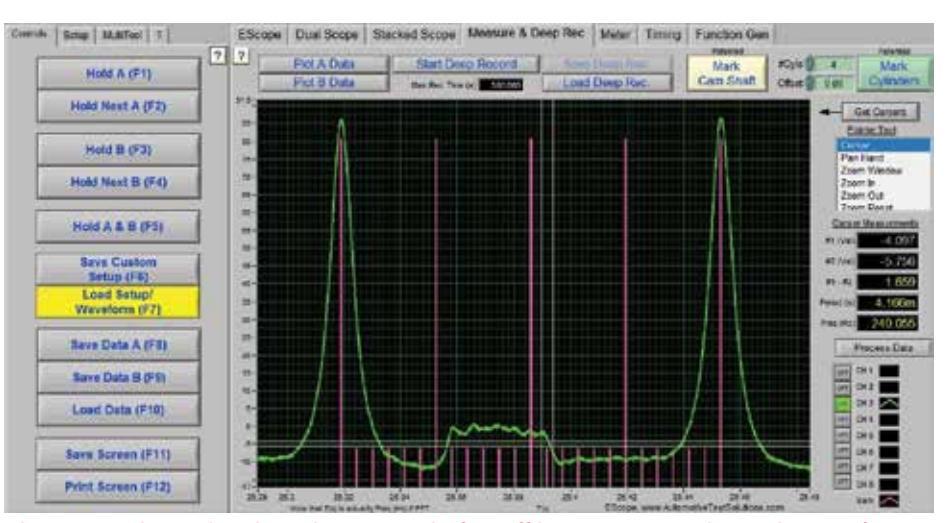
This image shows that the exhaust camshaft is off by approximately 60 degrees from its normal operating position, and the intake cam is off 30 degrees on Bank 2.

replacements was that, while the misfire codes were "almost gone," the vehicle still had a power loss issue, and the car was still setting the Exhaust Camshaft Set Point Not Reached code.

Because the timing chains on this engine are between the engine and transmission, it is essential to be accurate with the diagnosis because the customer had spent so much money already, and it was apparent that the engine needed to come out for repairs.

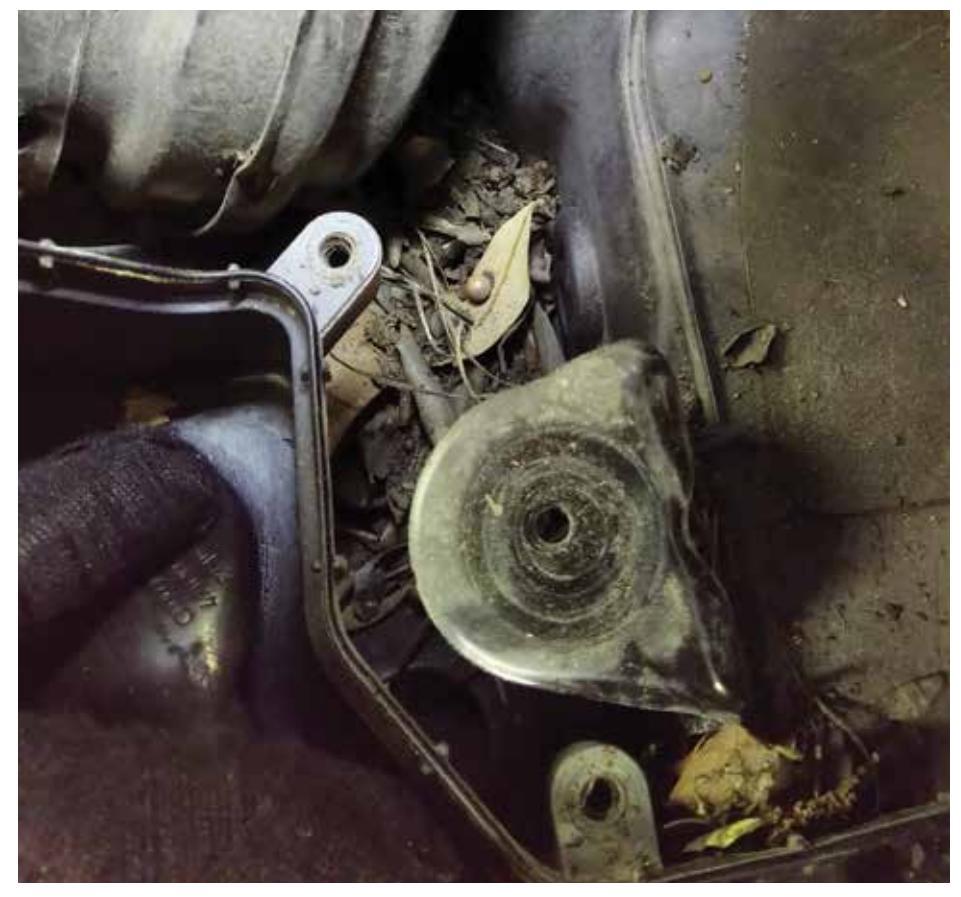
Noticed during the analysis and inspection of the A6 was the inner plenum area where leaves, twigs, seeds, and debris of all types accumulated and we wondered how long and how much moisture may have accumulated over time. That being said, how many rodents had a party in that area?

Debris at brake booster

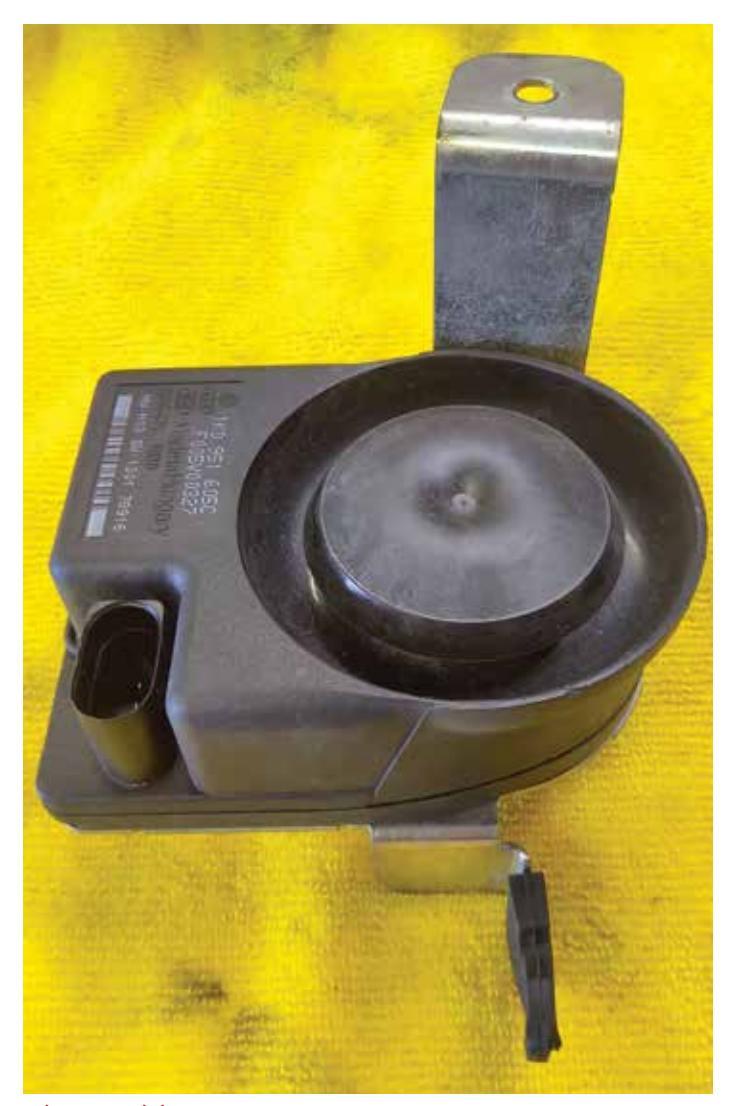
Alarm module

How and why did this module fail to the point of a no start?

Now imagine a LIN controlled alarm that has a backup battery and damaged circuit board screaming and yelling in silence and considered a parasitic load.

Fortunately for the customer, the local dealer found and ordered the new module for the next day. Of course the replacement had an updated part number and once it was installed, no faults returned. The last scan returned as perfectly clear.

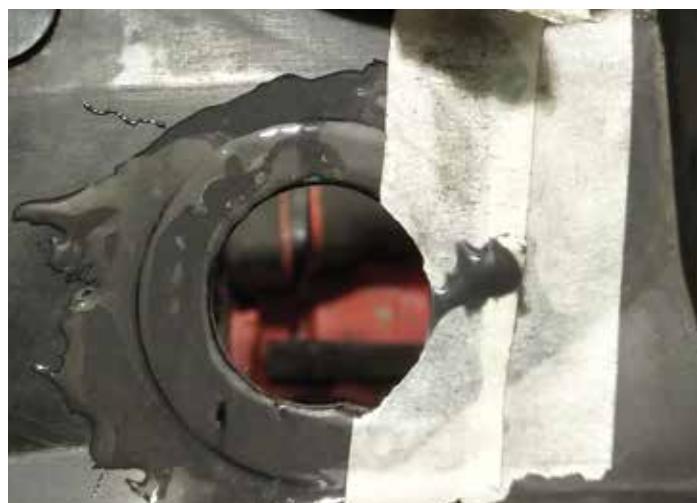
More epoxy layers

An attempt was made to use a two part metal epoxy to repair the cover and minimize the damage to the air filter. The attempt included affixing the rubber grommet to the stays/pins on the valve cover.

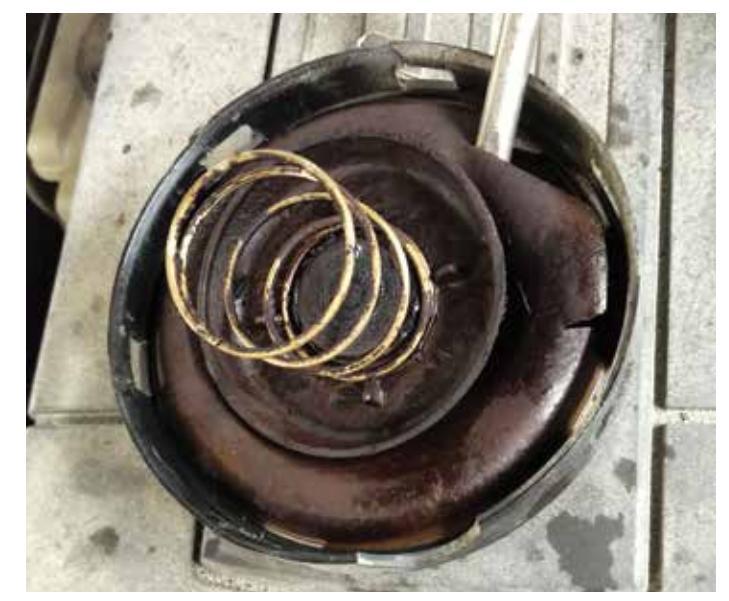
Damaged diaphragm

The repair to the engine cover will not address the lean or improper idle condition. The lean/idle condition is attributed to a vacuum loss and has to be identified as either internal (engine mechanical components) or external (engine vacuum connections).

As with anything, sometimes a replacement part is found that will solve the "torn diaphragm" syndrome. With some cleaning and re-assembly with a replacement, the fuel trims and faults were deleted and idle quality returned to normal. Note the replacement is an aftermarket part.

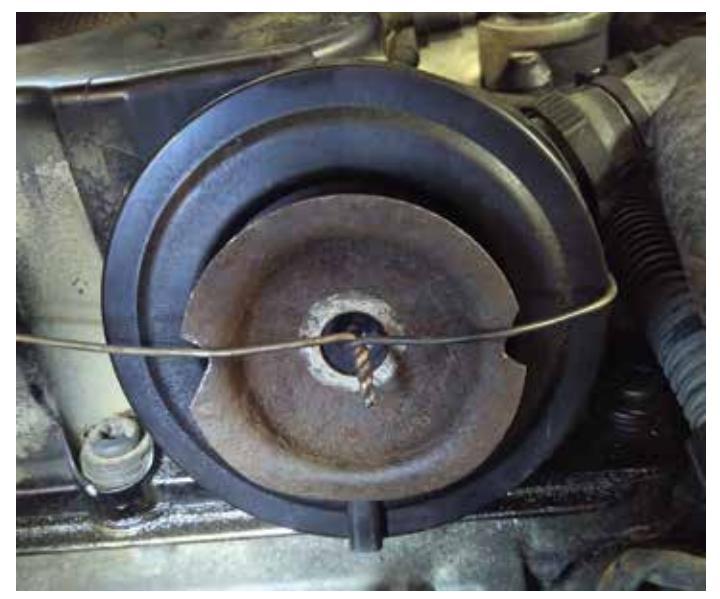
The Jetta returned two weeks later with a similar problem but the plastic PCV cover failed due to heat distortion and, this time, we heard the external vacuum leak. The "work of art" failed because of heat as well and that's where Lewis Black's rants reminded us all of human frailty.

Redneck repair

The redneck solution was to tie a large washer to "push" on the cover and keep the distortion minimized. It worked as a temporary solution until another replacement version arrived.

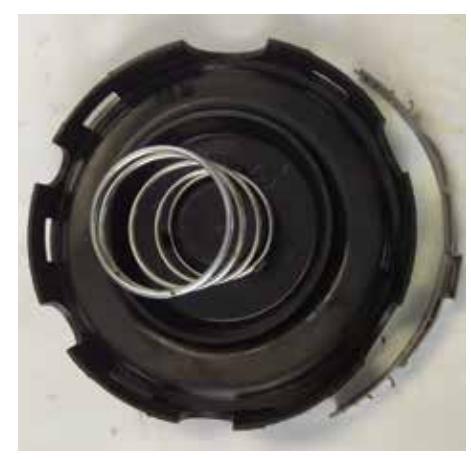
Cap and band

This kit offered a perfect solution to keep the replacement cap in place.

- 1. Calculate the length needed.
- 2. Use the correct clip to attach the length of band.
- 3. Push or have the cap tied firmly in place.
- 4. Use the correct tool to squeeze" the clamp onto the cap.

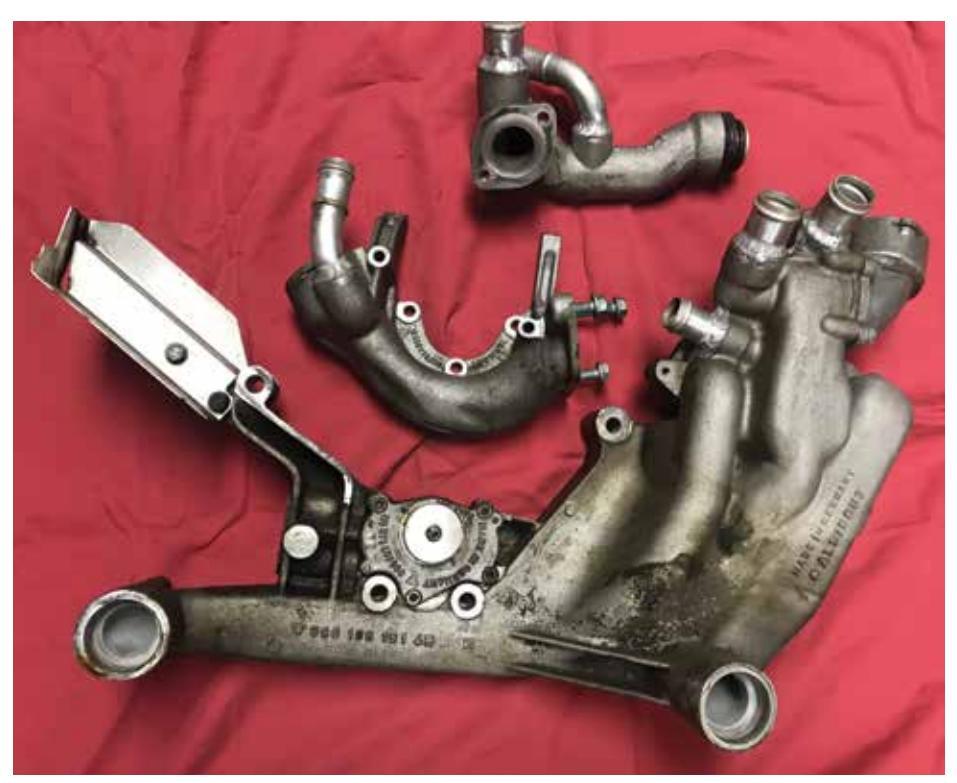
These are the external coolant manifolds for a 996 twin turbo Porsche engine.

These external passages, or manifolds, became a failure point on this otherwise robust design. In order to attach rubber cooling hoses to the manifolds it was necessary to have a smoothly machined end with a flange to properly secure the hose to the manifold. These flanged tubes were glued into place on the coolant manifold. After several years of heat cycling the glue can fail and the engine will dump a huge amount of coolant almost immediately from the gaping hole left at the detached point on the manifold.

Once the two surfaces have been cleaned they can be welded using a TIG (Tungsten Inert Gas) welder. Because of the variation of the thickness of the two materials, an experienced hand at this task is required, and many welders are not comfortable taking this approach as a result. When done properly, it is the best solution as it is permanent and does not allow for any leakage whatsoever at the joint between the two pieces of aluminum.

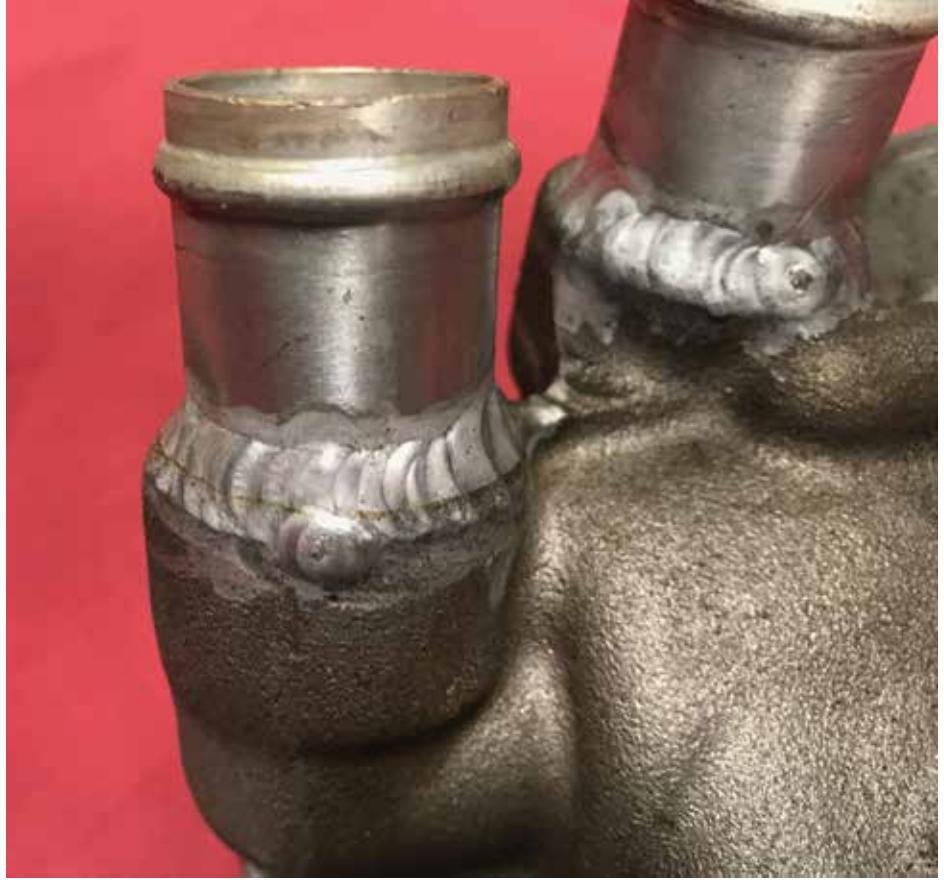
Example of a high-quality TIG welded connection of the coolant manifold to the flanged tube.

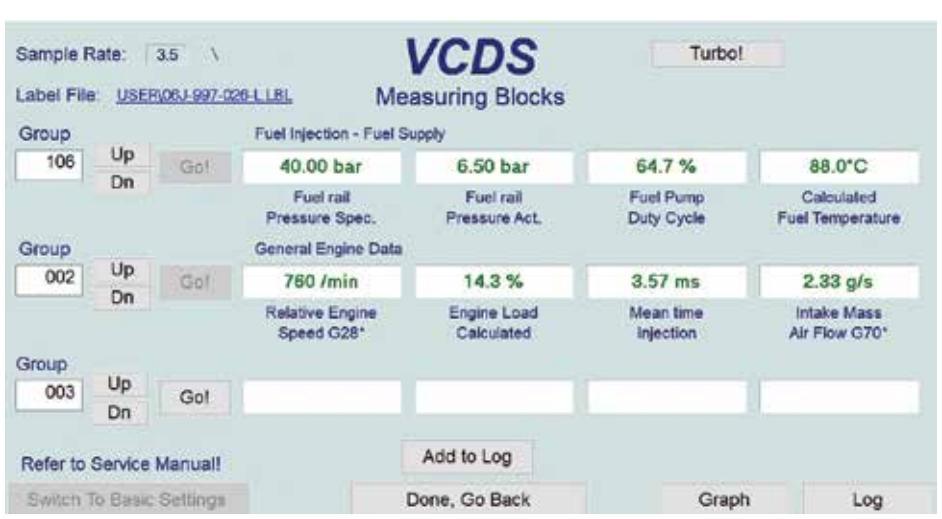
The primary complaint was an oil leak at the high pressure fuel pump. The facility opted to repair the pump with a new

Defective pump
