# TechNews

June 2020

## Diagnosing Ignition System Problems with CONSULT III Plus and an Oscilloscope

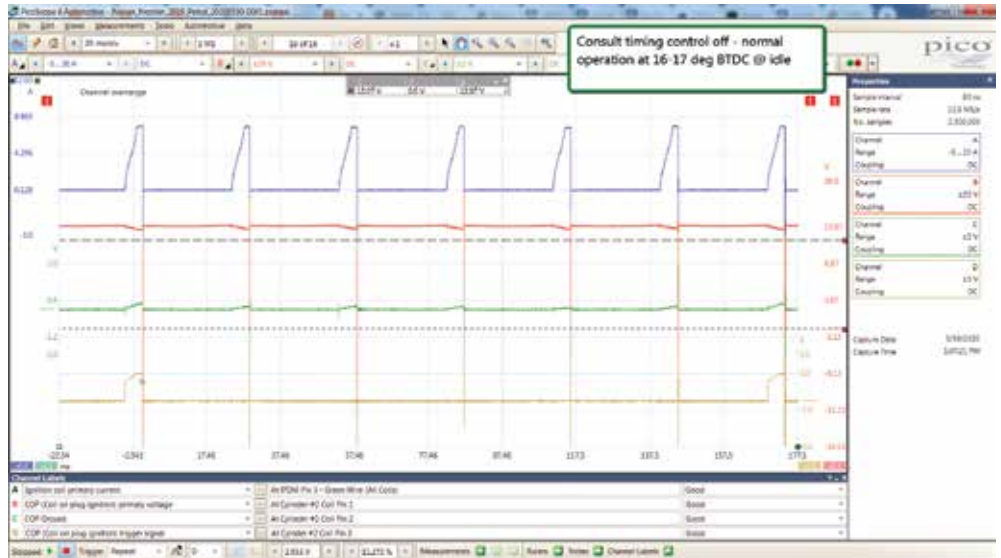
PicoScope pattern at idle – 2019 Nissan Frontier 4.0L V6

Since the vehicle we're working on is a 6 cylinder V design with a firing order of 1-2-3-4-5-6, and triggering on cylinder #2, the firing order sequence shown on the pattern is 2-3-4-5-6-1. The PicoScope image shows a normal pattern at idle.

For the purpose of this article, cylinder #4 was selected for coil-related bugs. Coil #4 is right next to Coil #2. For verification, service information confirms this as shown in the PicoScope image above.

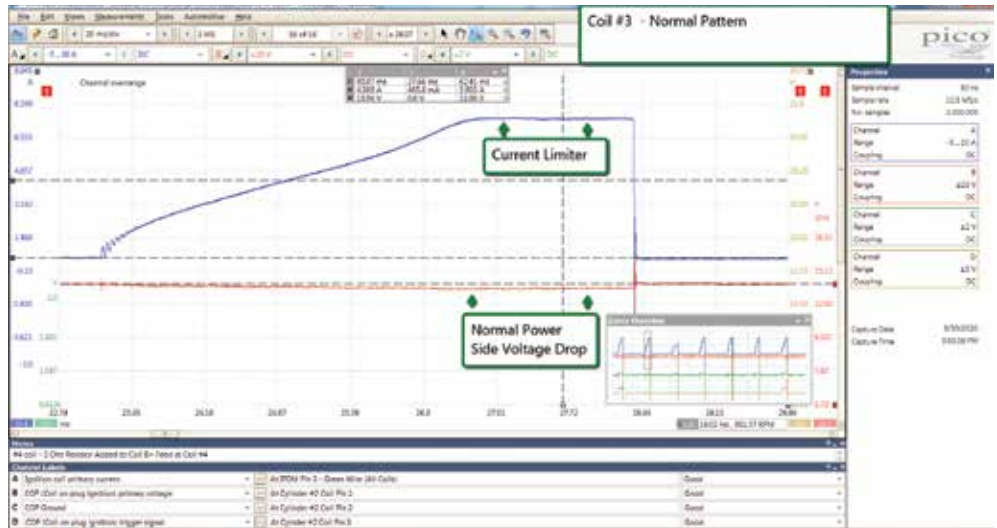
Normal primary current for cylinder 3

- Peak coil current and/or current limiting. This circuit is reaching just over 7 amps before current limiting takes over. Note: you'll also see that there is a normal amount of voltage drop indicated on Channel B when current is flowing.
- Coil transistor saturation turn-on. This area you'll want to zoom in on and take a look at the oscillations that occur upon the initial primary current circuit current flow. Compare this to the other cylinders to make sure that they're all similar.

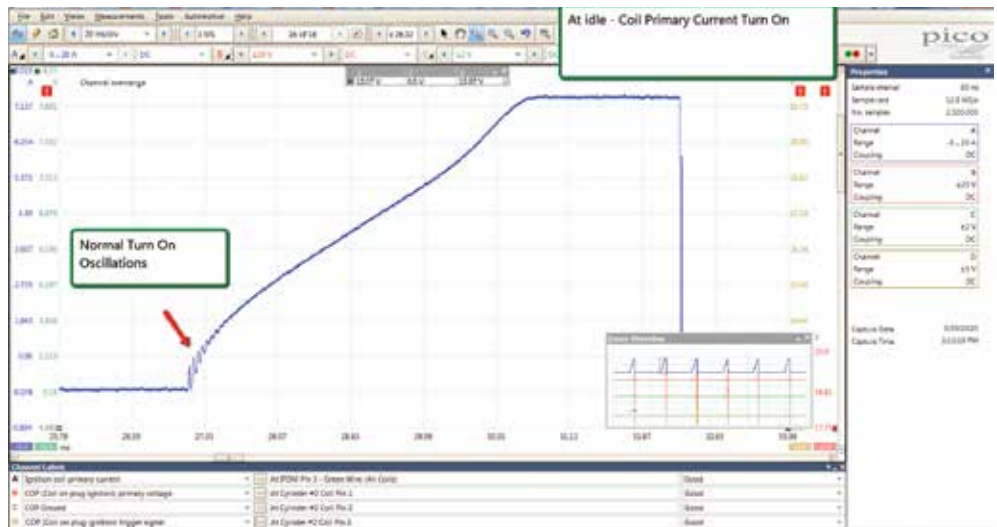
Ignition coil turn on analysis

A defective coil will typically be missing these coil oscillations.

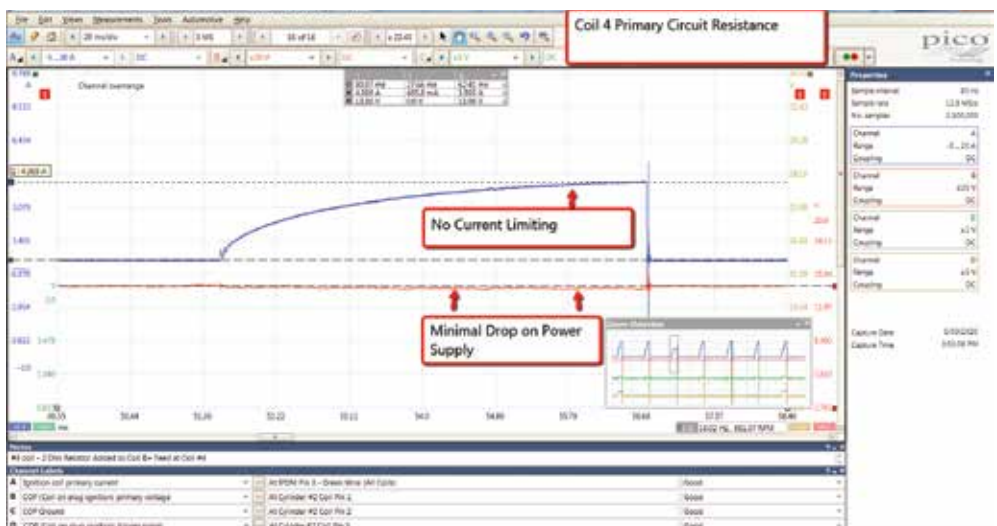
If one of your coil patterns is not reaching the current limiter, then this is an indication of high primary circuit resistance. A normal system should have the coils all be fairly equal. If you have any of them that are out of the ordinary, then you want to do a little more investigation. If the current is low, think about what could cause that. The likely cause is high resistance in the primary circuit, so that could be internal or external to the ignition coil.

For the purpose of research, we placed a 2 ohm resistor in between the #4 coil Pin 3 and power feed. This pattern shows the results where the primary circuit is only reaching 3.9 amps. This is 3 amps less than that of a normal system. If you look closely at the Zoom Overview, the third current ramp event for cylinder number 4 is lower than the others.

This primary current pattern shows the resistance for coil 4.

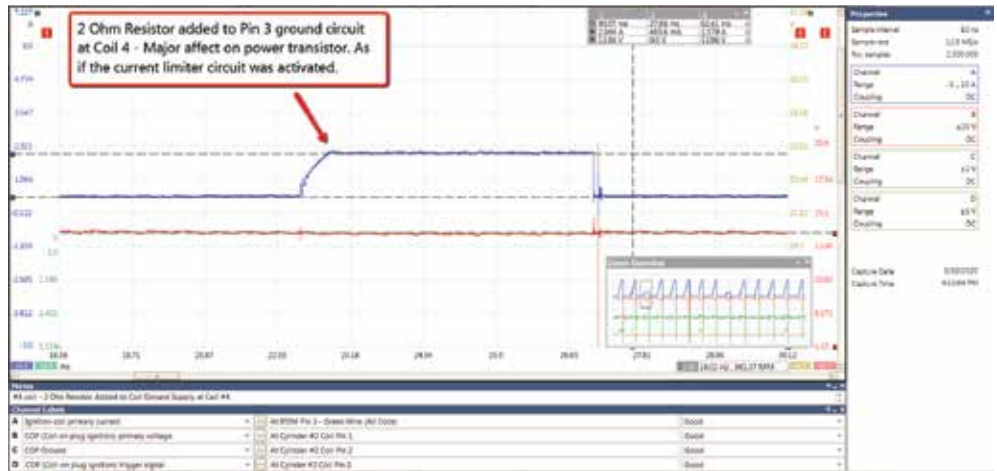
Next, we decided to move the same 2 ohm resistor over to Pin #2, (coil ground) and see the results. Looking at the next figure you can see that, although the current level never reached the current

limiting levels that the normal system achieved, it's clear that the internal coil circuit entered current limiting mode.

Coil 4 primary current pattern - primary circuit resistance on ground circuit

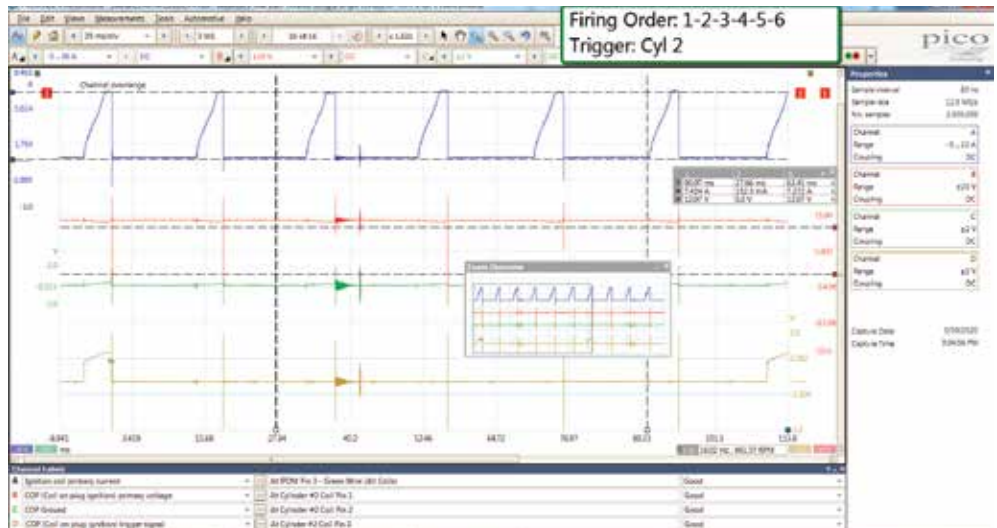
Next, we created a secondary voltage leak path for cylinder 4. As you can see, there is a clear indication that something is wrong following the coil firing event for this cylinder. After seeing several of these patterns in the real world, we know that this is how a secondary voltage leak outside of the cylinder looks.

Misfire due to secondary leakage
