September 2020

TechNews

Intelligent Key Problems?
Nissan Symptom Tables
Are Your Friend

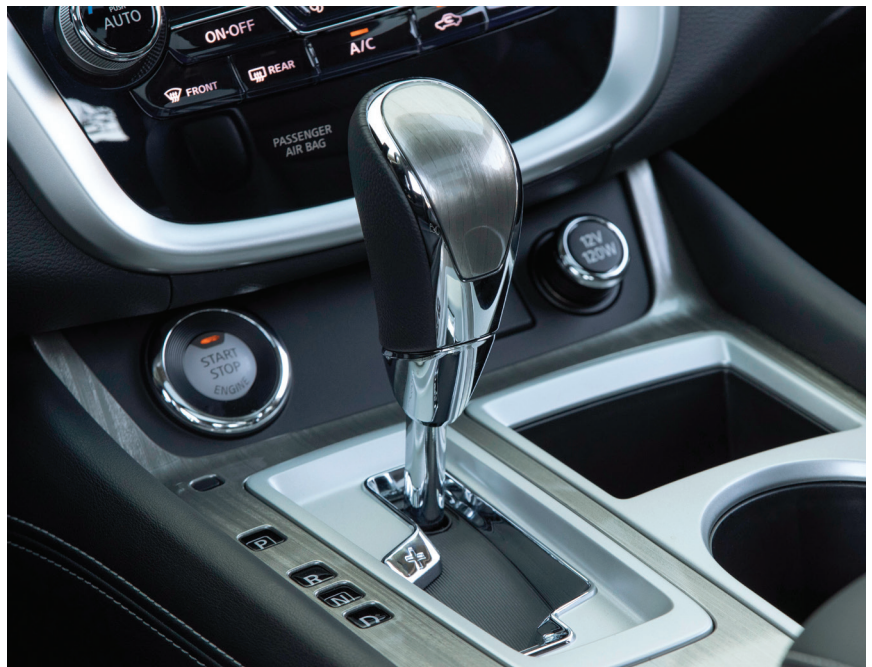
The push-button ignition switch works only with an intelligent key that is both registered to that vehicle and configured in the BCM.
