Oh, Behave! Stopping Mercedes-Benz Wiper Streaking and Skipping

Debris, contaminants, or an incorrect angle of contact with the glass can cause wiper blades to squeak, judder, and leave streaks. Here's how to stop it all.

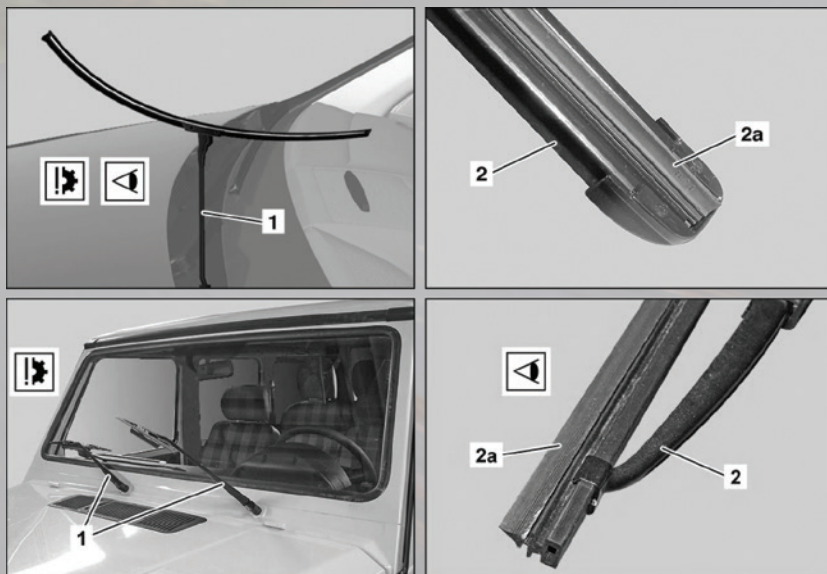
Some Mercedes-Benz wiper arms (1) feature a one-piece wiper blade (2) design (top image) that must be replaced as a complete assembly. Others use a blade on which the technician may replace the rubber insert (2a) separately (bottom image), or install a new complete assembly.

Check the rubber insert for hardening, cracks, wear, and correct seating in the blade guides and end caps. If you find problems, replace either the rubber insert if available separately or the entire blade, depending on the wiper type.

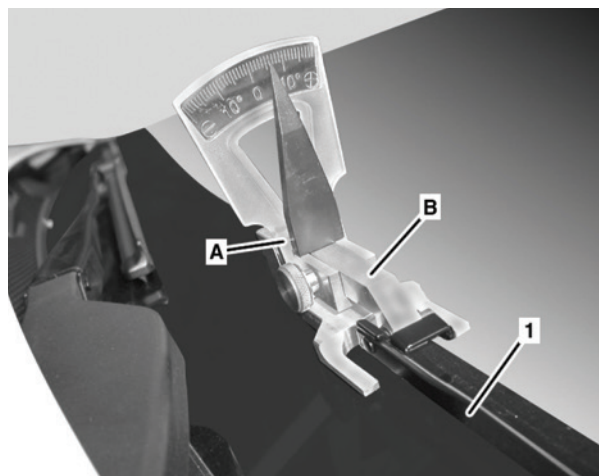
Use the angle gauge with the blade removed from the wiper arm. Attach the adapter (B) to the angle gauge (A) and slide both onto the wiper arm (1). This image shows measurement on a C-Class (W204) sedan with the wiper arm in the park position at the base of the windshield. Check WIS for the details of other models.

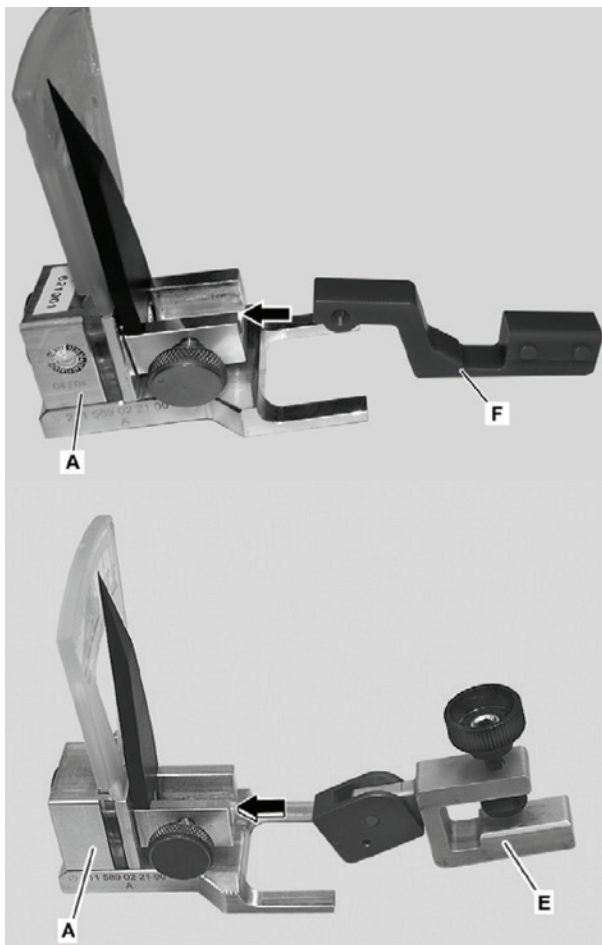
Different wiper designs require alternative versions of the adapter to connect the angle gauge to the wiper arm. For models 117, 156, 176 and 246 one adapter (part number W211 589 00 21 00, “F” in the top image) is used for model year 2015 and later, and the other (part number W205 589 05 21 00, “E” in the bottom image) is for model years up to 2015.

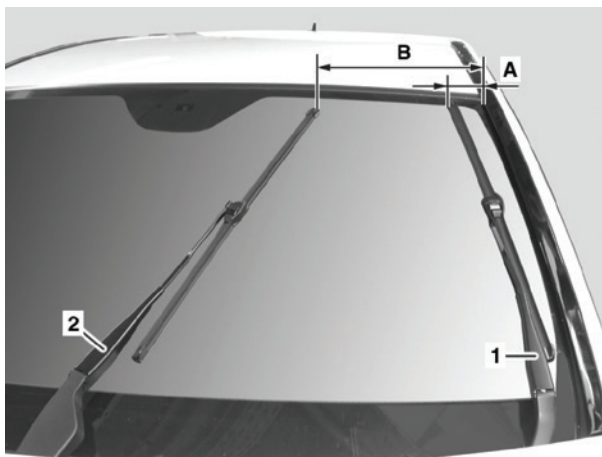
The exact wiper arm adjustment procedure varies by model. Here we see the driver (1) and passenger (2) arms in the specified positions (“A” is 60-mm and “B” is 330-mm), shown for the wiper angle of incidence measurement on a C-Class (204) sedan.

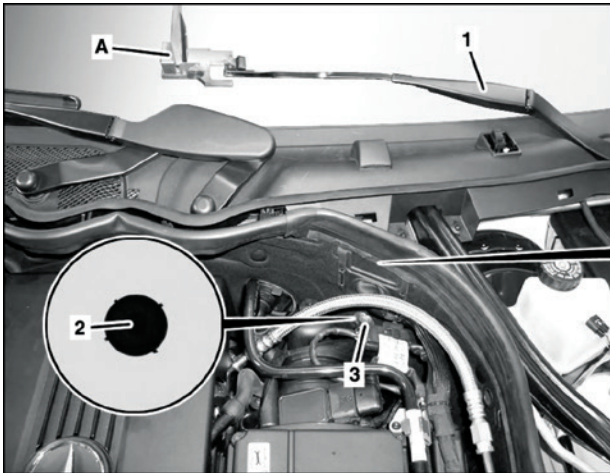
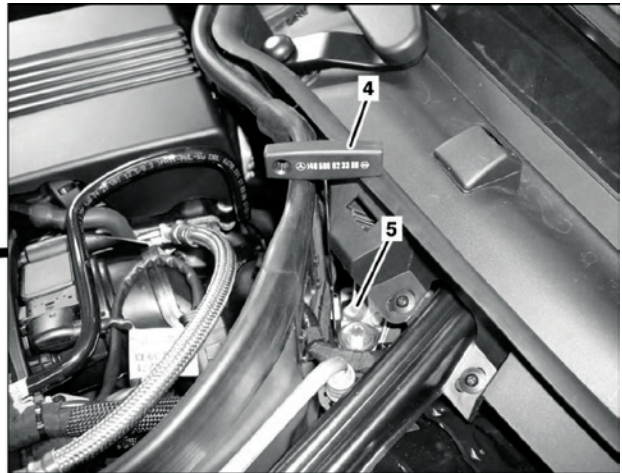
The image on the left shows the measurement tool (A) mounted to the wiper arm (1) on a Mercedes-Benz C-Class (W204). If both the driver and passenger side wiper angles are out of specification in the same direction, adjust the linkage through the windshield wiper system (5 in the close-up image on the right) under the hood. Loosen the screw (3) beneath cover (2), then adjust the wipers by moving the windshield wiper system using the extraction hook (4) until the angle gauge shows the correct value. The screw cover (2) is a discontinued part on the C-Class, and need not be replaced after repair to the system.

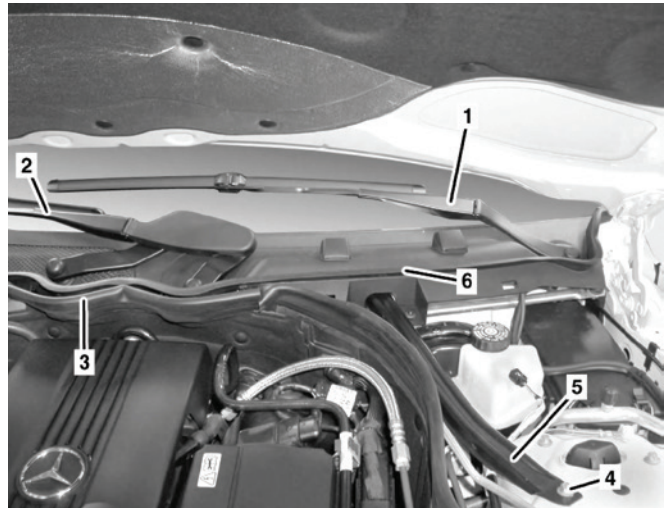
If only one wiper arm is out of specification, or both are off but in different directions, you can adjust each arm (1 and 2 in the above image) individually. Use the adjuster tools on each arm at the specified position (park, center, or reverse) on the windshield. If both arms are out of specification in the same direction and by a similar amount, the wiper system unit (not shown) located under the water collector tray (6) at the base of the windshield may have shifted position. A support beam (5) bolted (4) to the driver's side front suspension strut tower helps stabilize the wiper system unit.

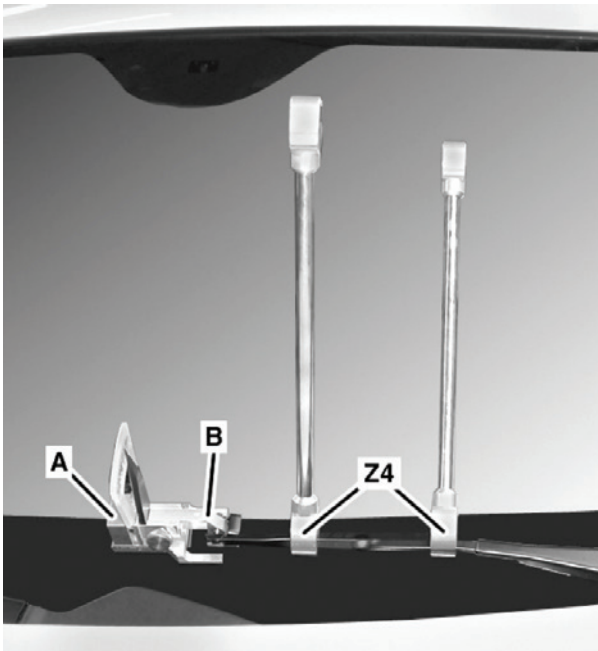
With the wiper in the recommended position (at the base of the windshield for the C-Class shown in this image) and the angle gauge (A) and adapter (B) mounted on the arm, place both adjustment levers (Z4) as far apart as possible on the wiper arm. Hold the lever that is farthest away from the angle gauge steady. Rotate the adjustment lever that is close to the angle gauge until you have twisted the wiper arm by approximately the amount of that arm's deviation from the factory-specified tolerance limit. Note: Even though you perform this procedure with the arm in the park position, you twist the lever until the angle gauge changes in an amount equal to the deviation that you measured with the arm at its reversing position.

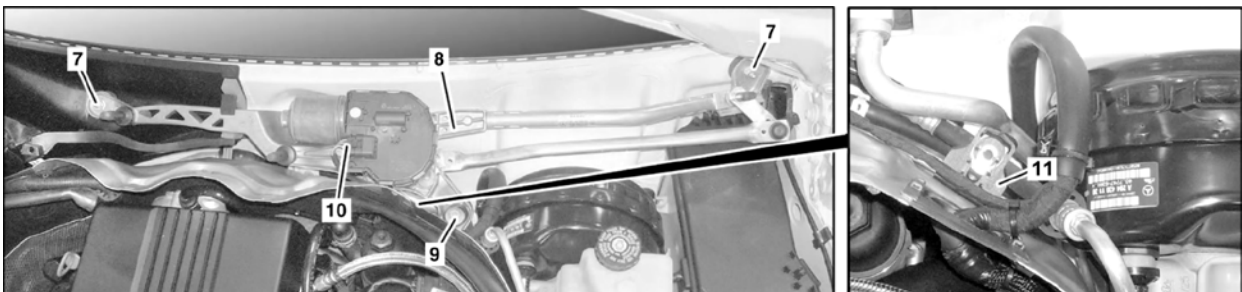
The wiper system unit (8 in the image above) links to both the driver and passenger wiper arms under the hood. Lifting and repositioning the wiper system adjusts the angle of incidence of both the driver and passenger wiper arms simultaneously and by the same amount.
