# Keep the Lights On

Here are tips for diagnosing BMW computer-controlled Intelligent Headlight technology, including intermittent or flickering lights, lens cracks or condensation in housings, and plugged headlight washer nozzles.

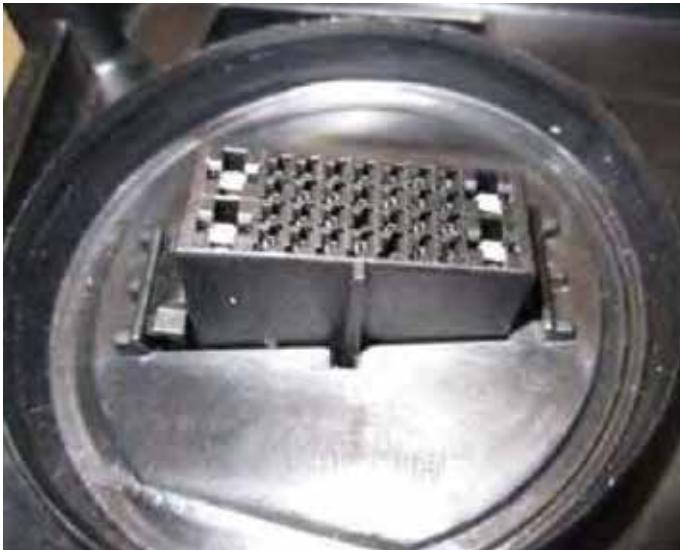
This situation is typically caused by a poor connection, not a defective headlight. The connectors at either the LED headlight or the LED main light control module (LHM2) end of the circuit could be loose.

*On the LED headlight, check to confirm that the connector is down to the position shown in the picture. If it is not, push the connector all the way down.*

modules to opposite sides, check to make sure the connector on each LED headlight is properly positioned and not loose. Remove the LED headlight. Push its connector down, then pull it back up until it locks into place. Do the same for each headlight.

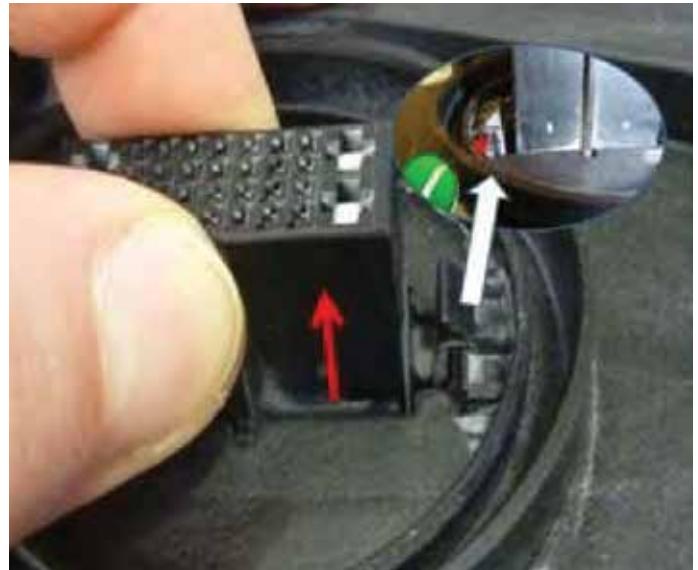
*Lift the connector up until you hear a clicking sound. The click means the locking tab has engaged and the connector is properly and securely positioned.*

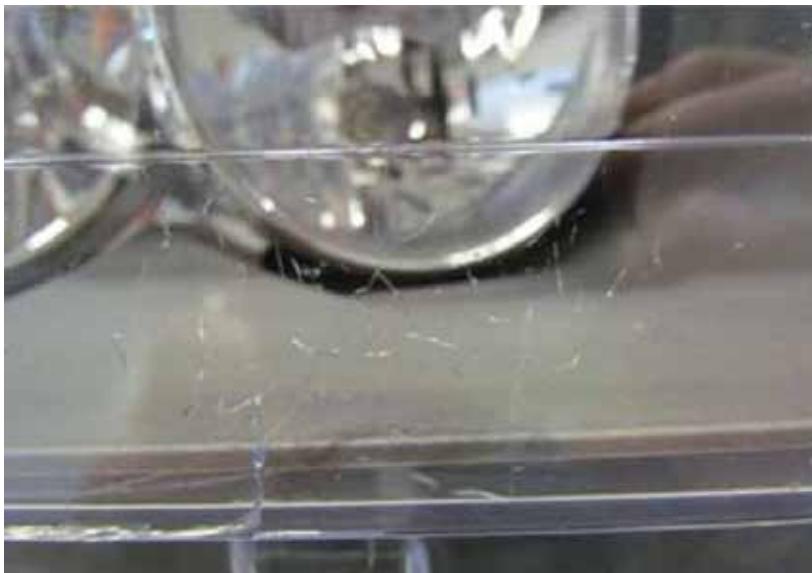
*BMW X3 models produced from October 2010 to June of 2012 may develop stress cracks in the headlight lens covers. The cracks often begin at the lower edge of the lens cover and spread upward.*

This fault in the lens cover material has two different potential causes. One is bump stops (pedestrian safety buffers) that are cracked, misaligned, or missing, and cause the front of the hood to weigh down excessively on the headlight lens cover. Another source of stress is old design hood lip seals that

may press too tightly against the top of the headlight housings when the hood is closed.

Replace only the headlight on the damaged side. Refer to ISTA REP 63 12 010 “Removing and installing or replacing headlight” for repair instructions. Install

only a headlight produced on or after November 10, 2012.

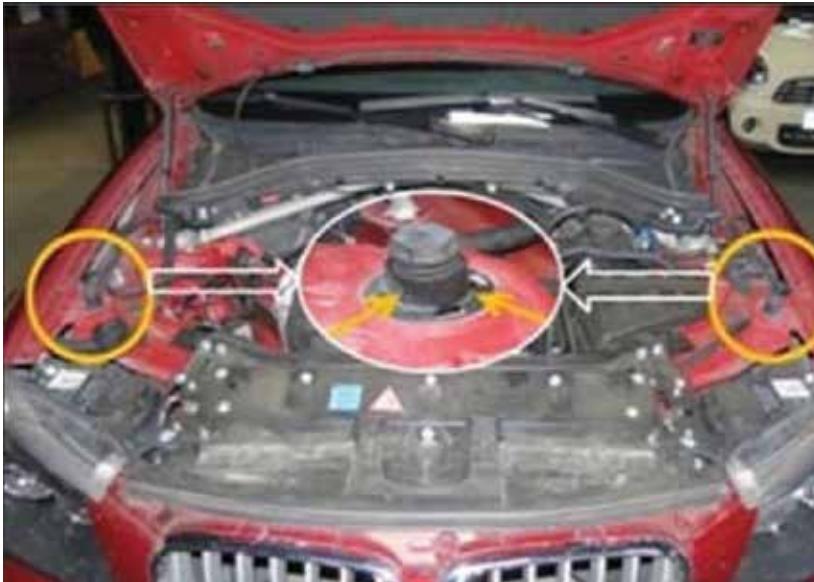
*If bump stops (pedestrian protection buffers, circled in yellow) are damaged or incorrectly positioned, they may allow the front end of the hood to press down excessively on the headlight housings, causing cracks and fissures in the lens covers.*

After replacing the headlight, check and replace any cracked, misaligned, or missing bump stops. Refer to ISTA REP

51 23 “Installing/Replacing bump stops” for procedural details. NOTE: Ask for the vehicle’s recent repair history. The bump stops may be out of alignment due to an incorrect previous repair.

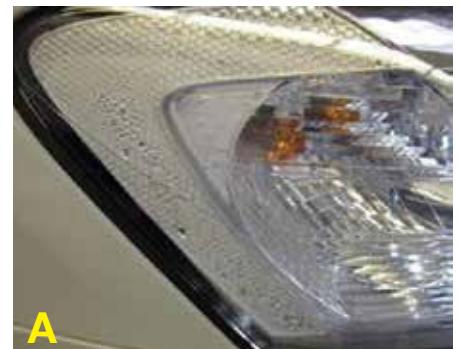
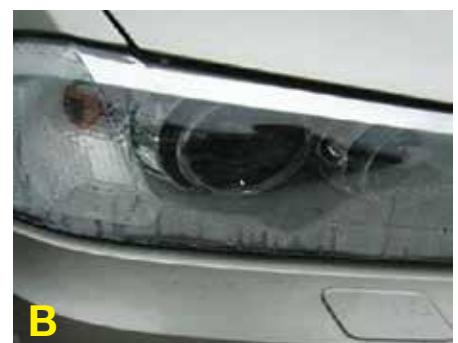
*Large droplets of water (A) inside the headlight lens cover are caused by leaks passing through failing seals or cracks in the housing. A fine mist (B) is due to the natural process of condensation.*

This problem can be caused by either a moisture leak into the headlight housing or condensation. How can you tell which has occurred? A leak will appear only on the headlight side that has a weakened seal or cracked housing. If the problem is due to condensation, you will see misting in both headlights. Additionally, a leak shows large droplets, while condensation appears as a fog or mist.

If the headlight lens is cracked or a seal is failing, replace the damaged component. If condensation is the problem, the solution is to dry out both headlights. See BMW TIS Service Bulletin # SI B63 05 16 (published in March of 2018) for repair procedure details.

Run the high beam to clear out the condensation. If after 30 minutes there is still a mist inside the lens, open all the service covers in the headlight assembly and, using a hot air blower, dry out the light. Do not let the temperature exceed 80 degrees C (176 degrees F).
