How
Volvo
Turbo
Systems
Work

CASE STUDY 2000 VOLVO C70 2.4 L TURBO WITH LOW TURBO BOOST COMPLAINT

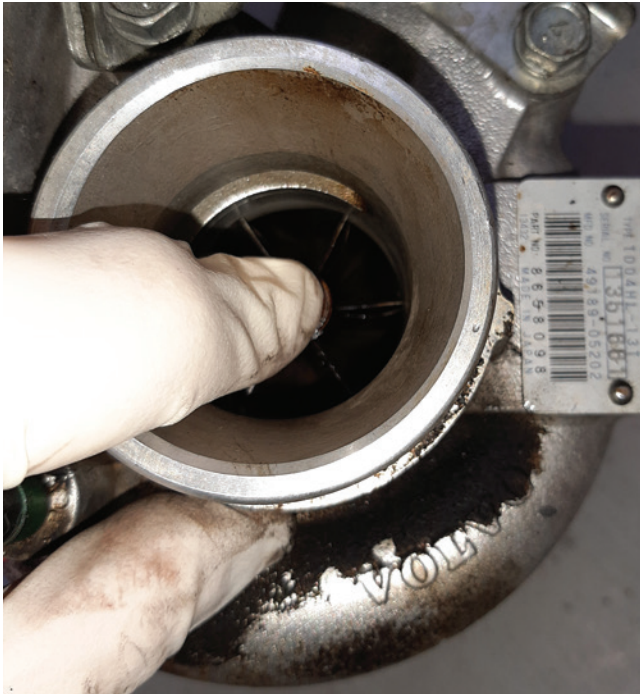
You can check for wear in the turbine fan bearing by trying to wiggle the shaft; a little play is normal, a lot is cause for concern.

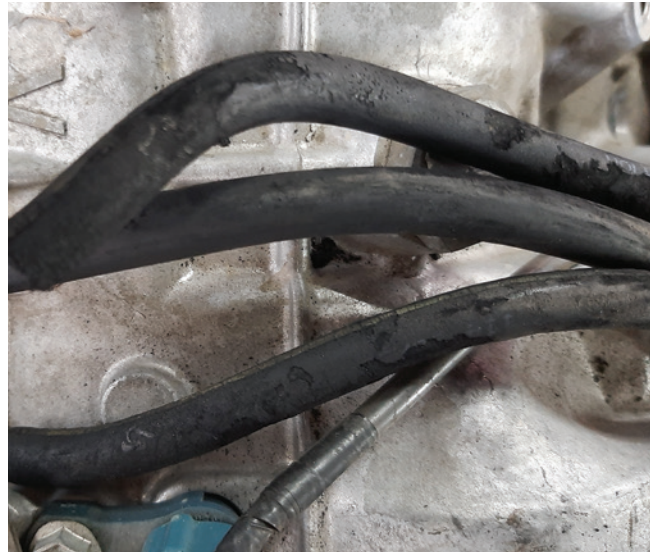
One of the most common turbo control issues you will see on older Volvos is caused by small leaks in rotted vacuum control hoses.
