Automatic Transmission Perfection

Get ahead
of shifting
complaints

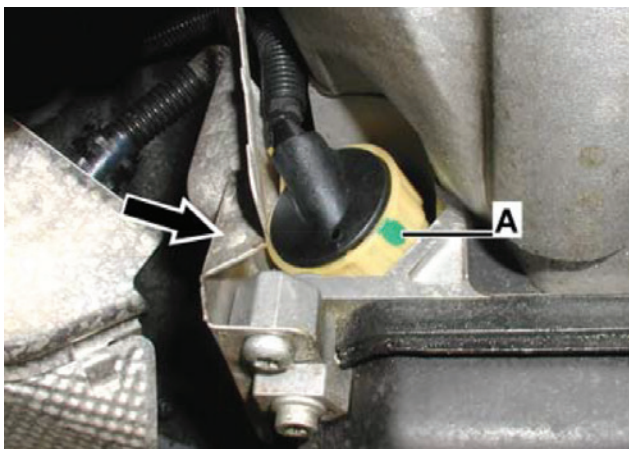
This old style 'pilot bushing' (electrical connector) is a common source of leaks and communication issues in the 722.6 transmission. When replacing, be sure to observe the 3 Nm tightening torque, which is barely finger-tight!

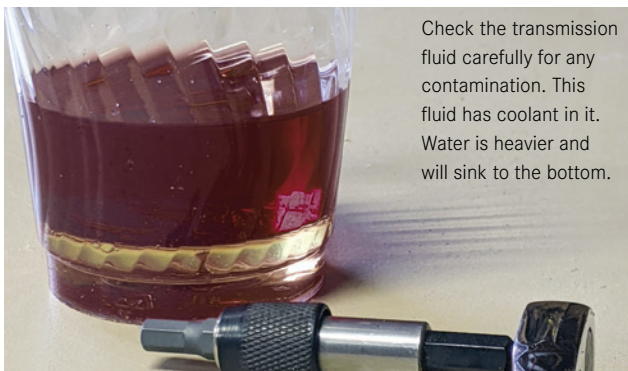
Check the transmission fluid carefully for any contamination. This fluid has coolant in it. Water is heavier and will sink to the bottom.

Before condemning the torque converter, check the basics, such as fluid level. Verify the correct transmission fluid is being used, perhaps by questioning the customer if any fluid has been added, and checking the dipstick seal isn't broken. The incorrect fluid can damage both seals and clutches in the transmission. Also verify that no coolant contamination exists. Use the glycol test procedure in DTB P-B-27.55/50g (or later), or take a sample and put it in a clear container and let it sit for a few minutes. The coolant will separate out and be visible at the bottom of the transmission fluid. This can be caused by a faulty transmission cooler, so be sure to identify and address the root cause. Note that service bulletin LI27.20-P-046908 advises that in Model 211 E-Class vehicles with the 722.6 transmission, worn fluid can cause shuddering. After verifying the fluid isn't contaminated with coolant, perform a fluid flush to restore proper operation.

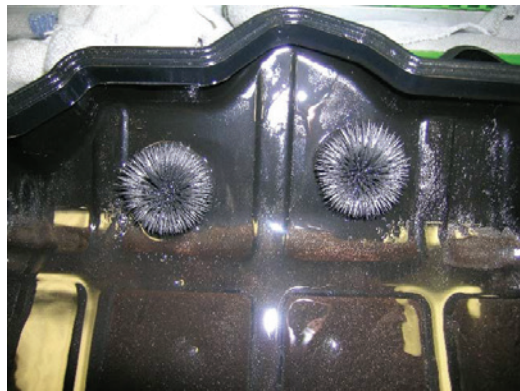
If you find a significant amount of metal in the pan and fluid, it may be time to replace the transmission assembly. This shows metal particles attracted to the magnets in the pan.

Check the transmission pan for metal contamination. If a significant amount of metal is found in transmission, it may be time to recommend complete replacement, and be sure to flush the system thoroughly. Verify all software is updated for the transmission control unit. Re-adapt the torque converter and transmission shift points with the scan tool. It is important also to verify that there are no issues with the engine or transmission mounts, as these have been known to cause shift or judder complaints.

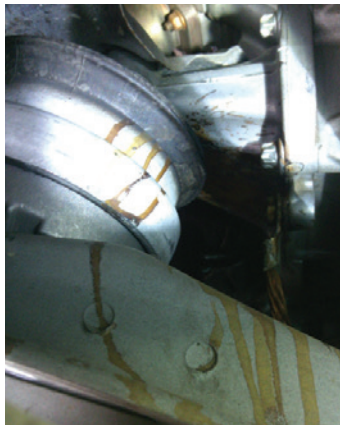
Note the leaking fluid from this engine mount. A damaged mount could be the cause of a judder complaint that the customer thinks is a transmission issue.

1. Inspect all engine and transmission mounts.
2. Inspect all sub frame and differential mounts.
3. Remove driveshafts and operate/inspect flex joints or U-joints to detect any binding. Mark drive flanges on disassembly so that they are matched on reassembly.
4. Consult WIS for a description of the transfer case on the 7-speed transmissions, as faults here can cause shuddering complaints.
5. Further tests should be conducted by referencing bulletin LI28.00-P-051499. There is diagnostic tree that specifically deals with judder complaints.
6. If the transfer case is the cause of the vibration or noise, be aware that the transmission and transfer case may only be sold together as an assembly.
