# Volvo MOST Networks and Infotainment Systems Problems and Solutions

## SiriusXM Radio inop or NO Sound on SAT

| REF: No: TJ 34021.1.1 |

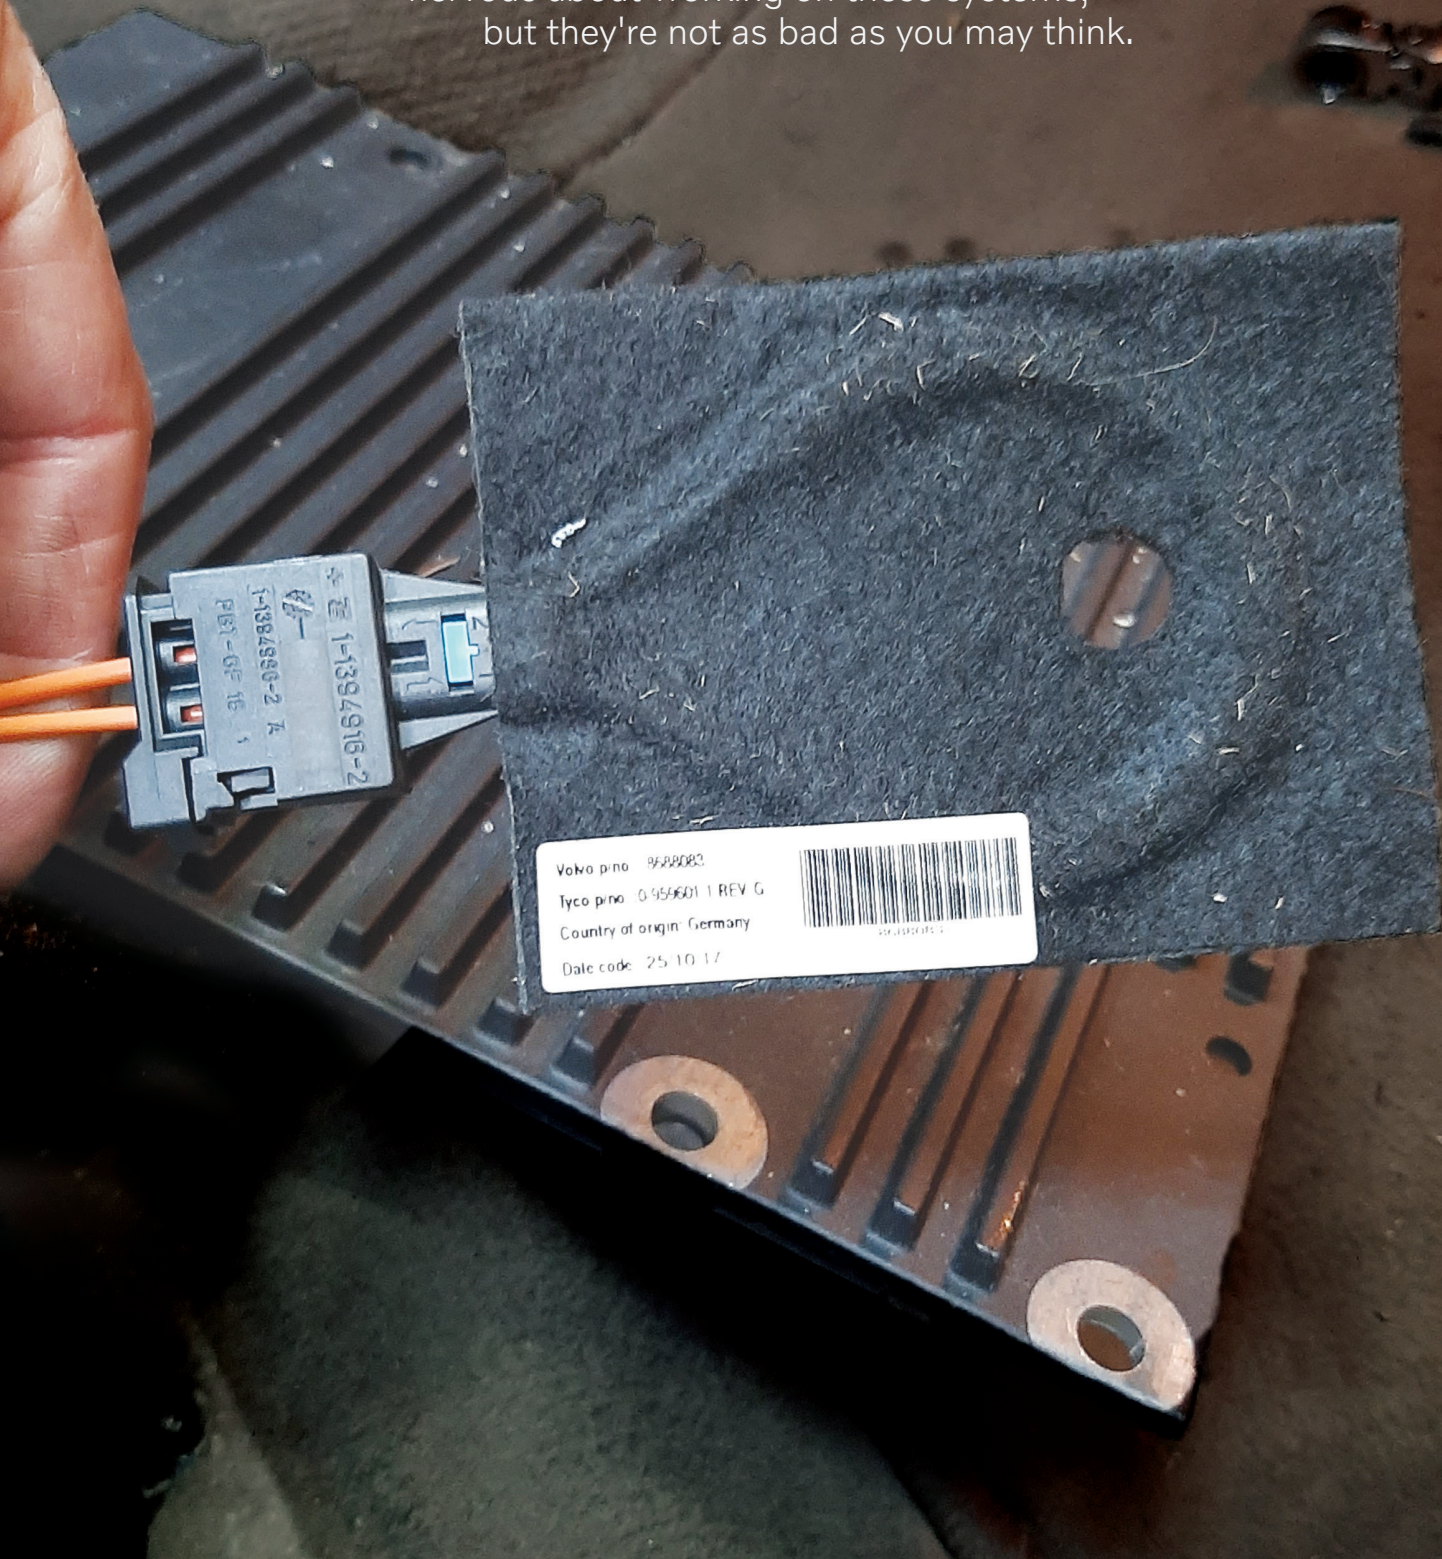
Volvo p/n: 96220083  
Tyco p/n: 0-956601-1 REV G  
Country of origin: Germany  
Date code: 25 10 17

Check the length of the RDAR mounting screws. If too long a screw is used in the mounting hole closest to connector "A" on the RDAR, it can make contact with and damage one of the internal capacitors (see image on right).

The screws should be no larger than M5 x 8 mm in order to avoid interference with the internal components of the RDAR (see images below).

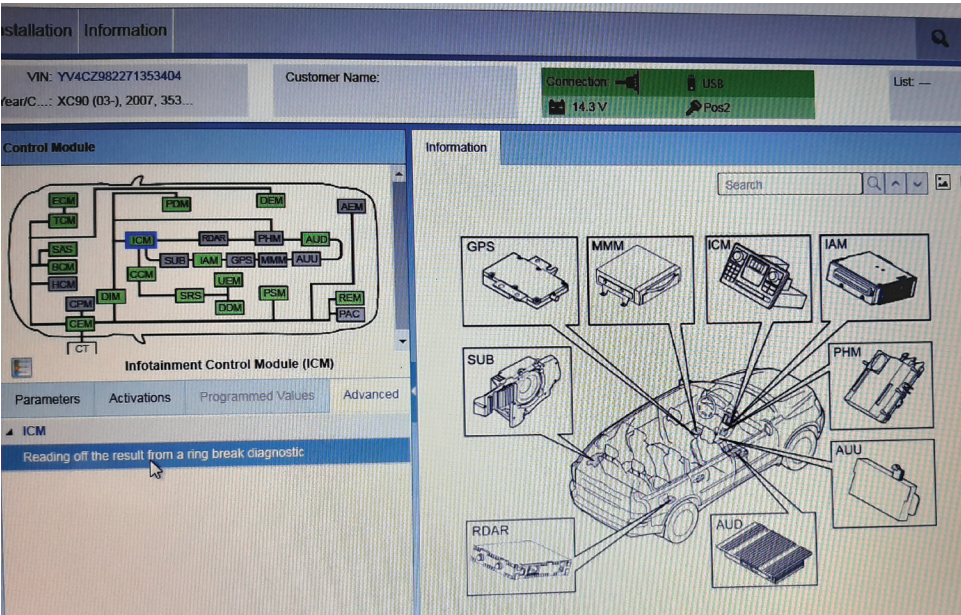
If you are trying to diagnose a problem in one of Volvo's Infotainment systems, the Volvo VIDA software has a great test to help find the cause — the MOST network ring break diagnostic procedure. You can find it in Vehicle Communication, select ICM under the Advanced tab.

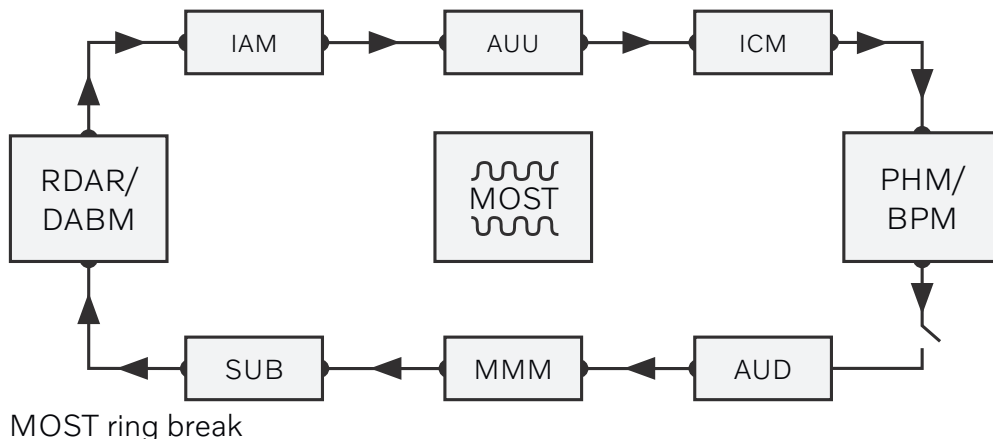
A MOST network contains all eight control modules. There is an open circuit in the cable between the Phone Module (PHM) and the Audio Module (AUD). See the MOST ring break illustration above.

In a ring break diagnosis the ICM receives replies from the control modules on the MOST network. Those located before the Audio Module, such as the Phone Module, cannot transmit their reply to the ICM.

The ICM now receives a response from all control modules except the integrated Phone Module, and therefore identifies the control module which is first in the loop, and which responded — in this case, the Audio Module.
