STARTUNED®

INFORMATION FOR THE INDEPENDENT MERCEDES-BENZ SERVICE PROFESSIONAL

JUNE 2021

The Causes of DTCs P0170 and P0173 in Mercedes-Benz Vehicles: Air, Fuel or a Red Herring?

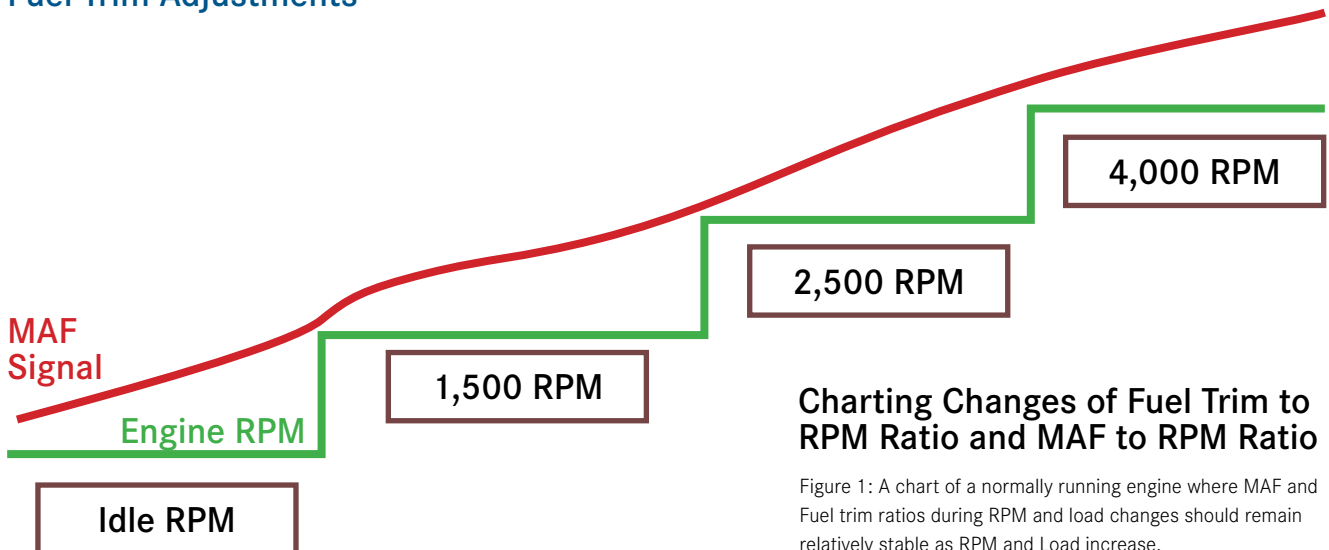
How could we see this using graphed data? Figures 1 and 2 are a representation of a vehicle bay test, where the ratios of two critical measurements help to split the system into air versus fuel. The green line shows RPM changes from idle to 4000 RPM in several steps, the red line indicates the ratio of MAF to RPM changes, as the engine is throttled, and the blue line shows the ratio of total fuel trim to RPM changes as RPMs increase.

Here are the physical rules of thumb at play here when all is well: First, MAF should always proportionately increase with RPM and load, and second, fuel trim correction to RPM load increase should be a smooth, almost linear adjustment to maintain stoichiometry. Both of these rules of thumb are

Figure 1: A chart of a normally running engine where MAF and Fuel trim ratios during RPM and load changes should remain relatively stable as RPM and Load increase.

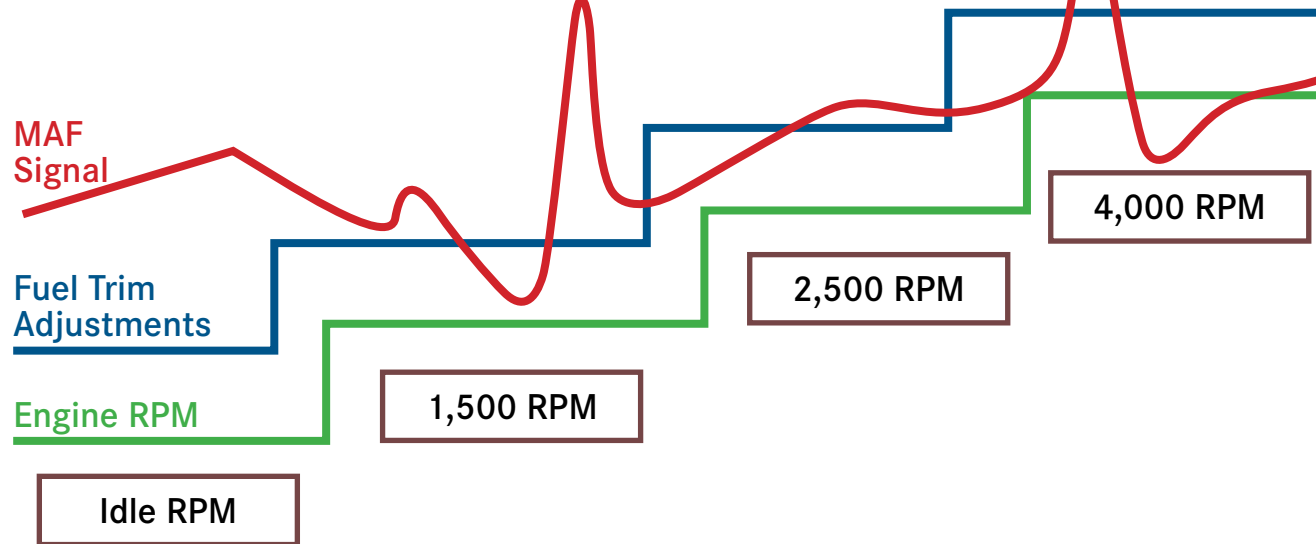
Figure 2: The fuel trim moving in step with RPM increases while MAF signal is faulting.

represented as working normally in Figure 1. Figure 2 shows a case where the fuel trim is changing dramatically with RPM and the MAF signal is all over the place. If we chart this data, or overlay it live while the engine is under test, we can often “see” or isolate the air or fuel direction of our diagnosis quickly.

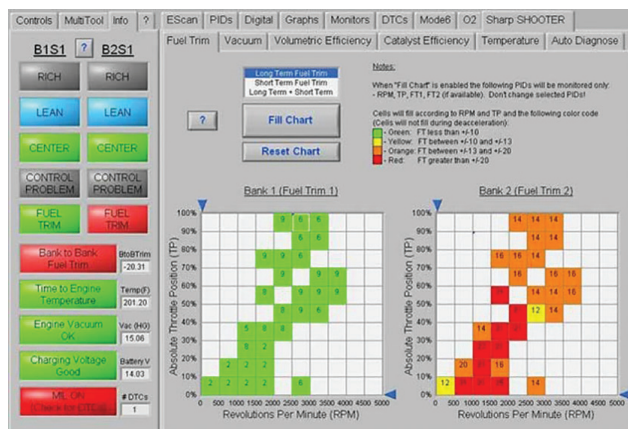
Figure 3: The Total Fuel Trim test in the Escan tool shows detail on each fuel trim adjustment throughout the RPM and load range on each bank. The software charts the fuel trim by recording the fuel trim adjustment for that RPM/Load block and assigns a plus-minus deviation for quick analysis of the fuel control system by the technician.

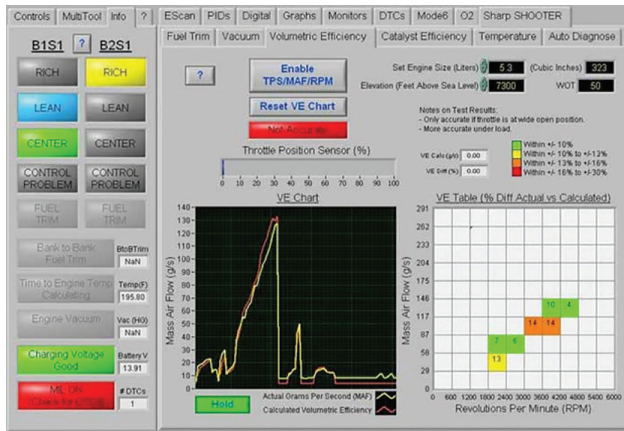
Figure 4: Using the Volumetric Efficiency test function of our ATS Escan Elite tester, we can quickly find a misreporting MAF sensor. The Red trace indicates calculated VE, the yellow trace is the actual MAF signal, and they must closely match as seen here. Deviation percentage from the norm is recorded in the blocks on the right throughout the RPM and Load range. This is a handy way to quickly and accurately confirm the source of the P0170-P0173 codes.

This means a careful data analysis of Volumetric Efficiency (VE) against the live MAF signal, or the ratio of MAF/RPM and fuel trim/RPM via a VE test spreadsheet is necessary: No matter how you decide to actually do it, this testing is critically important to avoid running yourself in diagnostic circles.

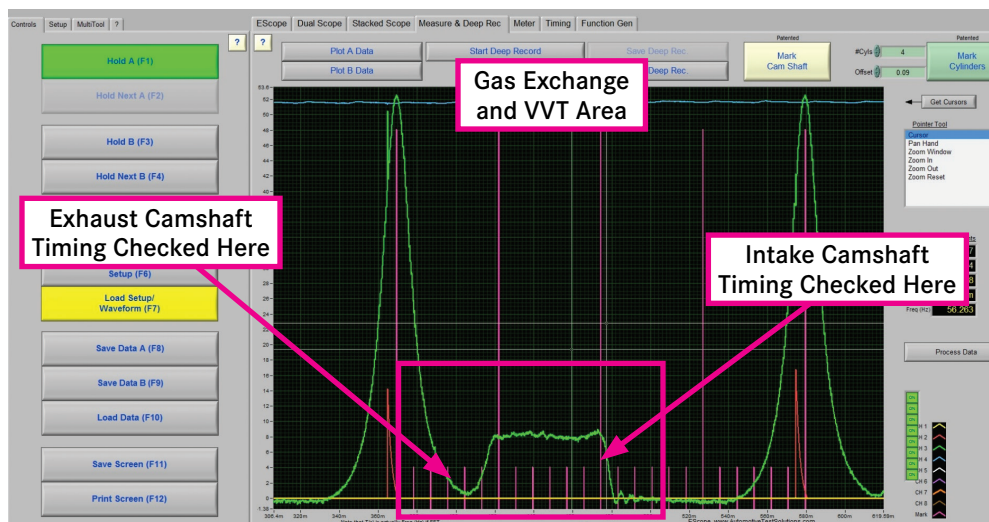
Most cam timing codes across the industry are set to flag a DTC somewhere between 10 and 20 degrees from target, and if we have a stuck cam-phaser adjuster, a loose timing chain (but not yet "jumped") or an oil pressure problem in the tensioners, VVT control solenoids, camshaft or phaser's oil feed and drain circuits, we could also potentially see this code set. To diagnose whether a mechanical fault is in play, we like to use the in-cylinder pressure waveforms. It can also be handy to compare triggered exhaust and intake vacuum waveforms to pinpoint the cause of the mechanical fault before disassembly of the engine for inspection. Refer to Figure 5 for measurement area identification of the in-cylinder waveform.

Figure 5: The in-cylinder waveform measurement for gas exchange, camshaft timing and Variable Valve Timing adjustment areas.

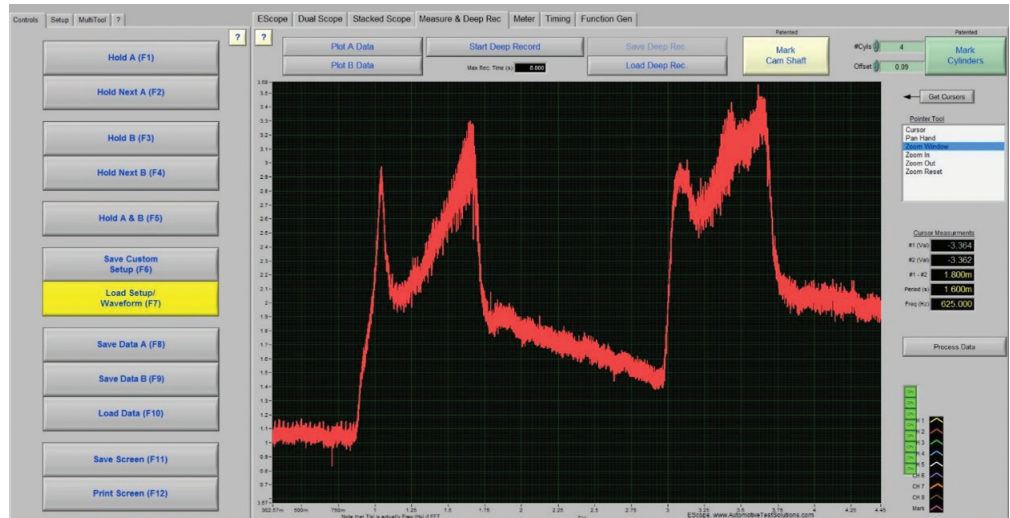
When the MAF is suspected to be at fault, a great way to catch and verify this quickly is to snap test the MAF while monitoring the signal on an oscilloscope. In a typical Analog MAF/ECU relationship, the amplitude of the sensor signal will reach about 4.0-4.2 volts, indicating that it is reading and reporting all of the air going past it. If the MAF voltage struggles or cannot reach to 4.0 (e.g., readings like 2.8, 3.2... 3.4 volts at the top of the second deep snap), the sensor is NOT capable of reporting all of the air entering the engine, and this confirms your P0170-P0173 code.

Always remember to measure the PEAK of the second snap throttle. This is due to the fact that on the first snap, the engine is just spinning up to higher RPM from off idle, so during that first snap, the engine is not going to ingest its maximum amount of air. After the first snap, let your foot off, then immediately perform the second deep snap without letting the engine idle down. If you do two successive deep throttle snaps, you will notice the second time (because the engine is already “spun up”) the engine will ingest it’s maximum peak of air intake and the MAF will measure it.

Figure 6: The MAF Snap throttle test. Be sure to measure the second snap throttle, not the first. In this case, the sensor didn't reach 4.0 volts and was ultimately replaced.

If we have a MAF that fails the 4.0V snap test, we always start by cleaning it and repeating the snap test. If the sensor makes 4.0 volts, or at least has dramatically better resolution, we replace the sensor. We have found that putting the vehicle back on the road with a "cleaned" MAF almost always comes back to bite you later as a "comeback" and the MAF will need to be replaced anyway, so avoid the comeback and replace the sensor if it first fails then passes this scope test after cleaning.
