TOYOTAtech

Quick Toyota Tech Tips

By Jordan Hill

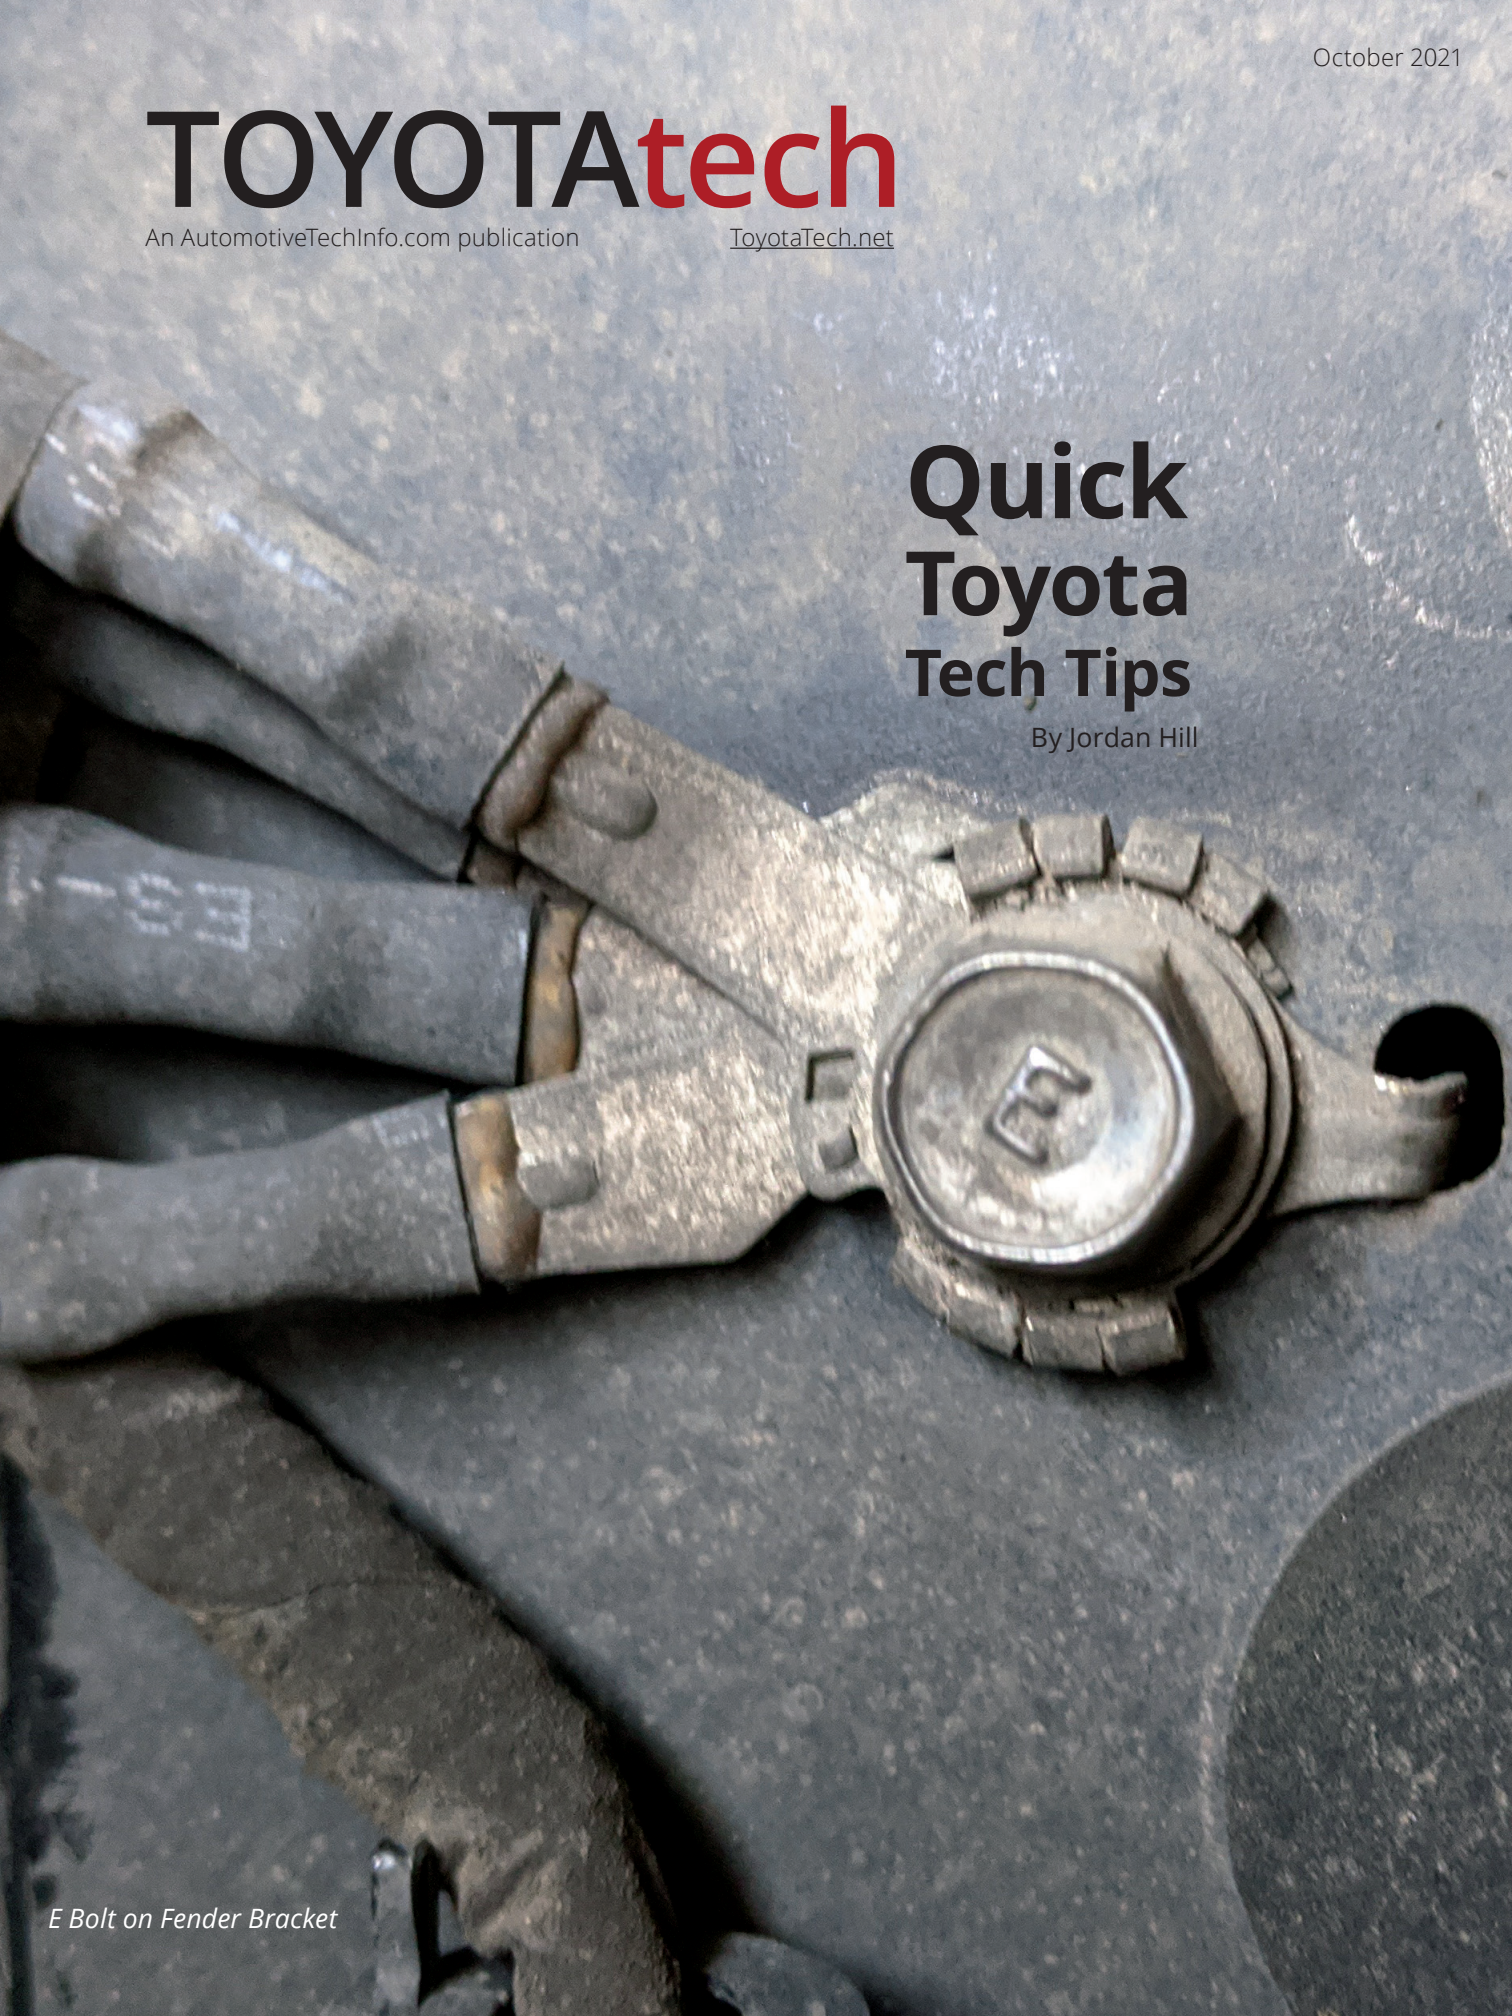
E Bolt on Fender Bracket

This first tip is relevant for technicians in both the repair and collision sectors. E bolts have been in use for quite some time now, but not all technicians are aware of them. An E bolt is a conductive bolt specifically designed to ensure proper grounding through the threads. They are denoted by a capital letter E on the head of the bolt.

The Toyota technical bulletin "T-SB-0179-12 - Integration Relay – Poor Ground" covers a specific E bolt example for the 2012 and 2013 Camry. If the ground wire bolts on the left front fender bracket are removed before the battery is disconnected, there can be circuit damage resulting in the passenger headlamp and rear defogger operating continuously.

Disconnecting an E bolt, splice pack, or other ground wire without first disconnecting the negative terminal at the battery can damage

There's a companion collision repair information bulletin for the same vehicles which covers the procedure in more detail. The bulletin requires the use of E bolts not only for the ground wires, but for the apron bolts as well since they are also part of the ground path.

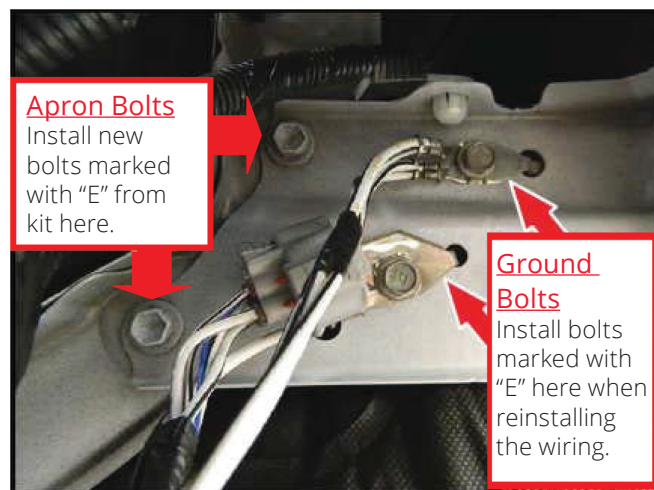
Collision Repair Bulletin

Model Year 2012- Camry/Camry HV and 2013-ES350/ES300H use the left front fender mounting bracket (Toyota PN 53804-33030 Lexus PN 53804-33040) as a ground location for an Integration Relay and the Engine Control Module. If this bracket is damaged and replaced, or repaired and reused, it is critical to follow the procedures and precautions provided below when removing or installing the bracket and ground wiring:

Note: Failure to follow these procedures and precautions to ensure a good ground circuit connection may cause damage to the electrical system.

Before removing any ground wiring disconnect the 12 volt negative battery terminal.

At no time while the ground wiring is loose or bracket is removed should the battery be reconnected or engine started.

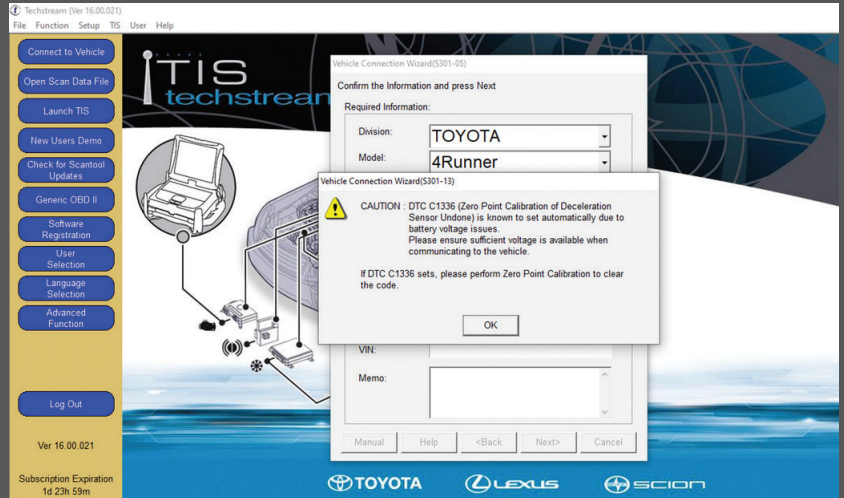
This quick tip covers several Toyota vehicle models with intermittent VSC and TRAC lights illuminated. The lights may be on solid or flashing. Often the lights will be off when the vehicle is first started, but when the shifter is moved out of the “Park” position the lights turn on. There may be fault code “C1336 - Zero Point Calibration of Deceleration Sensor Undone” logged in the ABS module, or there may be no faults present.

These lights are on because the Zero Point Calibration has been lost. The most likely reason for the calibration being lost is low system voltage. System voltage is critical for the ABS module, Deceleration Sensor and Steering Angle Sensor to operate correctly. This is a strong indicator that the battery is weak. There may also be a charging system issue or a drain on the battery.

Techstream caution notice via vehicle connection wizard

If there is any suspicion that the Zero Point Calibration has been lost then it is best to perform the calibration process to ensure proper operation and to avoid the vehicle returning to the repair facility.

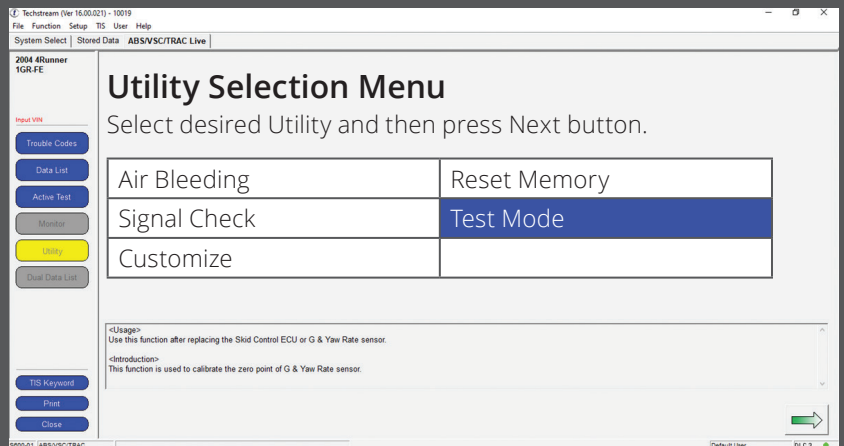
Run the Test Mode function to relearn the calibration.

The calibration is easy to perform with Techstream. The first step is to clear the memory using the Reset Memory option under the Utility section. Some older model years require the negative terminal to be removed briefly from the battery to clear the memory. Once the memory has been cleared, then

the Test Mode function needs to be run to relearn the calibration. Test Mode is a software function that only takes a few minutes to complete.
