TechNews Information for the Independent Nissan Specialist NissanTechNews.com

Nissan ADAS Solving the Puzzle		¹ N	
y Jordan Hill 2		S	
3		S	
² A D A ⁵ S ⁶		Α	
	11.2	Ν	
7

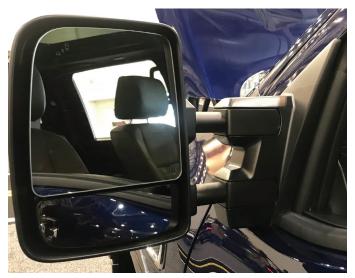
Titan Side Mirror

One such case happened on a 2017 Nissan Titan. The aftermarket side mirrors caused fault codes to set and the blind spot monitors to be disabled. Why would this happen? Well, the side mirrors have LED indicator lights to alert the driver there is a vehicle in their blind spot, and the LED circuitry in the aftermarket mirrors was not correct. It would cause faults to set for both side indicator light circuits having low voltage. The only option for this truck was to install the original side mirrors. Thankfully, the owner had kept the original mirrors and the repair was relatively inexpensive.

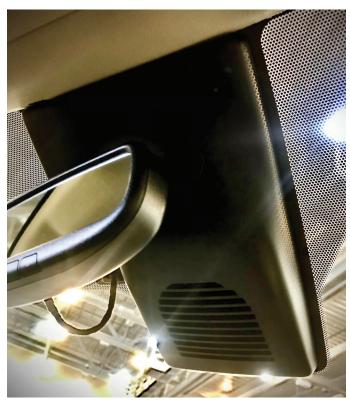
Lane Camera Cover

Checking for the correct mounting position of the Lane Camera is also important. The camera can be snapped into place without the alignment tabs on the base of the unit being fully engaged. This is visually evident when the camera body is not flush with the mounting bracket. Many Nissan vehicles have covers that conceal the camera and mounting bracket from view, so it may be necessary to remove this cover to properly inspect the camera installation.
