# TOYOTAtech

## The Toyota Corolla A 55-Year Retrospective

Lean Vehicle Study

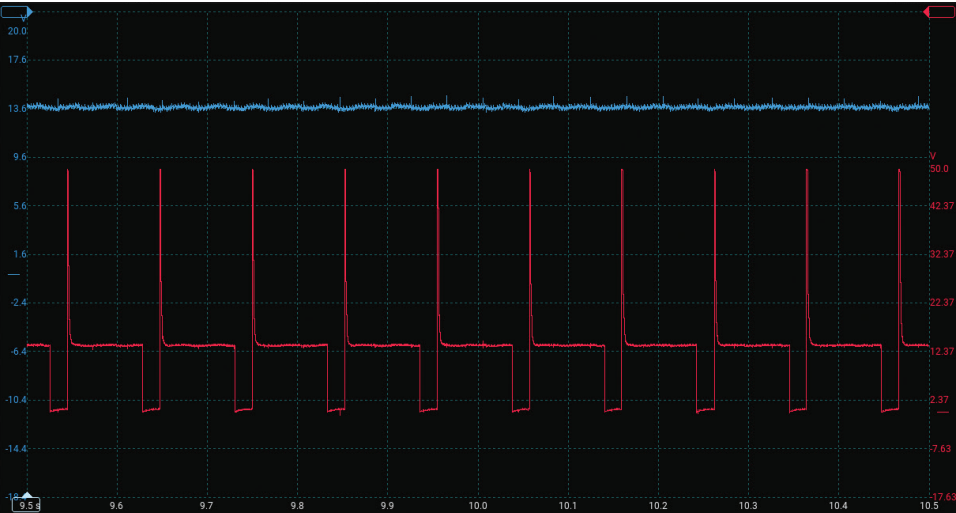
While on a road test, the air/fuel sensor operation was monitored via scan tool and found to be working correctly. A quick check of the purge valve using a lab scope showed that it was functioning normally as well (next page). The waveform showed that the purge valve ground was being duty-cycle controlled by the ECM and the electric solenoid was responding with a voltage spike each time the magnetic field collapsed.

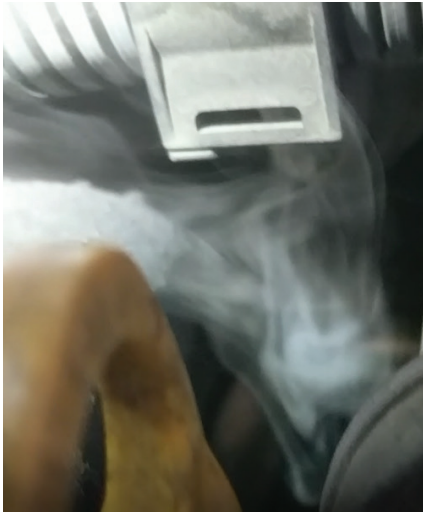
Intake Gasket Leak - [Watch Video](#)

That left an intake gasket leak as the most likely cause of the lean fault. A smoke machine was attached to the air intake system when the engine was cold and there was indeed a large leak from the intake gasket just above the oil dipstick. The vacuum leak was further confirmed when propane was injected near the intake manifold and the fuel trims rapidly dropped from positive to negative numbers.

A new intake manifold gasket was ordered and installed, and the throttle body was cleaned at the same time because carbon build up had accumulated and it was easy to clean while removed from the car.
