TechNews

Information for the Independent Nissan Specialist

New (and Old) Frontiers

These rugged trucks have aged well, with old plastic parts and a few TSBs needing your attention.

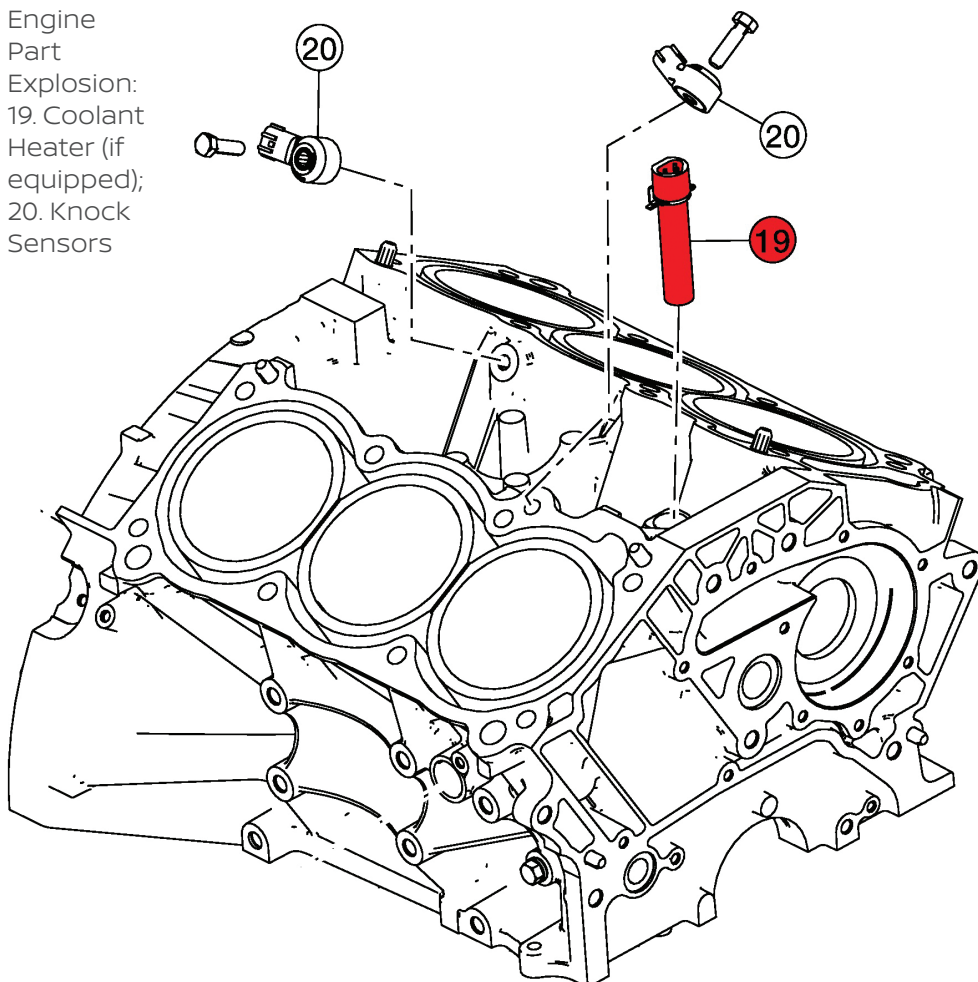
Another interesting item found while reviewing service information is an engine block heater in the valley of the engine. This optional coolant heater is shown on the parts diagram for the engine, and will undoubtedly have an additional set of wires for rodents to chew on, along with the two knock sensors under the intake manifold (more on that later). It is not clear which vehicles will have the coolant heater installed, but it may be intended for cold climate regions.

Engine
Part
Explosion:
19. Coolant
Heater (if
equipped);
20. Knock
Sensors

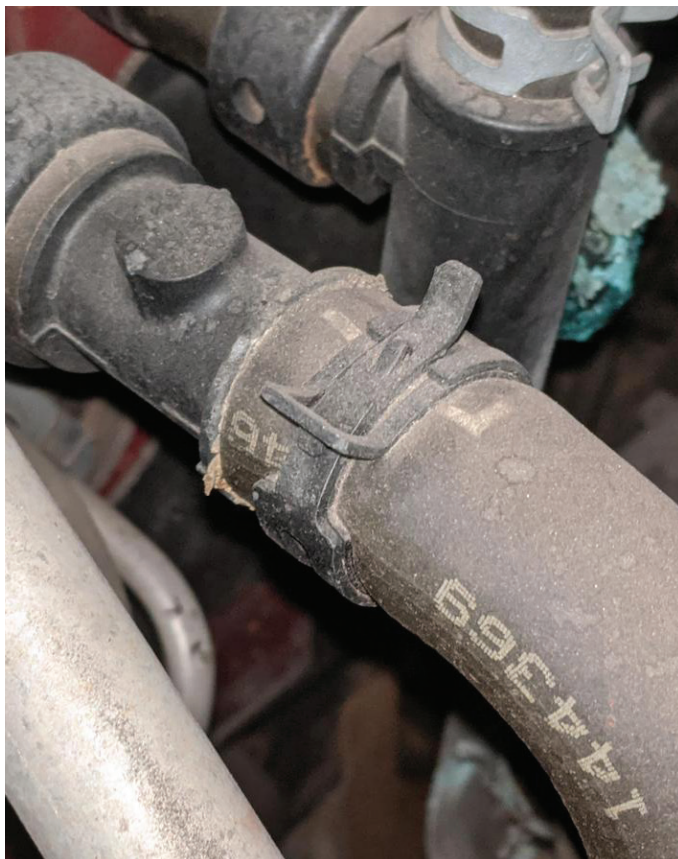
While not unique to Frontiers, there have been issues with plastic components under the hood, especially on higher mileage vehicles. More specifically, there are issues with the plastic valve covers with integrated spark plug tube seals, and the heater hose assembly on the passenger's side of the firewall. The extreme conditions under the hood take their toll on these plastic parts.

The plastic heater hose assembly can fail without warning and should be replaced at the first sign of seeping. In fact, the author installed a new factory engine in a Frontier at a very hefty price tag due to the plastic heater pipe failing and causing a catastrophic overheating condition.

Heater Hose Seepage

Replacing aged plastic components really should be looked at as normal preventive maintenance, and replacing them before they fail will save costly repairs down the road.

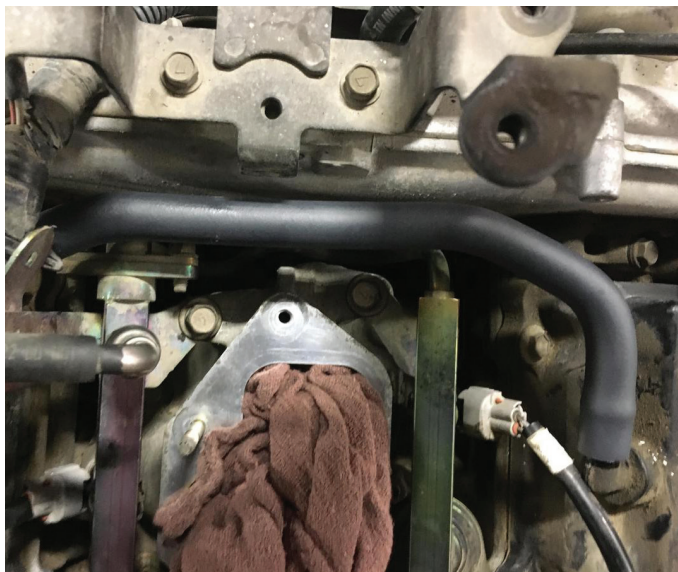
Breather Hose

to be replaced. Nissan offers complete valve cover assemblies at a reasonable cost, making replacement the superior alternative to resealing. Also be sure to replace the crankcase breather hoses that go between the valve covers. These hoses become hardened over time and usually cannot be reused.

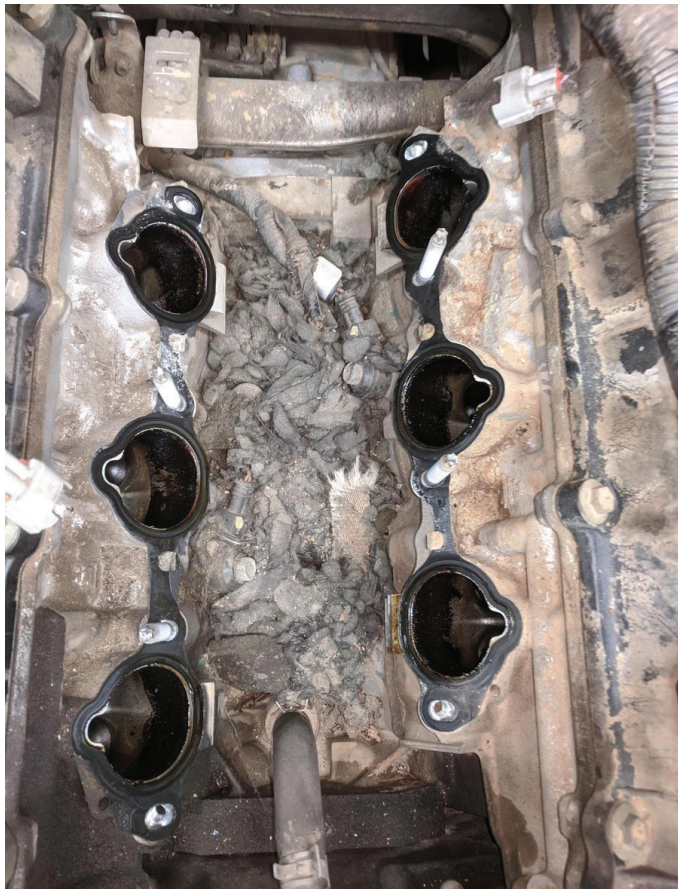
The valley of the V-6 engine is a very inviting place for rodents to get warm and build a nest. When there are knock sensor fault codes stored on a Frontier, it is quite common to find a nest under the intake manifold and a damaged knock sensor wiring harness.

Engine Valley Rodent Nest

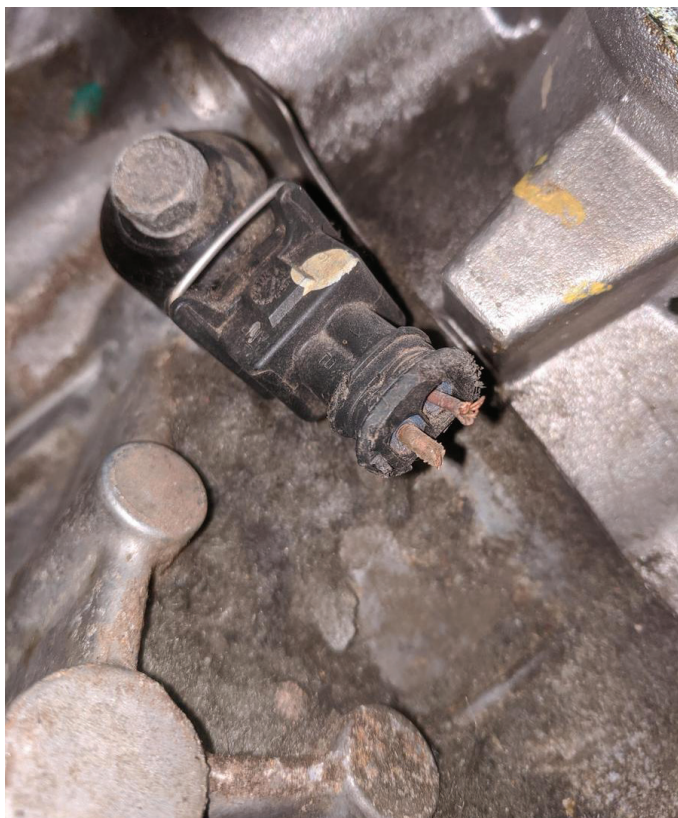
Knock Sensor Harness Damage

Thankfully, Nissan sells the knock sensor wiring as a sub harness to the main engine harness, making replacement easy and cost effective. It is strongly recommended to replace both knock sensors at the same time even if there was only a fault for one bank and not the other. Only use OE Nissan knock sensors, as aftermarket sensors are known to cause issues, and a fault code could return after a short time. Also, be sure to torque the sensors to the correct specification (normally around 20 ft-lbs). Improper torque can damage the sensors or cause them to read incorrectly.

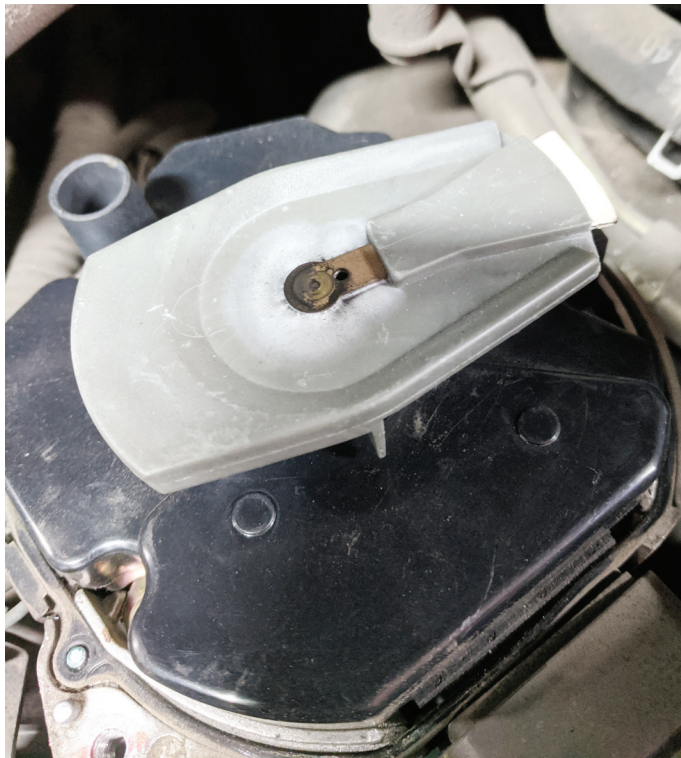
The first generation Frontier had a distributor ignition system, so a worn distributor rotor and cap were a good place to start looking for problems. At higher mileages the distributor was also prone to failures. (View the Ignition Coil Spark Test video at bit.ly/nissfro.)

Worn Distributor Rotor

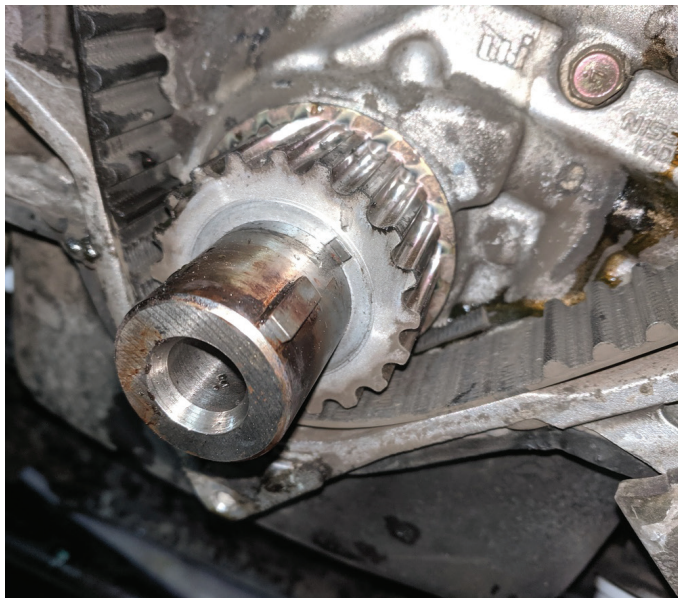
The recommended replacement interval for the timing belt on the 3.3L VG33 engine is 105,000 miles or 72 months. The timing belt should be changed earlier than that on the VG33ER supercharged version. When a timing belt fails, it usually happens at the crank sprocket, with multiple teeth tearing off of the belt.

Failed Timing Belt

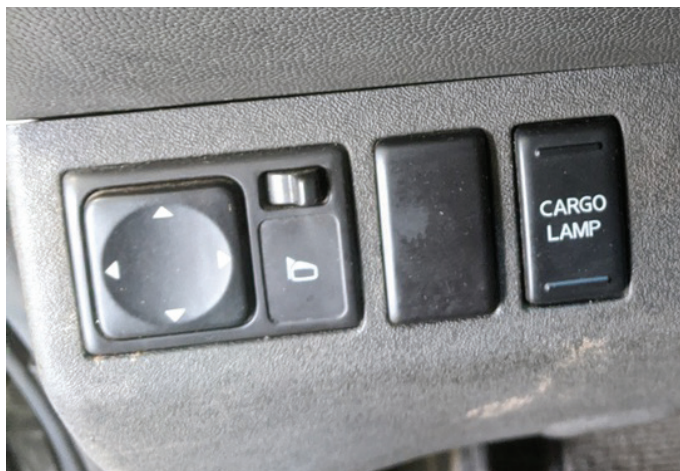
The cargo light switch was a red herring, and while it had drained the battery down in the past, it was not what was causing the current issue. The tow truck driver banging on the starter motor was also fake news. It was merely coincidence that the vehicle started after tapping the starter multiple times. The clutch pedal position switch hitting the half of the rubber bumper that was still intact was the real issue; a rubber bump stop has a list price of \$9.52. It would have been easy to just sell a new starter motor and release the truck only to have it come back again in a few days. |

Cargo Lamp Switch

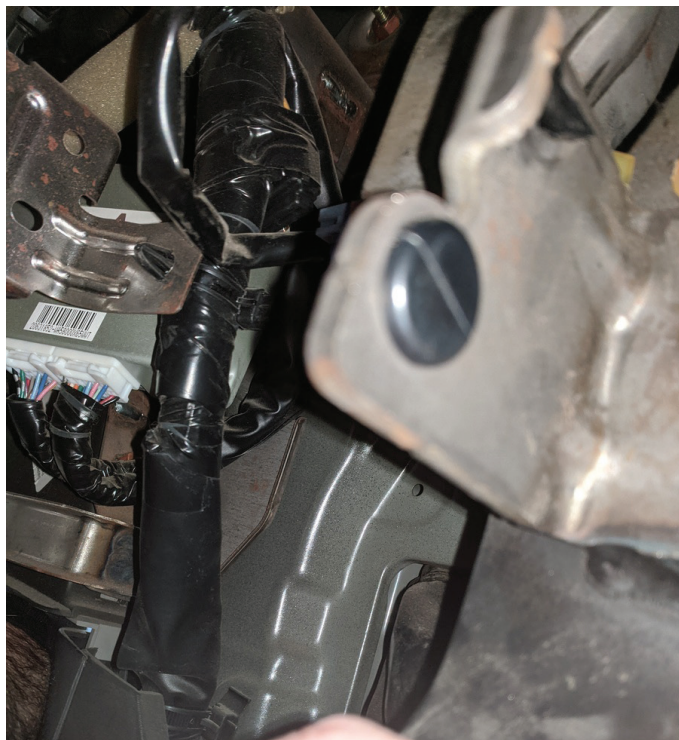
technician noticed the rubber bumper that the position switch contacted was split down the middle.

This small part, called a clutch pedal rubber stopper grommet, is a press fit into the clutch pedal, and it was really what was causing the intermittent no crank. The broken half of the grommet would not fully depress the clutch pedal switch, creating a no start. Thankfully the local Nissan dealership had one of the rubber grommets in stock, and the Frontier was still able to go home at the end of the day.

Clutch Pedal Rubber Stopper Grommet
