Technical Knowledge for Volkswagen[®], Audi[®] and Porsche[®] Service Professionals

AN AILING AUDI A6 – IN THREE ACTS: Testing, Repair and Validation

By Jordan Hill

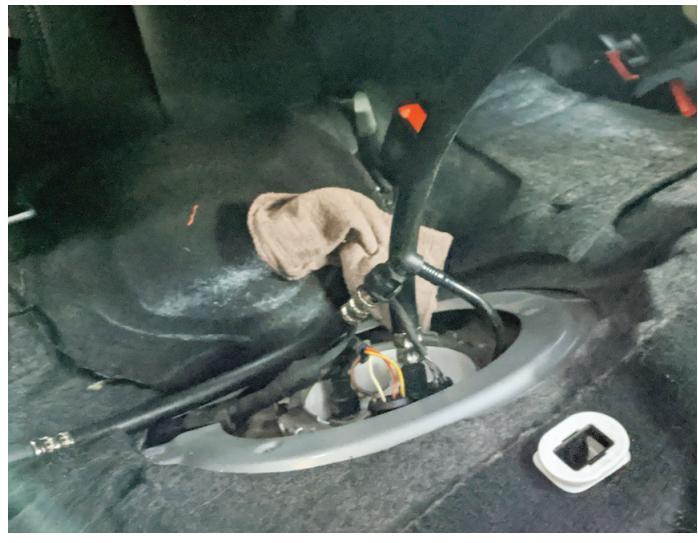
Fuel Pump Access (under rear seat)

In order to test the fuel pressure on this Audi the rear seat needs to be removed and the access panel unscrewed. Once the fuel pump assembly is accessed, install a fuel pressure gauge in-line so the engine can be run while monitoring the pressure.

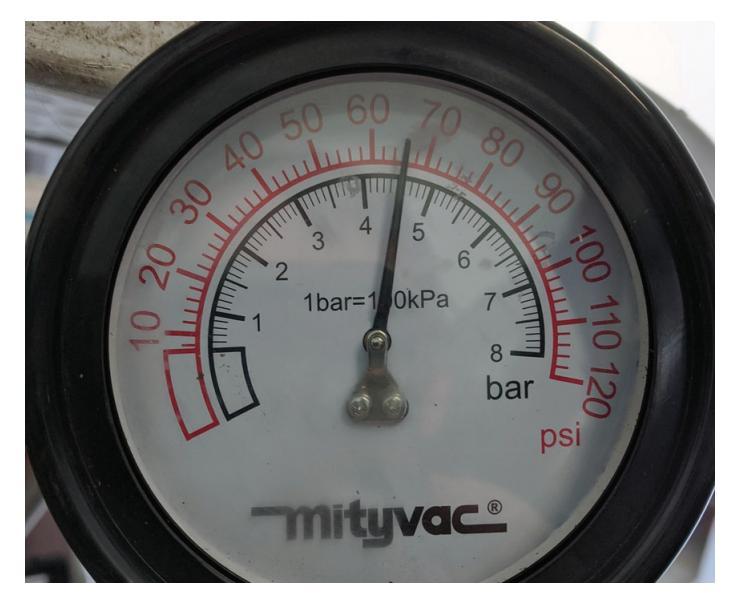
Audi Fuel Pressure

Our Audi had a running pressure of 4.6 bar, or 66 psi, which is well within the specification of 3.5 to 6 bar (50 – 87 psi) provided in Audi service information. Audi SI also

listed a residual fuel pressure test, in which a pressure of at least 3 bar (44 psi) needs to be present for ten minutes after shutting off the engine. The A6 was holding strong at 3.5 bar (50 psi) long after ten minutes elapsed.

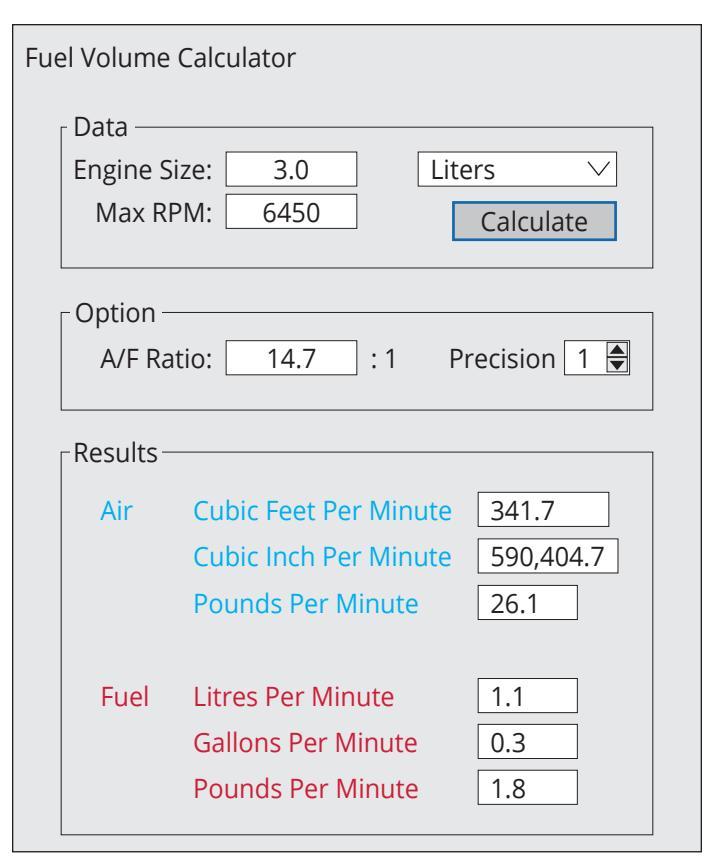
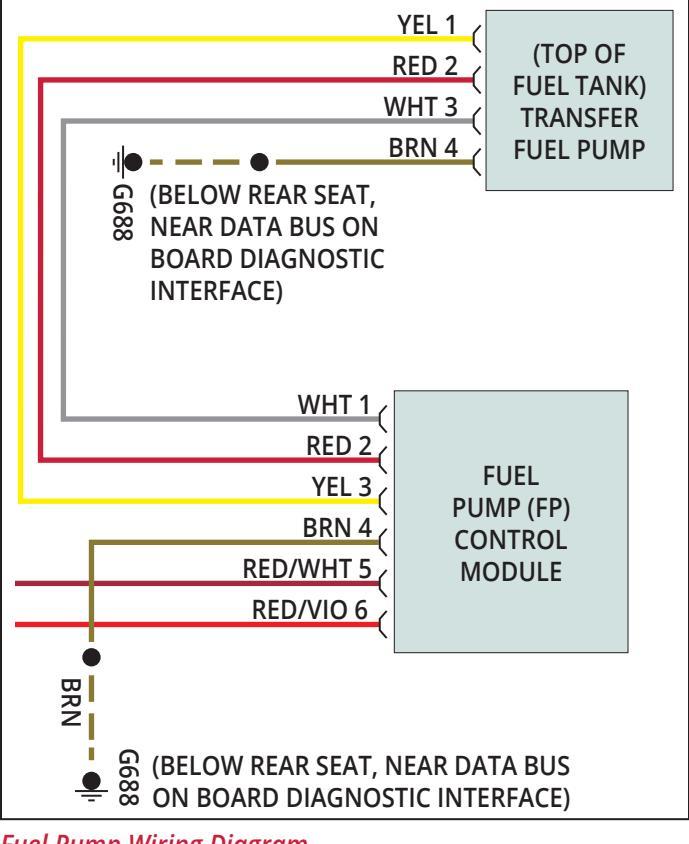
Fuel Volume Calculator

sometimes available from the OEM in service information, but if there is not a printed spec, a fuel volume calculator can also be used. The image above shows the fuel volume calculations for the A6.

The Audi A6 had a fuel volume of 900 milliliters in 30 seconds, so this BLDC fuel pump was easily outpacing the listed specification.

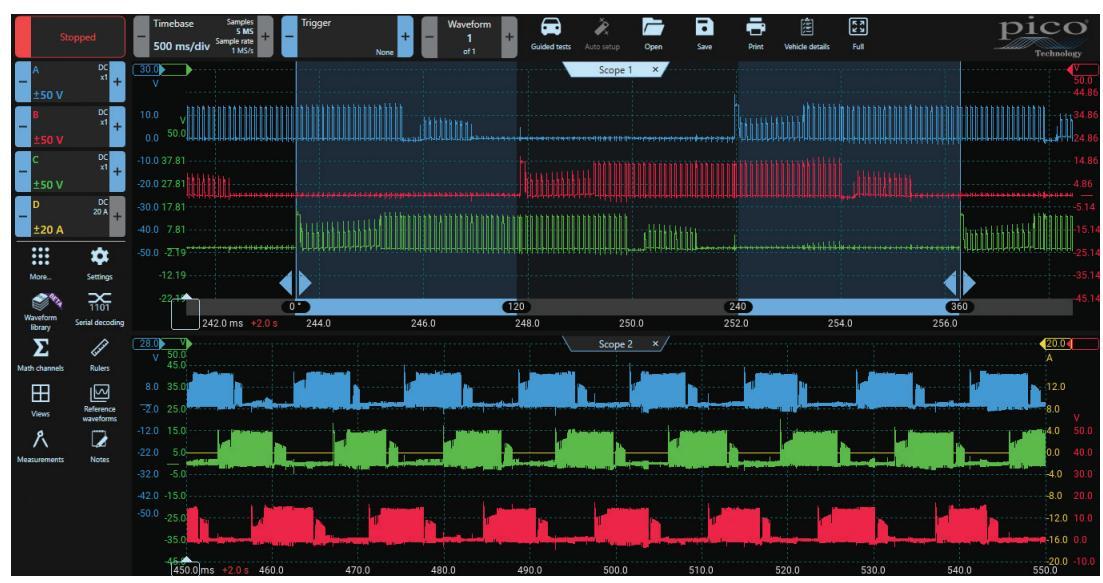
BLDC Fuel Pump Waveform

By connecting an oscilloscope to each of the phase power wires, the *BLDC Waveform*, on the next page, was captured. The waveform can be analyzed to determine if the three phases have the same voltage amplitudes and frequencies, as well as the same 120-degree phasing. Using PicoScope's multiple scope views feature, the fuel pump voltages can be viewed at different zoom levels and the phase rulers can be used to verify that a new voltage phase begins every 120 degrees.

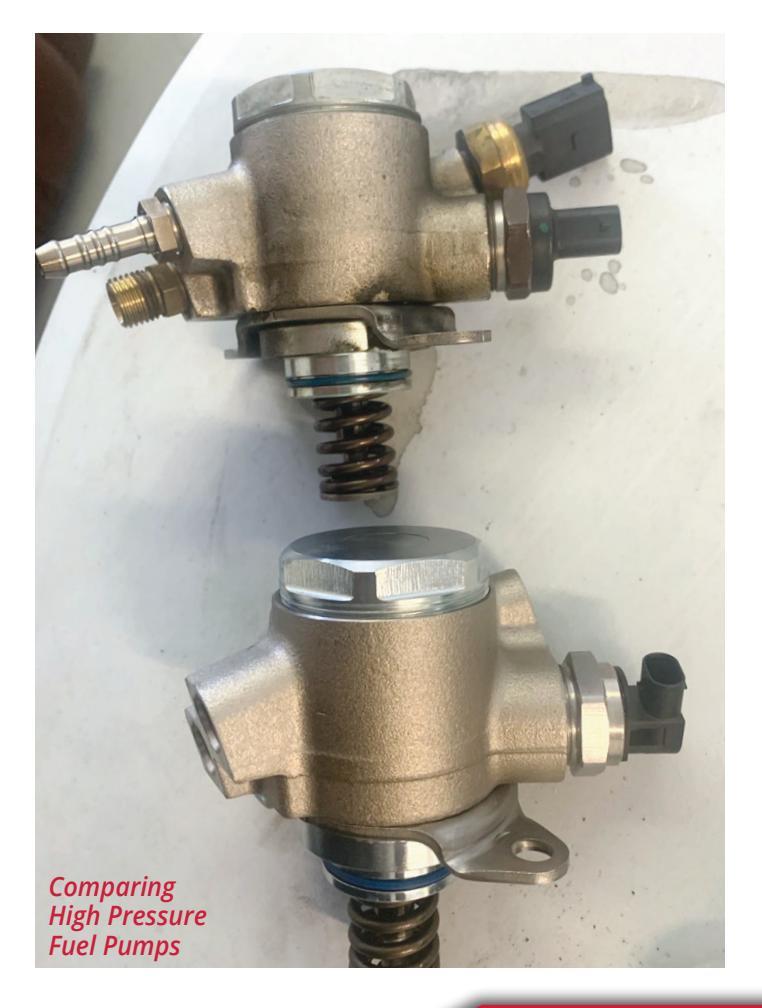
Make sure to line up the new pump next to the old part and verify correct fitment. Also, double check to confirm that the part numbers match. or confirm that the part number has been superseded if they do not match. As seen in the photo, the HPFP on this Audi had been updated and the electrical connector for the fuel metering valve had been reoriented. It is also worth noting that the low fuel

pressure sensor (G410) and two line fittings needed to be transferred to the new pump and, of course, a new o-ring seal was installed. Also, do not forget to check for technical bulletins related to the HPFP system to see if there are any updated parts or repair procedures.
