# STARTUNED®

INFORMATION FOR THE INDEPENDENT MERCEDES-BENZ SERVICE PROFESSIONAL

# Benz and the Art of Mercedes Maintenance

**Maintenance procedures are not always as simple as you think.**

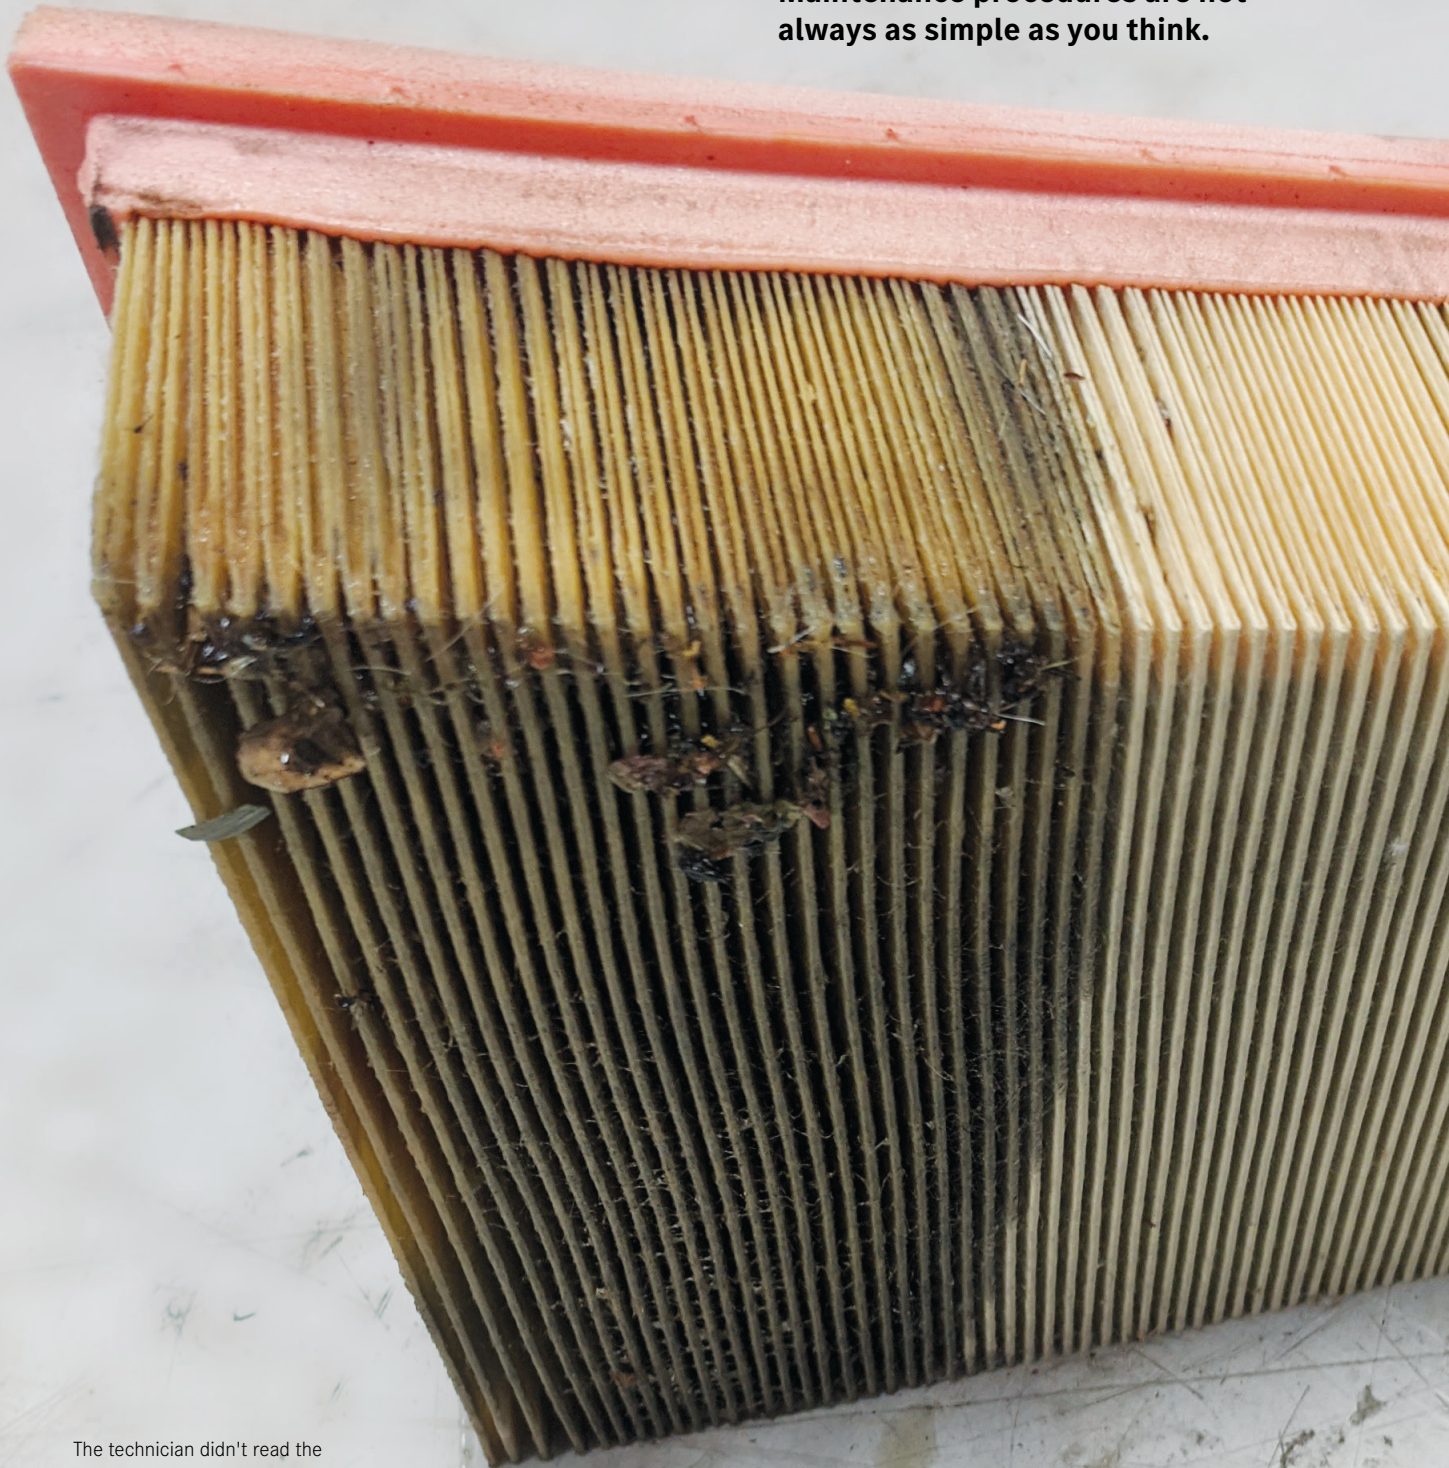
The technician didn't read the instructions and ended up with this oil-soaked air filter.

Now the technician was thoroughly confused and asked the foreman to take a look at the vehicle. Removing the air filter confirmed there was significant amount of oil soaking the air filter and pooling in the bottom of the air cleaner. The foreman decided to take a few minutes and read through the service information for this vehicle, and that is where everything became clear.

So where did the technician go wrong? He was unfamiliar with this Mercedes-Benz engine and did not read through the Mercedes-Benz Workshop Information System (WIS) maintenance instructions before beginning the oil change. He had not pulled the dipstick up out of the tube, which as a side note, is good practice for any oil service as it serves as a visual indication that the engine needs oil and should not be started, and he pumped in the oil as fast as the overhead oil gun would pump, resulting in an oil bath air filter and an oil slick under the vehicle. To dig a little deeper, where did the shop go wrong? The shop had not created a standard practice where any time a new vehicle or unfamiliar engine is being serviced or repaired the first step is to consult the factory service information.

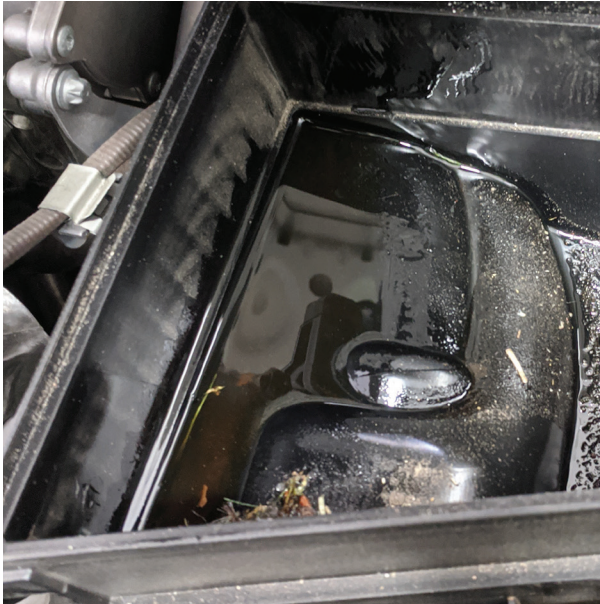
Oil pooled in the air cleaner housing

draining the oil while performing an inspection of the undercarriage. Once the oil had finished draining the drain plug was tightened, under trays reinstalled and the SUV was lowered to the ground. A new cartridge oil filter was installed and at this point, the technician pulled down the overhead oil reel, reset the fluid counter and began pumping in 5.6 liters of 5w40 oil. After the oil was pumped in, the technician walked over to the oil sticker printer and printed out a windshield sticker. When he returned to the vehicle, he was confused and dismayed to see fresh oil steadily dripping out from under the left side of the vehicle. He quickly raised the vehicle back up and checked the drain plug; it was clean and dry. The engine hadn't even been started yet and it really wasn't clear where the oil was dripping from. Further inspection revealed the fresh oil was dripping out of the bottom of the air filter housing.

*in slowly. To ensure pressure compensation when the oil is being poured in, the oil dipstick must not be inserted. Backpressure can otherwise occur under the cylinder head cover causing engine oil to be forced along the vent lines to the air intake duct and then to be discharged at the air filter box as well as the exhaust gas turbocharger."*

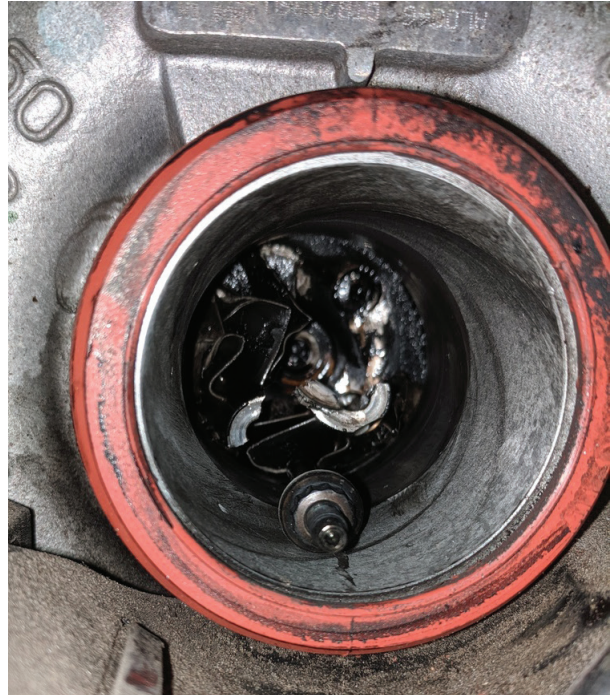
There are several issues to be aware of when replacing air filters on vehicles equipped with turbocharged diesel engines. The turbocharger system introduces additional components like intercoolers, charge air tubes and pressure sensors. Any of the components can cause drivability issues, limp modes and warning lights if not addressed properly. Often times, charge air pipes need to be loosened or even removed to gain access to an air filter. These are usually plastic pipes with clips or clamps holding them in place. Great care needs to be used when dealing with these plastic pipes to ensure they are not damaged. One specific area that needs to be paid close attention to are the charge air pipe seals. These are usually thick rubber seals that are used to seal two air pipes together, or used on the inlet of the turbocharger. Any time a charge air pipe is removed these seals need to be inspected and replaced if there is any sign of damage or deformation. Air leaks at these seals will quickly cause under-boost and air mass faults, but more importantly, a torn seal can damage the turbocharger. Damaged seals can get sucked into the turbocharger and cause catastrophic damage, as shown in the photo of a turbocharger from a Sprinter Van (note the new charge pipe seal which was unfortunately installed too late, after the damage had occurred).

Failed Sprinter van turbocharger

Inspect the charge air pipe seals during every air filter replacement and if there is any question of the integrity of the seals, replace them. This is in the best interest of both the vehicle owner and the repair shop.

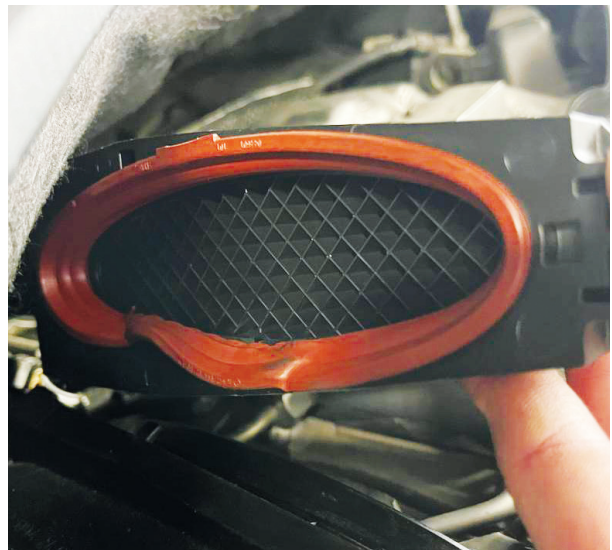
Deformed charge air pipe seal

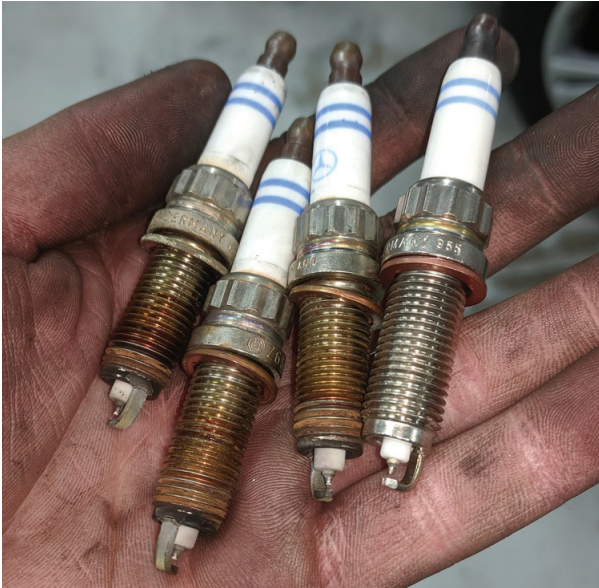
Genuine Mercedes-Benz Spark Plugs from a GLK350. Using aftermarket plugs can lead to engine damage.

Select the correct spark plugs based on the vehicle application and always use genuine Mercedes-Benz plugs. Many aftermarket spark plugs can cause performance issues, and in some cases, lead to misfires due their electrodes being misaligned. See the [March 2021 issue of StarTuned](#) for the details.

Be sure to torque the spark plugs to the correct amount, which is 23 Nm in the case of this GLK350 SUV. Over-torquing the plugs can weaken or crack the porcelain insulator. This may not cause an issue immediately, but the vehicle will likely be back in a few days or weeks with a misfire complaint.

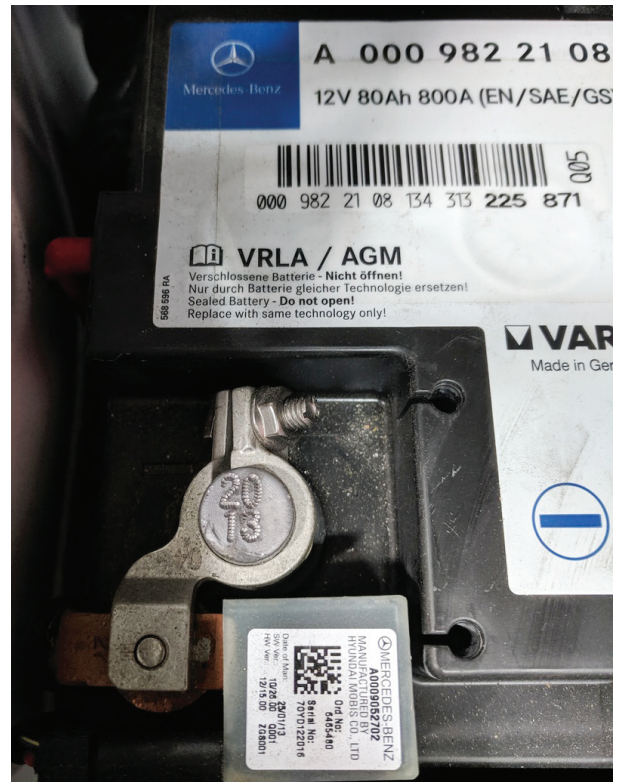
The battery terminal date code can be stamped on the negative post, or found on a label.

AGM battery or not before recommending a battery replacement. Misquoting the battery will greatly change the estimate price and installing the incorrect battery type in a vehicle can cause serious issues with the charging, starting and other electrical systems, not to mention vehicle and passenger safety. Also, most batteries have a vent hose that must be reinstalled on the new battery, along with a plug for the vent hole on the other end of the battery cover. Missing this could cause significant corrosion or allow hydrogen gas to reach dangerous levels.

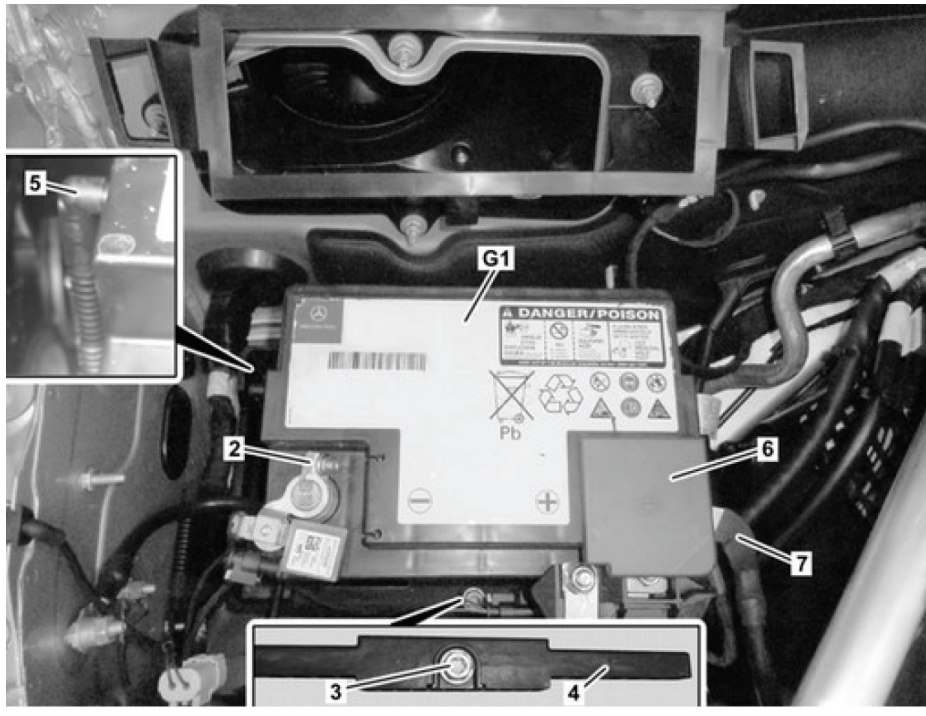
Some battery replacements require a scan tool function to communicate to the engine controller, charging system or other module that a new battery has been installed. This can vary by year and model, so consult service information closely to determine if a battery registration is required. The battery replacement procedure for a 2018 C300 states, "Confirm battery change in front SAM control unit in the Actuations menu item."

Under a separate heading it goes on to say, "Due to technical modifications in the energy management system, it is essential to reset the charge throughput of the starter battery using XENTRY DAS each time the starter battery is replaced. Replacement of the starter battery is confirmed in the SAM control unit (N10) in the 'Actuations' menu item."

C300 battery registration procedure
