# Volvo TechTips

Spring 2023

# Supercharger Service on High Mileage Volvos

## Supercharger Air Leaks, Late Style 2.0L Twin-Charged Engines (2015 and up)

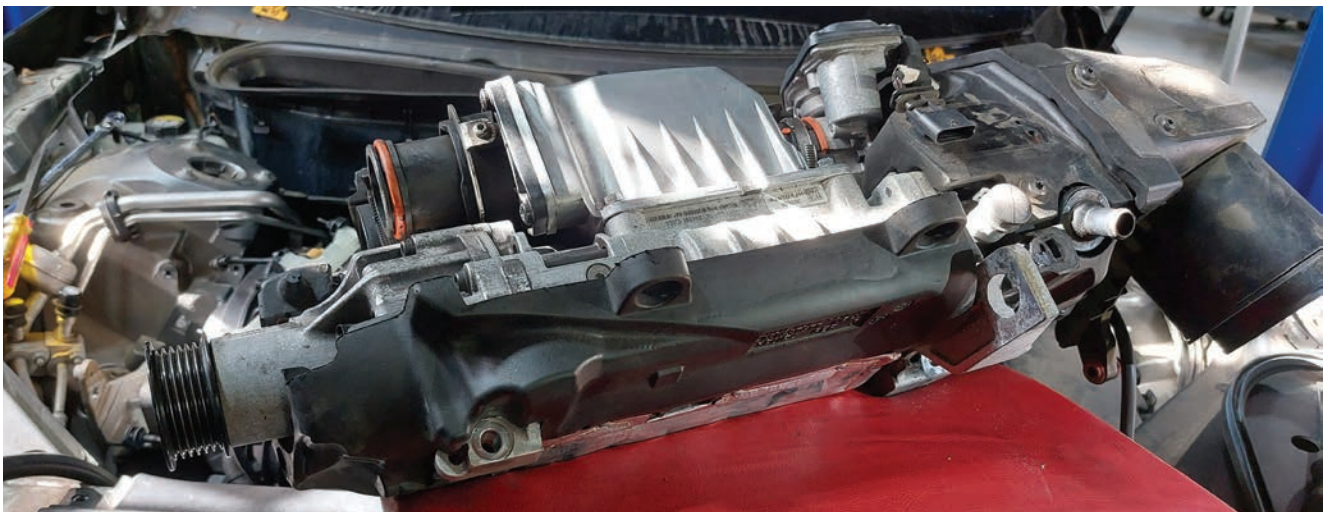
Supercharger assembly removed from the engine

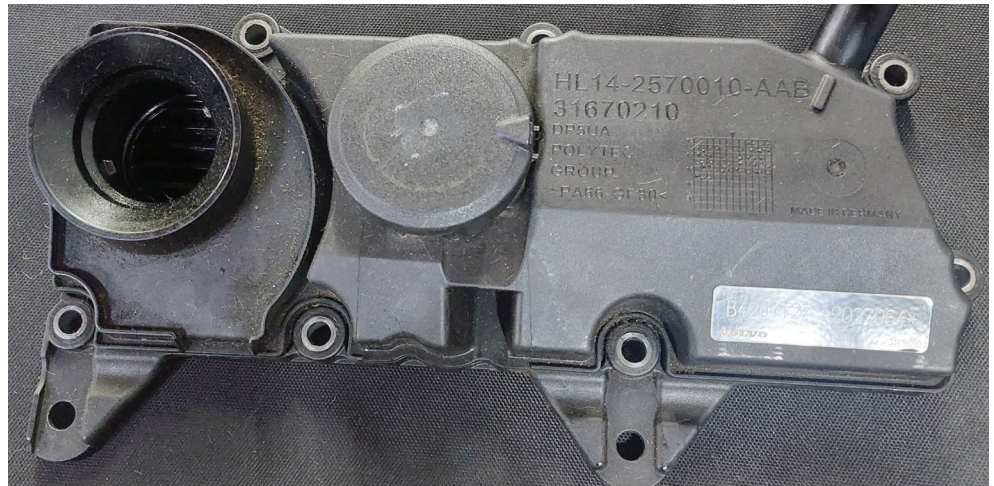
That's not the case when it comes to Volvo's 2.0L engines, where a leak in the PCV oil trap diaphragm will usually only result in a lean code being stored in the ECM.

If the oil trap diaphragm is intact, the filler cap will be easy to remove; but if there is excessive vacuum in the crankcase caused by a broken oil trap diaphragm, the oil cap will be difficult to remove while the engine is running.

One of the most common causes of unmetered intake air leaks in late Volvo 2.0L engines is an internally leaking oil trap diaphragm.

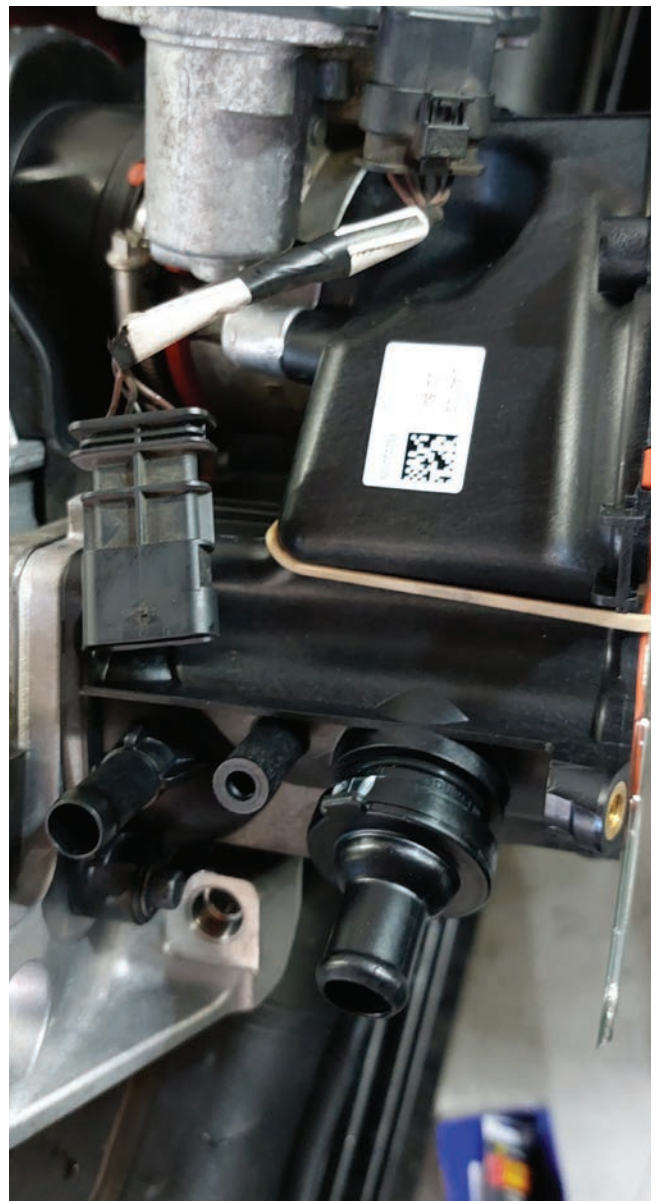
New supercharger check valve

The check valve is not replaceable on its own though; it's part of an assembly that's part of the supercharger called a resonator assembly, and to replace it you will need to remove the supercharger from the engine.

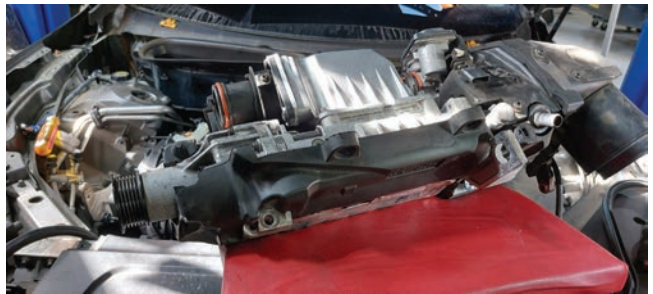
Supercharger removed

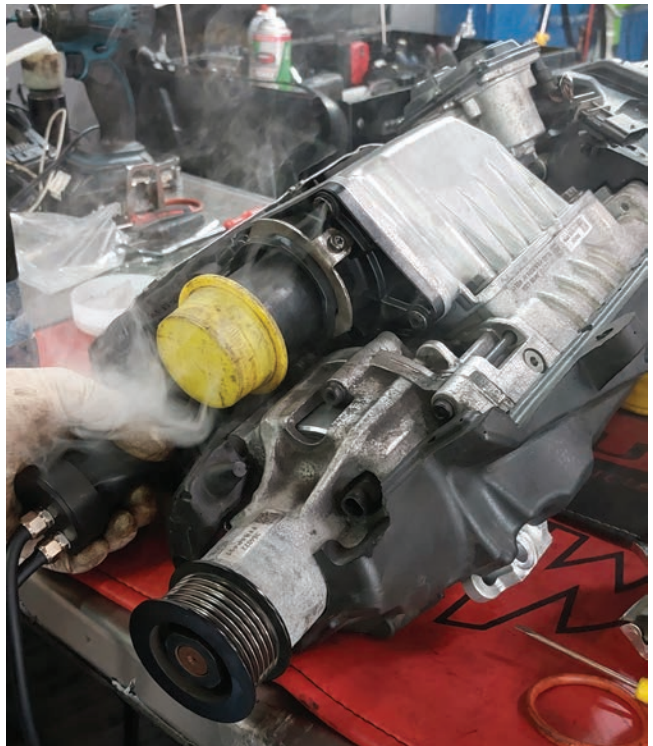
When you get the supercharger assembly out of the engine compartment, you can seal it up and use a smoke machine to check for leakage; it will probably come from multiple worn seals in the assembly.

A smoke check of the supercharger assembly when it is first removed will show most of the leaks.

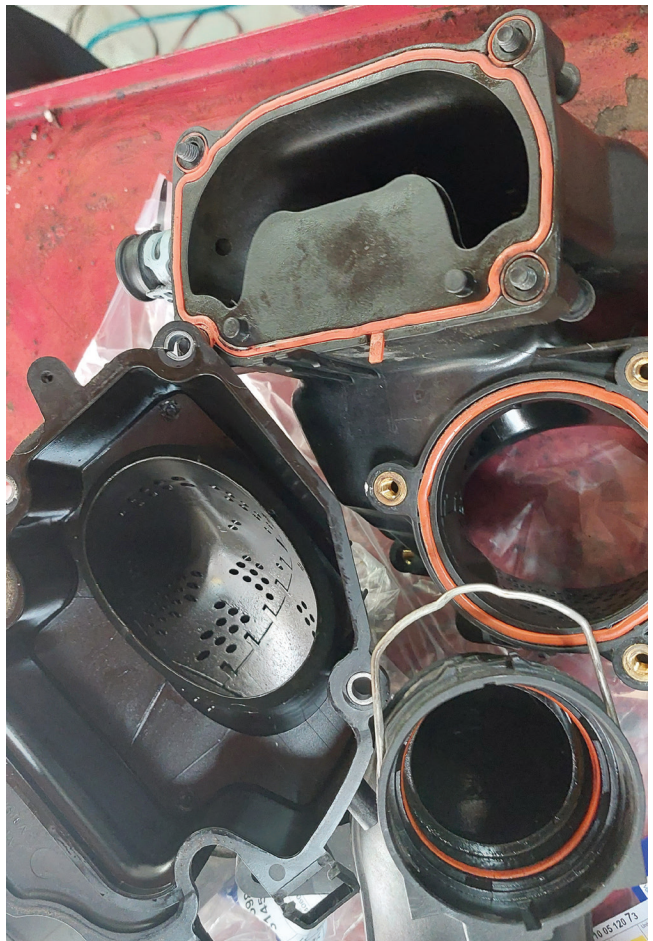
When you start to disassemble the supercharger assembly, in some cases you will be able to see the areas that were not sealing well due to age and wear.

Worn supercharger parts

Clean all surfaces and reassemble the supercharger with new seals and parts.
