Volvo TechTips

Replacing the Air Conditioning Evaporator in the 2006 Volvo V70

di-AGNOSTIC Volvos

This *Volvo TechTips* article will focus on using a di-AGNOSTIC approach on a pair of 2015 Volvos: an S60 and an XC60.

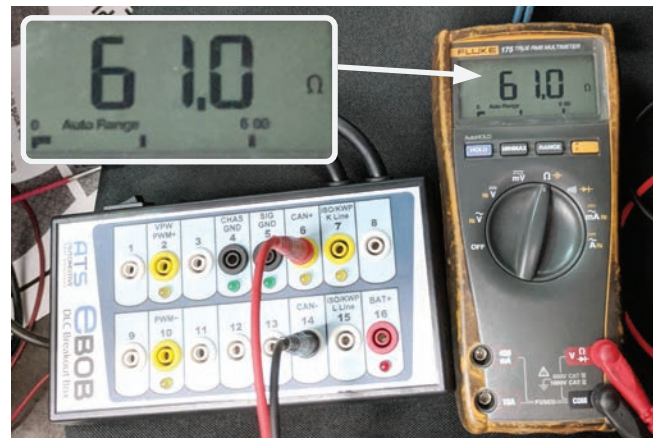
Checks of the powers and ground to the rack motor and control module proved good. Next, the technician used a DLC break-out box to measure the CAN network resistance across terminals 6 and 14; resistance was as expected at 61 ohms. Ideally, the negative battery cable would be disconnected before checking the network resistance, but waiting five minutes after shutting the ignition off is usually adequate to get an accurate reading.

Network resistance measurement

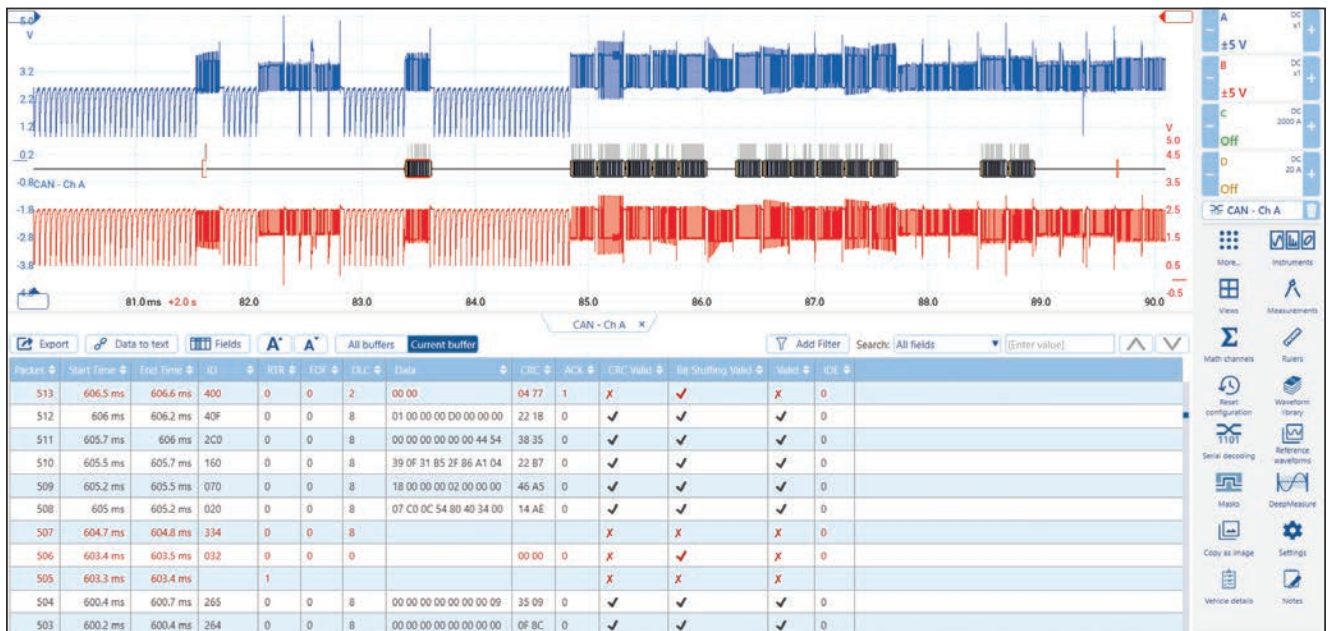
CAN bus waveform

This technique was used on the Volvo sedan and yielded surprising results. With the ignition on and Picoscope hooked up to the high-speed CAN bus, the harnesses and connectors were flexed while monitoring the computer screen. It made sense to start under the hood, specifically in the area of the rack-mounted power steering module. When the harness on top of the transmission was moved, there were visible glitches in the CAN waveform. This was easily repeated every time the harness was repositioned.

Further analyzing the waveform showed that the high and low CAN voltages were being pulled toward ground in a repetitive sawtooth-type pattern between message frames. Using the serial decoding feature built into the oscilloscope software confirmed that there were invalid messages being transmitted on the CAN network. The invalid messages are shown in red in the table below the voltage waveform (see CAN bus waveform image on page 20).

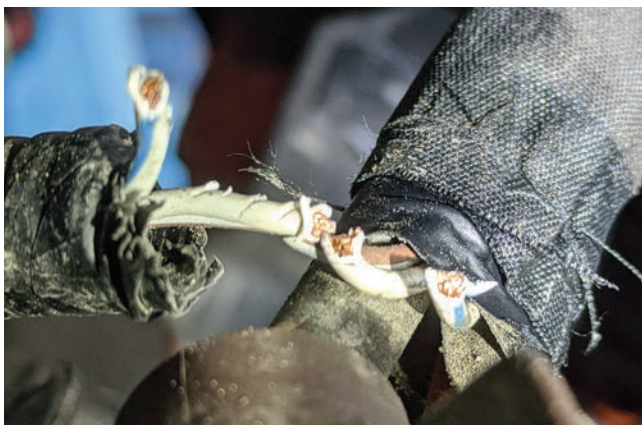
CAN wiring damage

rack. The twisted pair of CAN wires was almost completely severed at the harness junction, save for a few copper strands. This explained the intermittent nature of the power steering issue. As the vehicle moved and the harness flexed, the connection would be partially lost on the twisted pair of CAN bus wires leading down to the EPS module.

The cause of the wiring damage was unclear. It was possibly from a rodent looking for a snack, but it was in an unusual location, with no other damage nearby. It may also have been from an errant pry bar placement during a previous repair.

The wiring harness was repaired, and all the fault codes were cleared. The power steering worked perfectly during the road test, with no warning lights. All that was left was the engine misfire, but that would have to be dealt with at a future date. In the case of this S60 Volvo, a di-AGNOSTIC approach paid dividends for the customer—a simple wiring repair instead of a high-dollar rack and pinion replacement.

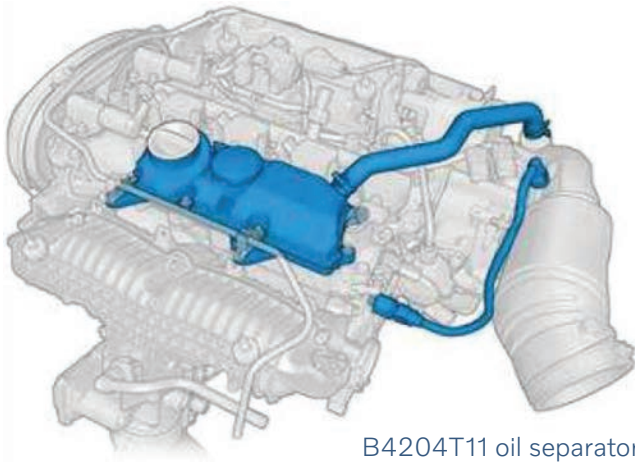
B4204T11 oil separator

With the data collection and research completed, attention was turned to the Volvo. A few symptoms were noted with the hood open and the engine running. First, a high-pitched whistling sound could be heard from the engine compartment. This whistling was louder with the engine cover removed. Second, while the engine had a shaky, unsteady idle, it was not misfiring. Suspicions about the plastic oil separator or crankcase vent valve mounted to the camshaft cover were high, so testing began there.

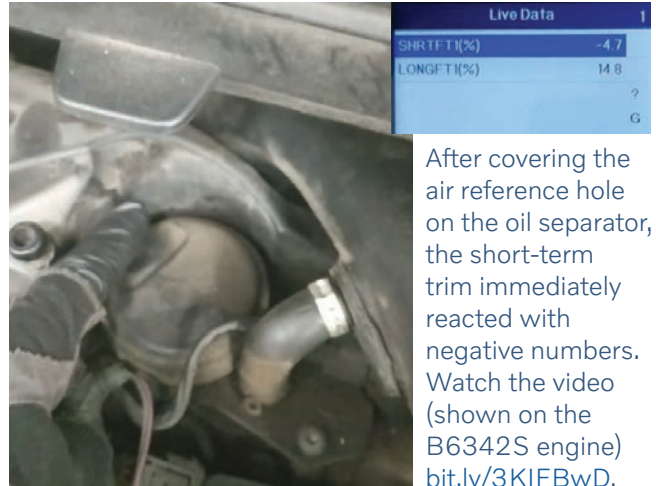
After covering the air reference hole on the oil separator, the short-term trim immediately reacted with negative numbers. Watch the video (shown on the B6342S engine) bit.ly/3KIFBwD.

Fuel trims were checked with a handheld scanner, which allowed easy viewing of global OBD II data. In some diagnostic situations, it is more practical to view generic data PIDs instead of using enhanced vehicle-specific scan data. The long-term trim was elevated at almost 15%. By covering the air reference hole on the oil separator, the short-term trim immediately reacted with negative numbers, showing that the engine computer was self-correcting and removing fuel. This simple test proved that the oil separator's internal diaphragm was torn.

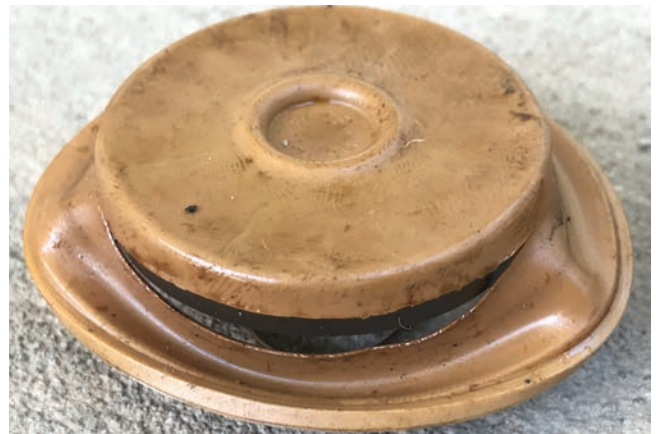
Torn internal diaphragm in the oil separator

When the parts arrived, the new oil separator and spark plugs were installed. Next, the oil was changed, which is a good idea after a walnut cleaning procedure and

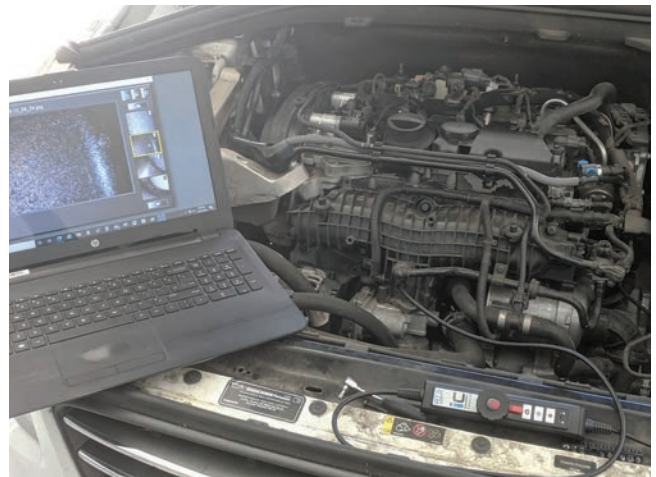
Checking valves with borescope

Based on previous experience with Volvo GDI engines, a borescope was used to inspect the intake valves. This is quickly done through a central vacuum port on the intake manifold. The intake valves showed heavy carbon buildup, typical of gasoline direct-injected engines. Carbon deposits like this can cause misfires on cold and warm start-ups, fuel mixture faults, and performance issues.

While waiting for the parts to be delivered, the walnut blasting got underway. Removing the intake manifold on the B4204T11 engine is a straightforward procedure, and it was quickly out of the way, exposing the intake valves. The valves had a lot of carbon buildup, with cylinder 2 looking worse than the others. All eight intake valves were cleaned with the air-powered walnut blaster, and the vacuum attachment made for easy cleanup. The valves cleaned up well, and the intake manifold was reinstalled with new gaskets.
