SERVICE NEWS

Bulletin No. 13

August 1984

Troubleshooting Toyota Charging Systems

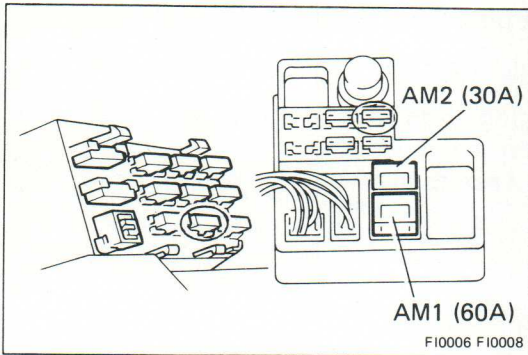
3. CHECK FUSES AND FUSIBLE LINK

Check the fuses and fusible link for continuity.

FUSIBLE LINK AM1, AM2
Fuse ENGINE (15A)
Fuse CHARGE (7.5A)

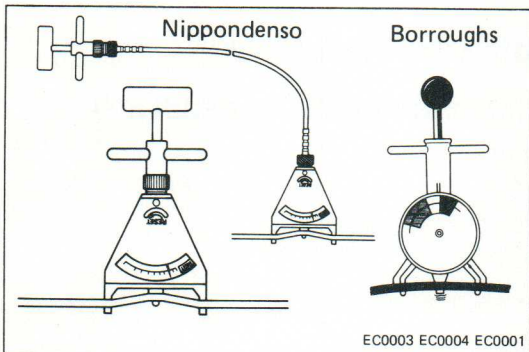
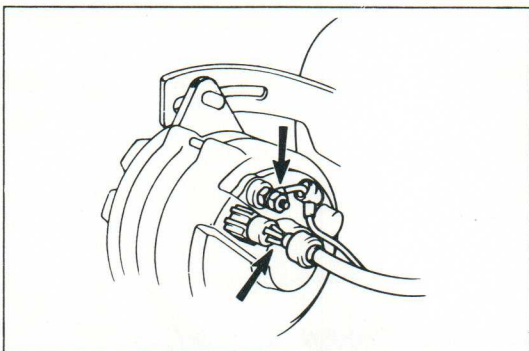
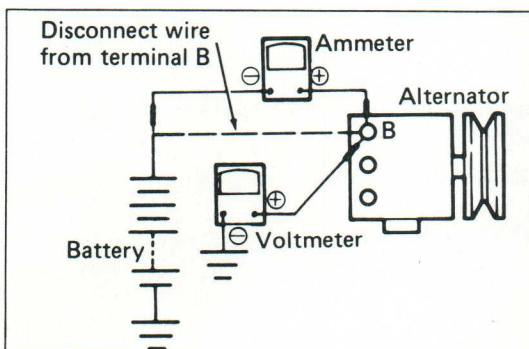
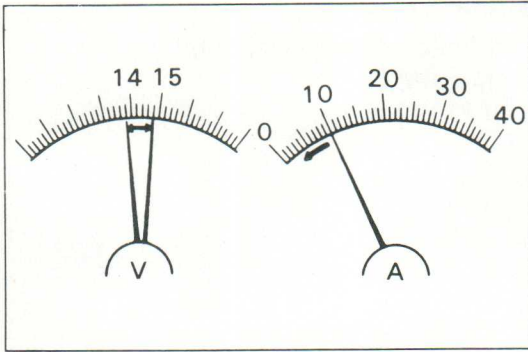
7. CHECK CHARGING CIRCUIT WITHOUT LOAD (NON IC)

(a) If a tester is not available, connect a voltmeter and ammeter to the charging circuit as follows:

- Disconnect the wire from terminal B of the alternator and connect the wire to the negative terminal of the ammeter.
- Connect the test lead from the positive terminal of the ammeter to terminal B of the alternator.
- Connect the positive lead of the voltmeter to terminal B of the alternator.
- Connect the voltmeter negative lead to ground.

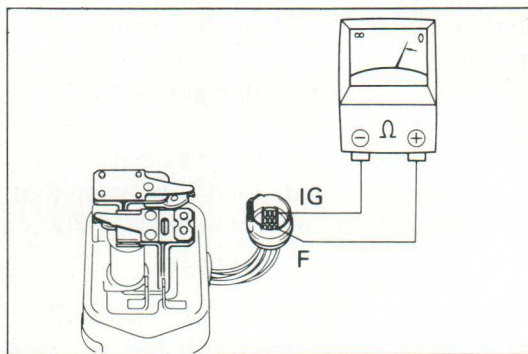
(4.) MEASURE RESISTANCE BETWEEN TERMINALS

(a) Using an ohmmeter, measure the resistance between terminals IG and F.

Resistance (Voltage regulator):

At rest 0

Pulled in Approx. 11

If any of the above checks are not correct, replace the alternator regulator.

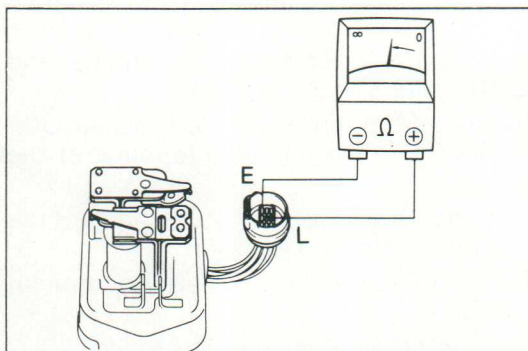
(b) Using an ohmmeter, measure the resistance between terminals L and E.

Resistance (Voltage relay):

At rest 0Ω

Pulled in Approx. 100Ω

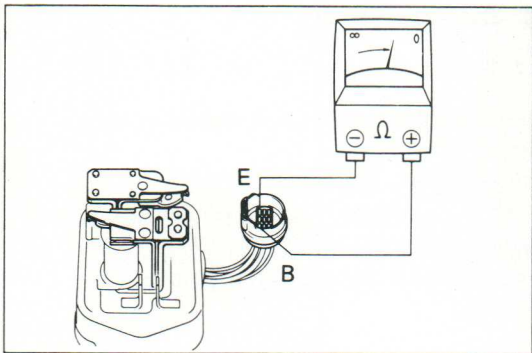
(c) Using an ohmmeter, measure the resistance between terminals B and E.

Resistance (Voltage relay):

At rest infinity

Pulled in Approx. $100\ \Omega$

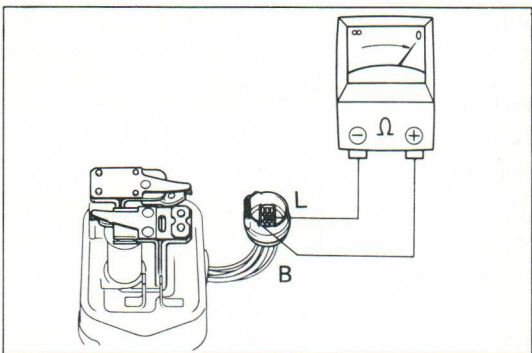
(d) Using an ohmmeter, measure the resistance between terminals B and L.

Resistance (Voltage relay):

At rest infinity

Pulled in $0\ \Omega$

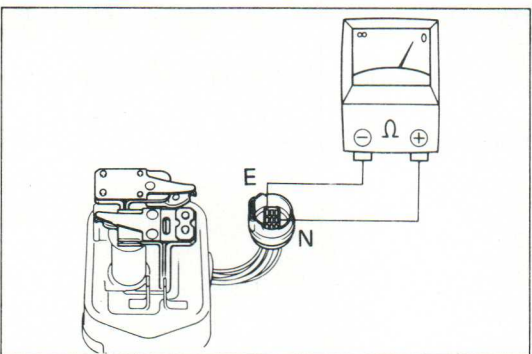
(e) Using an ohmmeter, measure the resistance between terminals N and E.

Resistance: Approx. $24\ \Omega$

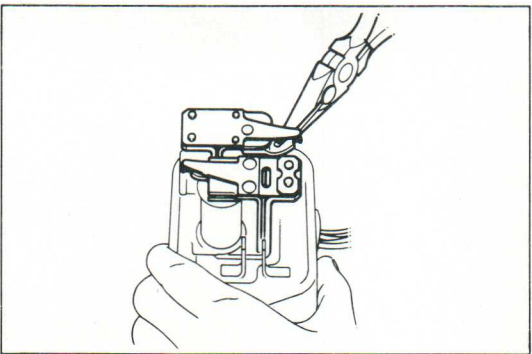
TO ADJUST VOLTAGE REGULATOR, BEND REGULATOR ADJUSTING ARM

Regulating voltage: 13.8 — 14.8V

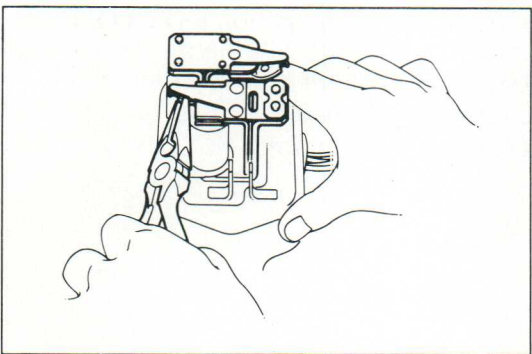
TO ADJUST VOLTAGE RELAY, BEND RELAY ADJUSTING ARM

Relay actuating voltage: 4.5 — 5.8V

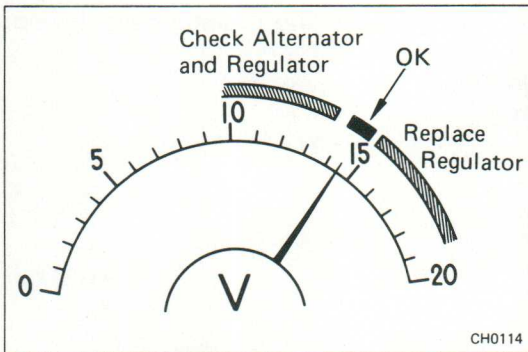
With the engine running at 2,000 rpm, check the reading on the ammeter and voltmeter.

Standard amperage: Less than 10A

Standard voltage: 14.0 — 14.7V (25°C or 77°F)

NOTE: If the temperature is not 25°C (77°F), find the voltage limits in the chart for the correct temperature.

- (1.) If the voltage reading is greater than 15.0V, replace the IC regulator.

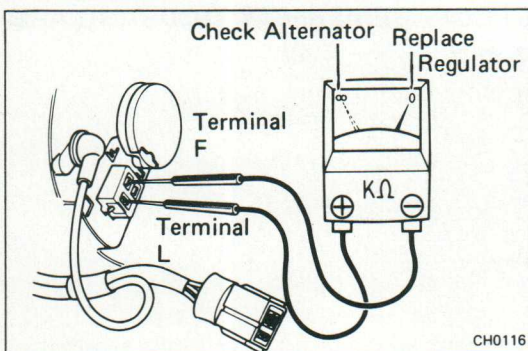
- (3.) • Check the voltage reading at the alternator terminal L. If the voltage reading is 1 — 2 V, check the alternator.

If the same as battery voltage, turn ignition switch OFF and disconnect the connector from the alternator. Check that there is continuity between alternator terminals L and F.

No continuity — Check the alternator.

Continuity — Replace the IC regulator.

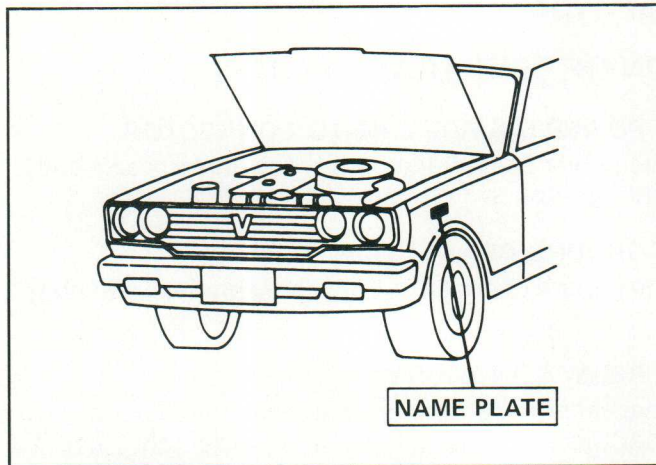
Model number and engine type are printed on the metal plate located on the firewall.

Production date is printed on the metal plate attached to the doorjamb.

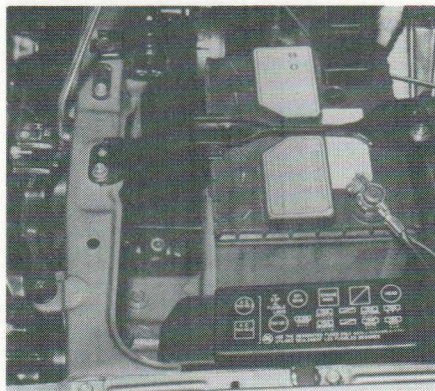
Battery & Fuse Panel

Many major components have been relocated rearward to decrease their damage potential in relatively minor frontal impacts. Such high cost items as the battery, the A/C dehydrator and fuse panels have all been protected in this fashion.

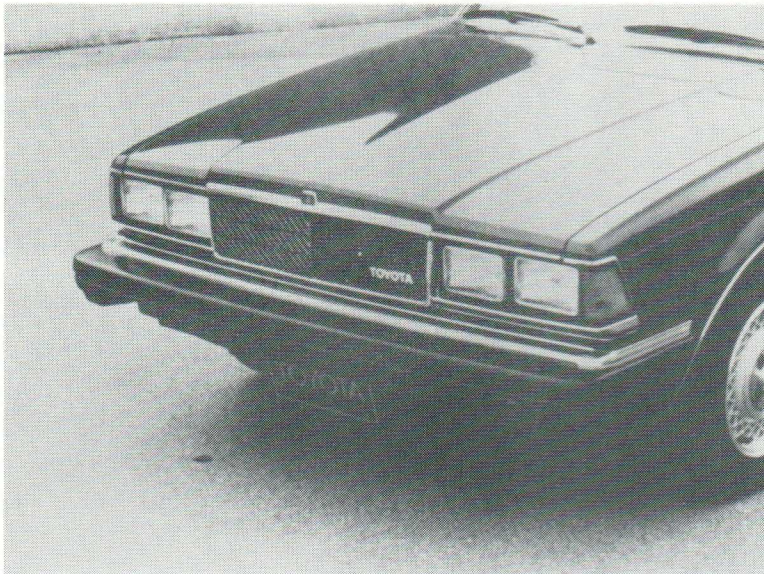
Front Bumper

All Toyota passenger cars are equipped with large pad urethane foam bumpers to reduce low speed impact damage. Through model year 1983, all bumpers on Toyota passenger cars are designed to meet the 5

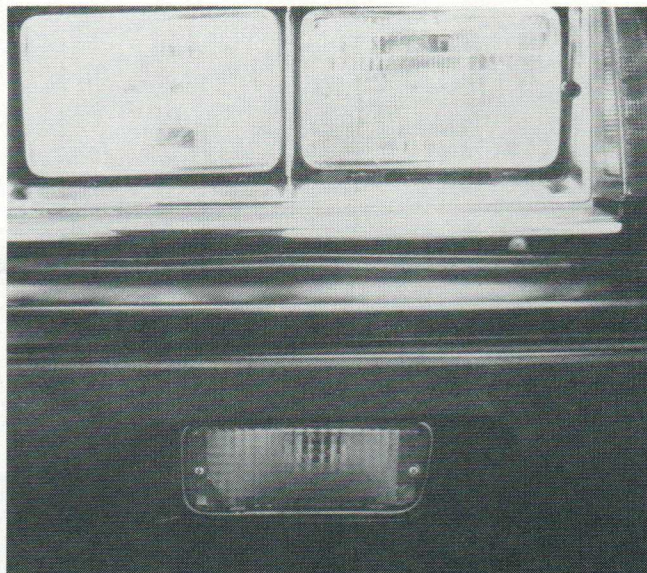
Parking Lights

mph bumper standard. Also, to preclude their involvement in slow speed impacts, the parking light assemblies have been recessed into the bumper.

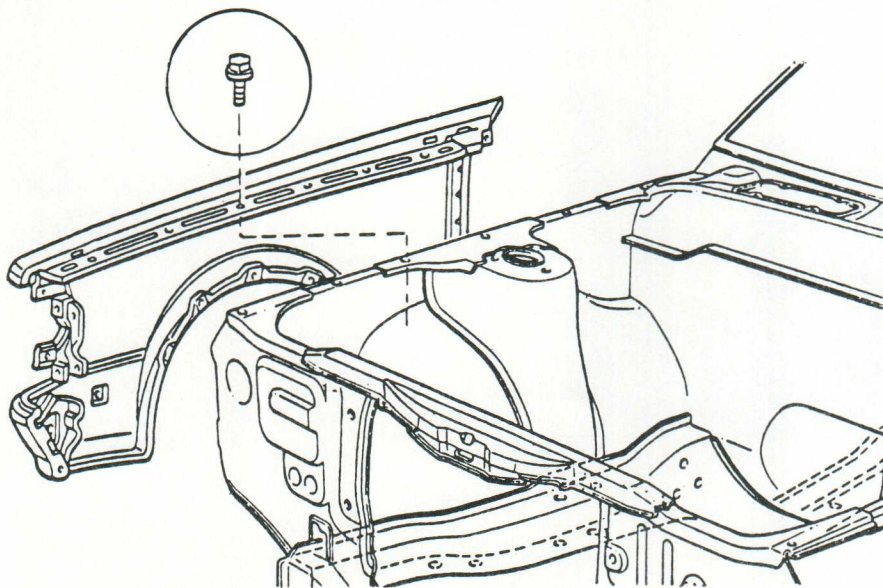
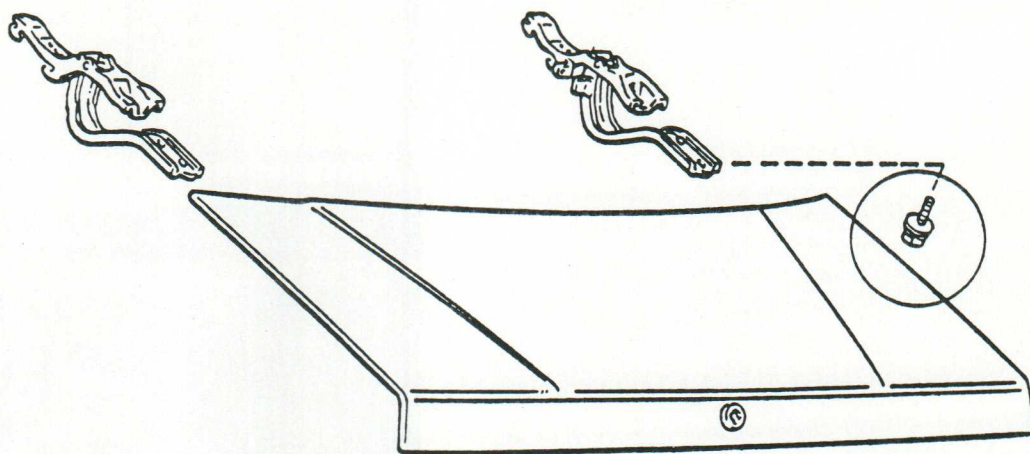
BOLT-ON BODY PANELS

Toyota continues to use bolt-on fenders, and also door, hood, and liftgate/deck lid hinges as opposed to the easy-to-manufacture weld-on attachment. This provides valuable time savings during both the dis-

mantling and reassembly processes. It also allows for easy adjustment after the repair has been completed.

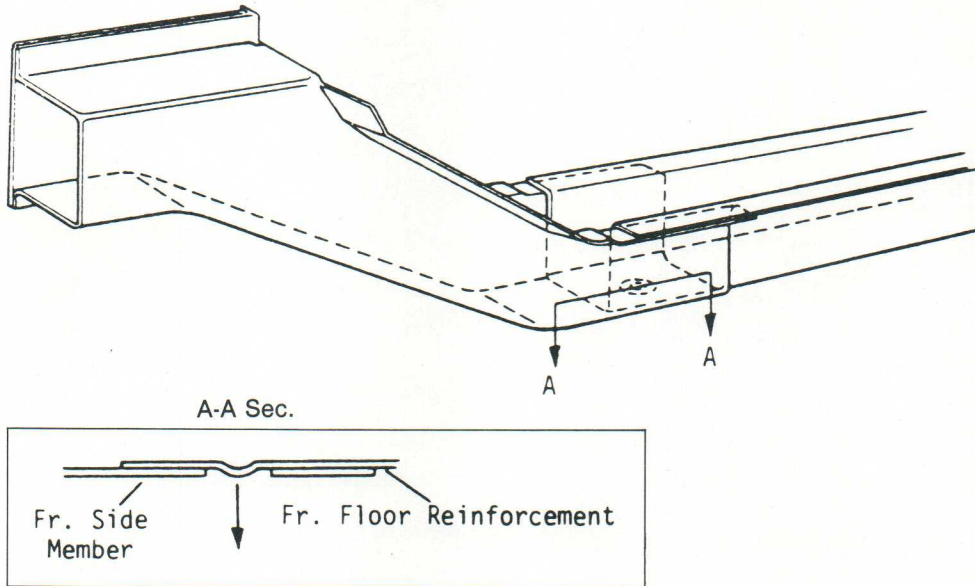
PANEL OVERLAPPING SEQUENCE

The sequence of panel overlapping can result in significant labor savings. Therefore, we have reversed our old procedure of lapping the center floor reinforcement over the front side member (frame horn).

We now overlap the frame horn onto the floor support so that it is no longer necessary to peel back the floor support to remove the frame horn.

Since we know that the frame horn suffers a higher frequency of collision damage, we expect this improvement to result in major labor savings.

As you can see, alignment reference marks are also provided to insure easy and proper installation.

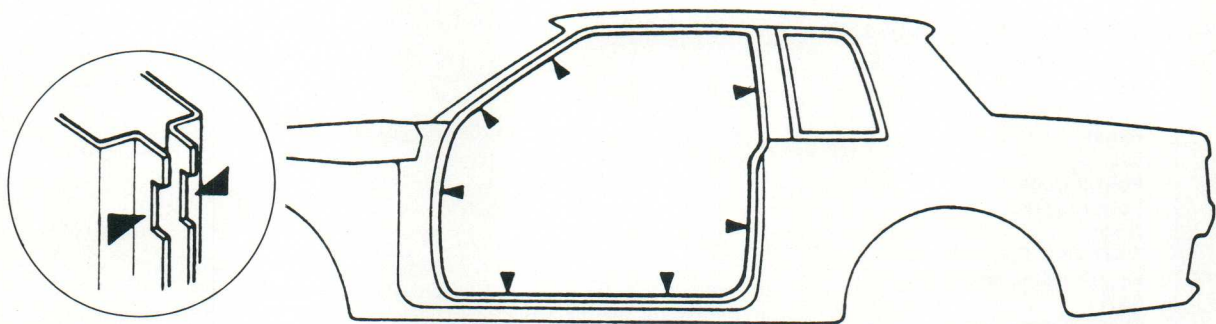
MATCHING CUTAWAYS

Realigning major panels has traditionally been a cumbersome, awkward operation due to the precision measurement required to properly install each panel. Most Toyota passenger vehicles are now equipped with matching cutaways that will make

replacement panel positioning nearly automatic. We expect to have all Toyota passenger vehicles equipped with this feature with the introduction of our 1984 model line.

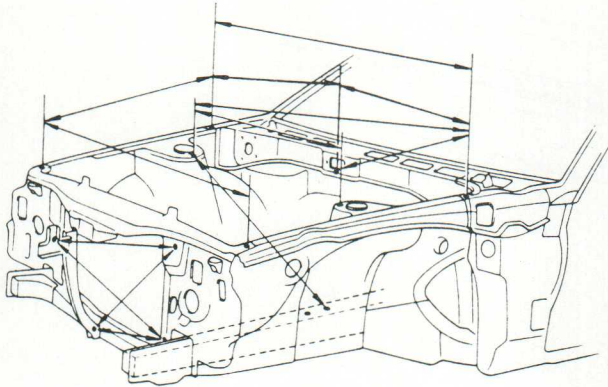
Engine Compartment

Alignment reference marks and specifications are also provided in many areas to aid in properly relocating replacement parts. For example, reference marks are

seen here inside the engine compartment and trunk area. Underbody dimensions/specifications are available to facilitate utilization of these reference marks.

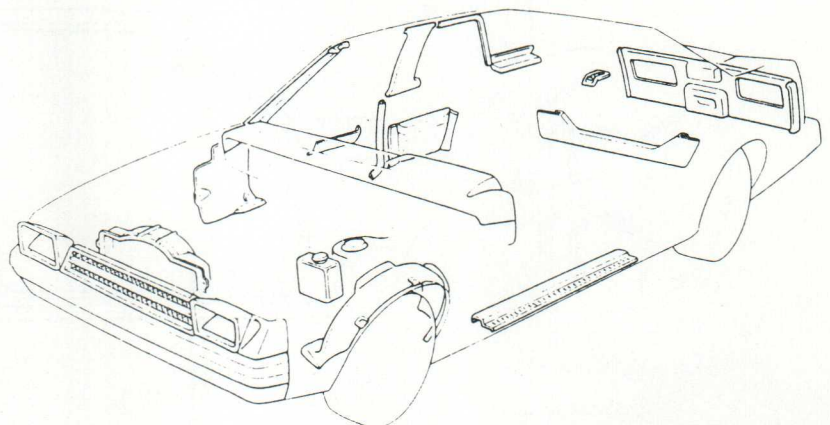
PLASTIC IDENTIFICATION — CODE LIST

The use and variety of plastics has grown rapidly in the automotive industry. Many of these materials are easily repaired if the material type can be identified. Toyota, realizing that the results of the commonly us-

ed practice of burning a sliver of the plastic were easily misinterpreted, has now placed a plastics material code on each plastic component to eliminate the possibility of error.

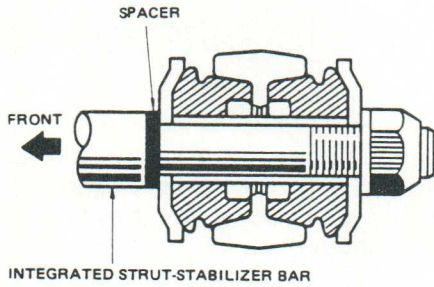
Caster

With today's unibody type construction, proper wheel alignment is to a large degree dependent on the inter-relationship of chassis and body alignment. Post collision repair driveability characteristics of a vehicle can be inferior to the pre-collision characteristics. To

alleviate this problem, Toyota now provides front end alignment adjustments on most current production vehicles. Rear toe-in and toe-out adjustments are also provided on those vehicles with independent rear suspension.

TURN CAM TO ADJUST

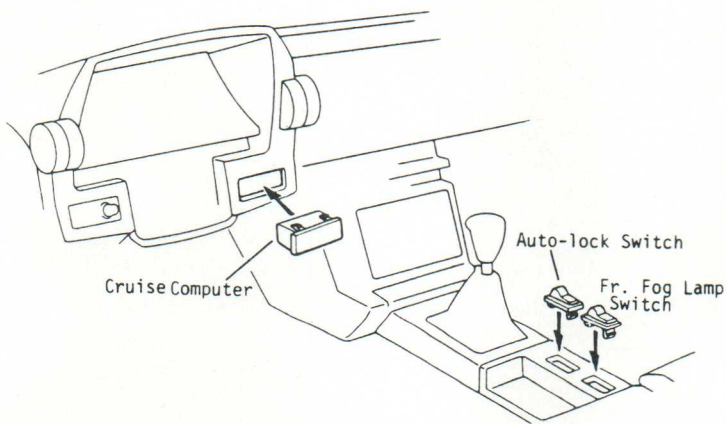
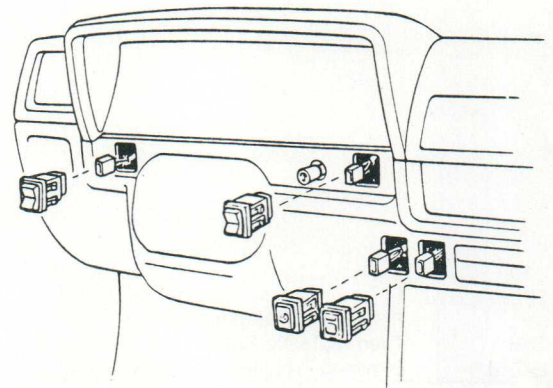
QUICK MOUNT COMPONENTS

Repair technicians can more easily access and remove components which in the past were somewhat troublesome, because Toyota has mounted the urethane bumper system on four easily accessible

bolts, made instrument panel switches removable from the front, and provided independently removable panels for the instrument panel and grille.
