Nissan Sentra Rear Wheel Alignment Tricks

Many front wheel drive imports feature independent rear suspensions. Some have a provision for adjusting the rear toe-in, others don't. The 1982-86 Nissan Sentras and 1983-86 Pulsars used a non-adjustable type suspension.

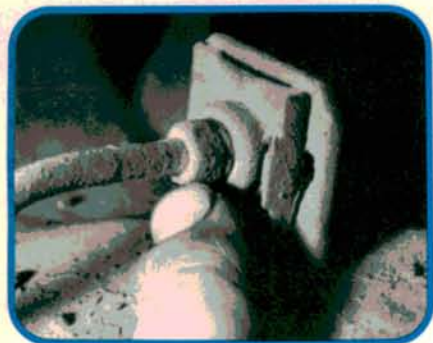
1

Start by separating the rear brake line where it joins the flexible line and remove the clip holding the fitting to the control arm. You may want to cap or plug the flexible line with a clean suitable rubber cap or plug.

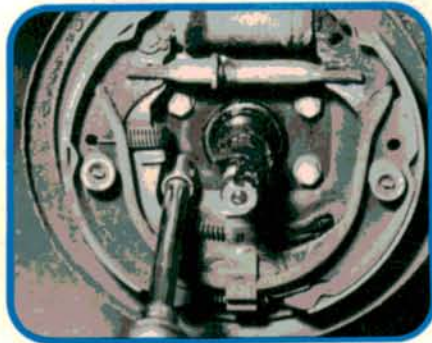
2

Take off the brake drum to get at the four bolts which hold the backing plate to the control arm. Bend back the tab that holds the parking brake cable. Then slide the plate past the spindle and let it hang by the cable, out of the way.

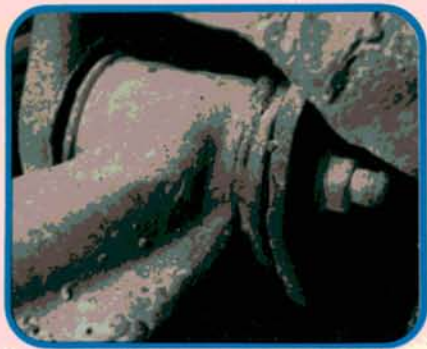
3

Depending upon the age of the vehicle and the local climate, the control arm bolts may or may not be easy to remove. Rust may seize the bolts to the bushings. Just loosen them at this point. Wait until after the next step to remove them.

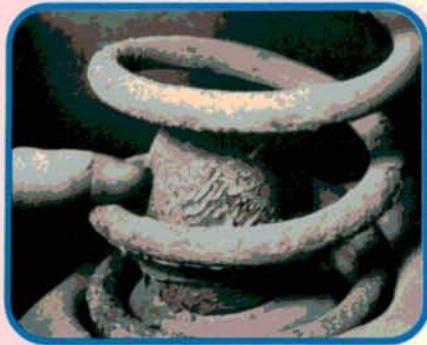
5

On all other Sentras and Pulsars, Nissan suggests that you replace just the springs, then road test the car to see if the vibration's gone. All the cars I have done ended up needing control arms too! You can do them now or do them later. Don't forget to transfer this snubber to the new control arm.

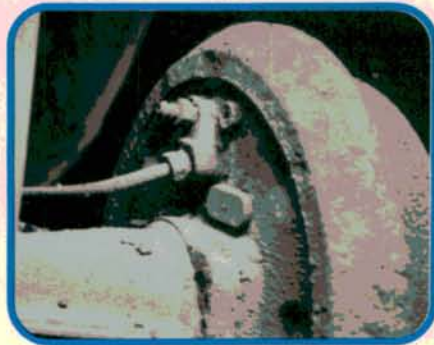
6

After reassembling everything in the reverse order, bleed both rear wheel cylinders. It doesn't take much rust to seize the bleeder screws. You may want to include two wheel cylinders in your price quote if they look bad.

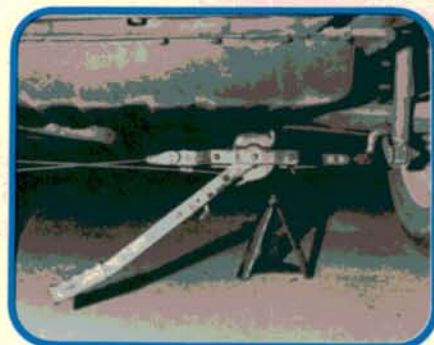
8

I raised the car for this photograph, but you must do this last step with the car on the ground or on a drive-on lift. Tighten the cable until you can feel that you've taken all the slack out of the rear suspension. Then torque all four control arm bolts to 45-51 ft/lbs. Don't bend anything!
