Honda Transaxle Repair

This month's knuckle buster tranny teardown covers a 5-speed transaxle from a Honda Civic. This particular transaxle type was used in Civics for 10 years, starting with the 1973 models. You'll be happy to know that you can disassemble, repair, and adjust this transaxle without a fortune in special tooling, or a Ph.D. in nuclear physics. It is a friendly, straightforward little unit.

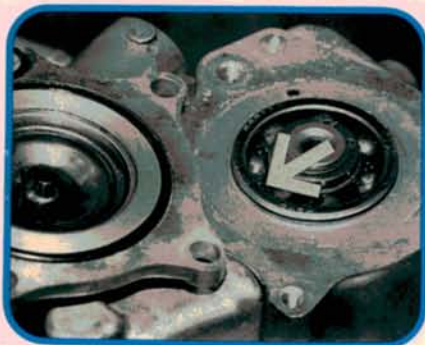
1

After draining the oil, remove the end cover. This ball bearing supports the mainshaft in the 5th gear housing. The oil barrier plate at the left is indexed in the cover by a small tab. Remove it and make sure its oil passages aren't clogged. We suggest replacement of all three o-rings.

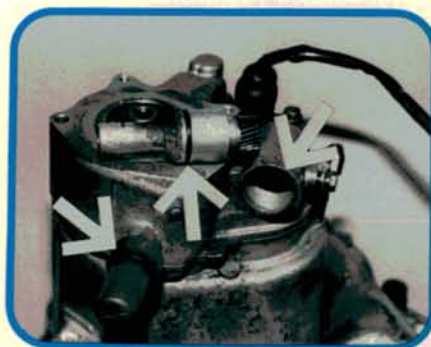
2

Now remove the large snap ring that goes around the bearing to locate it in the housing. Remove the speedo drive gear and inspect it for damage. Tap the 5th gear housing with a soft mallet to loosen it and remove it. Also check the rubber breather cap to be sure it's not plugged.

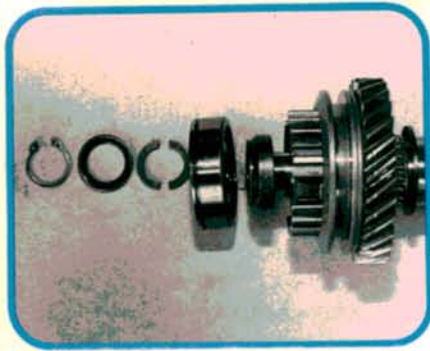
**3**

This photo shows the stack sequence for the 5th gear parts on the mainshaft. Remove the small snap ring on the shaft (always replace), the retainer collar and the split retainer ring below it. Then you can pull the bearing and spacer collar that rides between the bearing and the synchro hub.

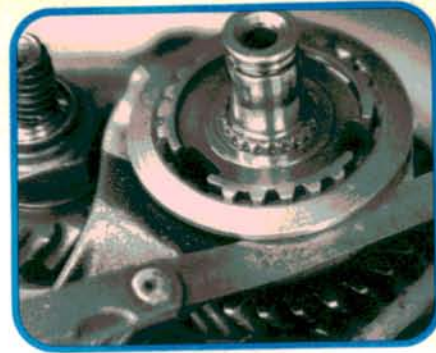
**4**

Check the clearance between the 5th gear shift fork and the synchronizer sleeve. Fork-to-sleeve clearance specifications for all the forks are 0.5-0.7 mm (0.02-0.04 in) for new parts. The wear limit for used parts is 1.0 mm (0.04 in). Also check to see that the fork hasn't been bent.

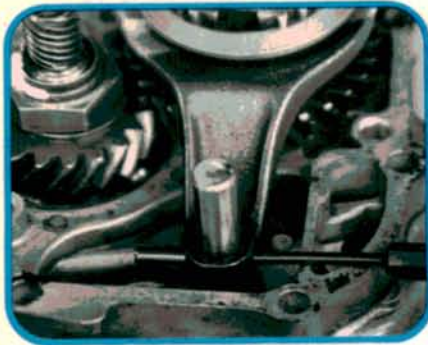
**5**

Shift the fifth gear fork up high enough so you can remove the roll pin with a suitable punch. Make sure you have a punch big enough to catch the head of the pin without jamming or binding in the shift rod. Remove the fifth gear fork and gears together and lay them aside as an assembly.

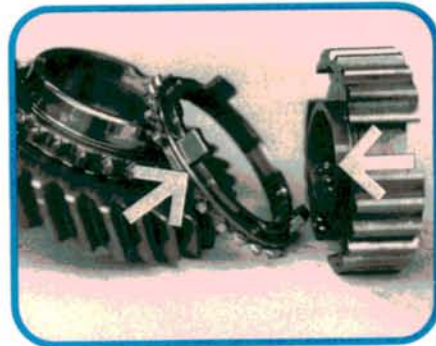
**6**

If you disassemble 5th gear to inspect it, don't forget that the synchronizer hub has a top and bottom. The shoulder on the synchronizer hub faces toward 5th gear. See the synchronizer spring? Even if synchro clearances are correct, replacement of the springs is good insurance.

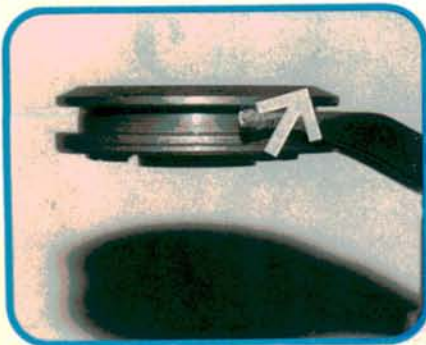
**7**

If the measured clearance between the shift fork and synchro sleeve was greater than 1.0 mm, mic the fingers on the fork. The fingers on the 5th gear fork should be 5.4 mm (0.21 in) when new. Wear limit is 5.0 mm (0.20 in). Also note that the domed face of the synchro sleeve faces upward.

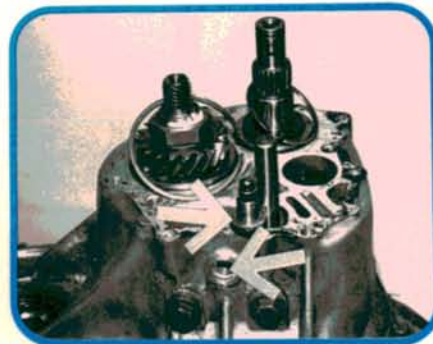
**8**

With fifth gear removed you can remove the spacer housing. Remove the two large snap rings on the main and countershaft bearings, the detents, and the 11 bolts holding the case halves together. You don't have to remove the nut and countershaft 5th gear just yet.

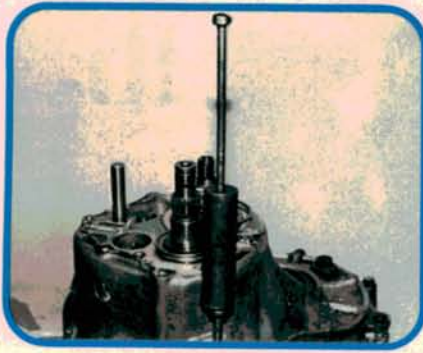
9

Don't start driving wedges between the case halves to separate them. Thread a slide hammer into the threaded boss on the case. We don't want the mating surfaces of the case damaged or distorted. There are two small bosses on the upper case. If you tap on them to help the slide hammer, do it gently.

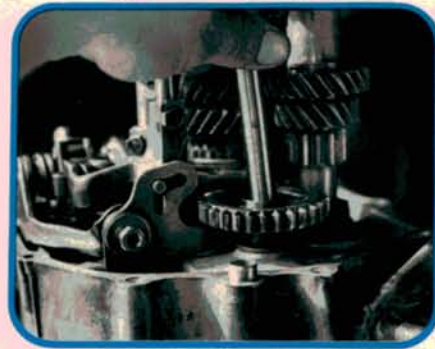
10

With the case split, carefully clean away the gasket, making sure you don't gouge the mating surfaces. Inside the case, start disassembly by removing the reverse idler shaft. Lift the shaft until it clears the case and slide the reverse idler gear and shaft out of the reverse shift fork.

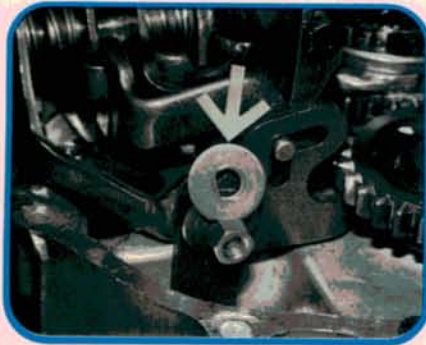
11

Remove the retaining nut on the reverse shaft and the special washer below it. The washer has a locator flat to keep it from turning on the shaft. Be careful not to lose it in the "miscellaneous" pile on your workbench. Pull the reverse fork and lay it aside.

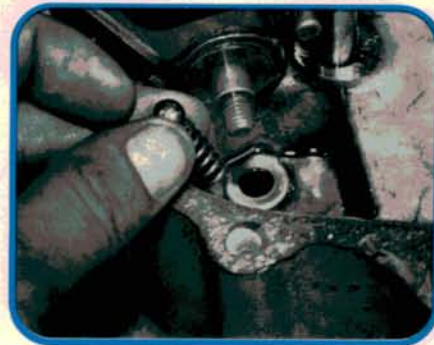
12

Pull the detent ball and spring for the reverse shift fork and lay them aside so they don't fall out and disappear into the nearest floor drain. Don't forget them at reassembly. Also be sure to check for proper detent alignment and spring action when you put things back together.

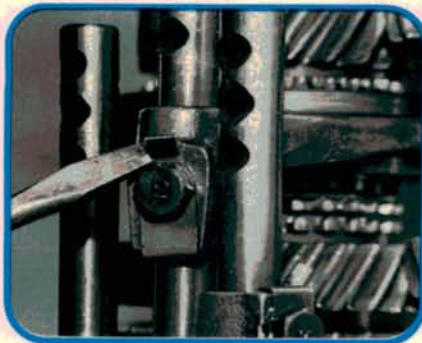
13

The three remaining shift forks are bolted to the shift rods. Each is a hardened shoulder bolt held in place by locking tabs that locate on the shift fork and are peened over the bolt head. Bolt torque is a mere 17 Nm (12 ft/lb). Use a drop of thread lock and new locking tabs at reassembly.

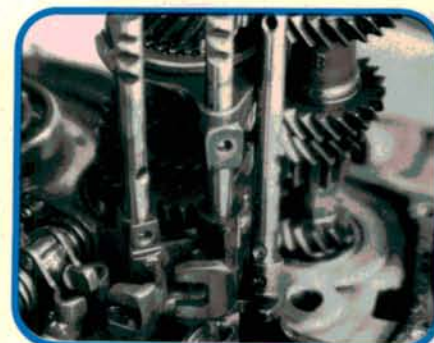
14

Bolts removed? Slide 5th/reverse selector shaft upwards and swing the shift guide off to the side. Next remove 1st/2nd shaft, shift fork, and shift guide. With those two out of the way, you now have enough room to get 3rd/4th shift fork out of its synchronizer sleeve when you raise the shift rod.

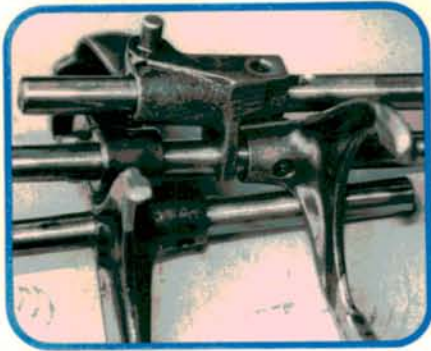
**15**

Keep the rods and forks together as shown. Note that the shift fork bolt holes are not threaded all the way through. The threaded portion is away from the bolt heads. If you mistakenly turn the rods 180 degrees, the bolts will tighten, but the forks will be loose and the detent grooves will face the wrong way.

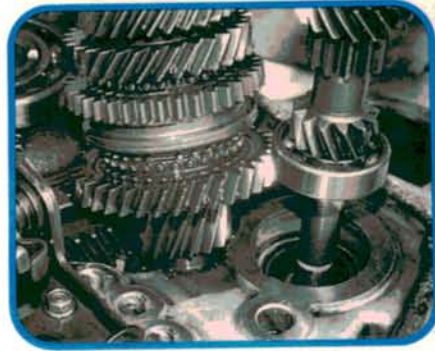
**16**

Now we can remove the main and countershafts together. We had to tap on the input shaft with a soft mallet to coax it from the case. Make sure that both shafts move together. Don't just drive the input shaft into the countershaft or the impact may damage the gears.

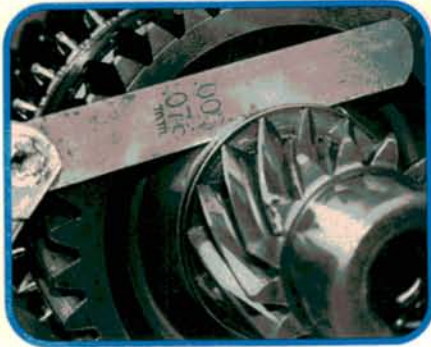
**17**

We have some clearances to check with the countershaft still assembled. You'll need a good feeler gauge set to do the job. Check between the thrust washer and first gear. Maximum allowable clearance is 0.18 mm (0.007 in). Replacement washers are available in different thicknesses if adjustment is needed.

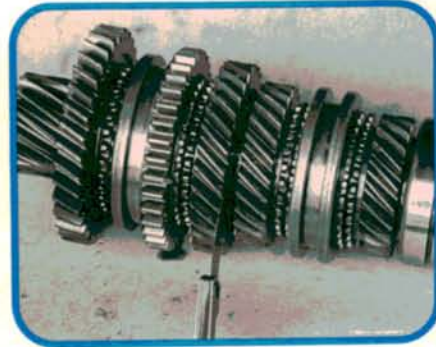
**18**

Next check for play in 2nd and 3rd gears where they ride against this spacer plate, as shown. Check on one side of the spacer for 2nd gear, and on the other side for 3rd. Gear-to-spacer standard clearance is 0.05-0.12 mm (0.002-0.005 in) with a wear limit of 0.18 mm (0.07 in).

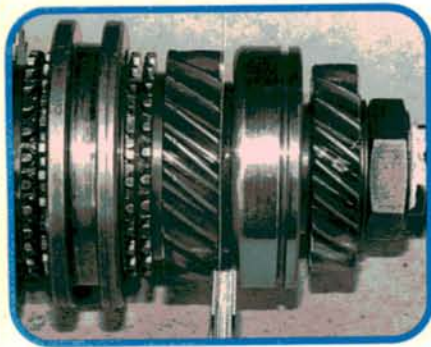
**19**

Check 4th gear end play between the gear and the thrust washer that separates it from the bearing. Clearance specifications are the same for 4th as they were for 2nd and 3rd gears. Remember that the shaft must be fully assembled with the end nut properly torqued to take these measurements.

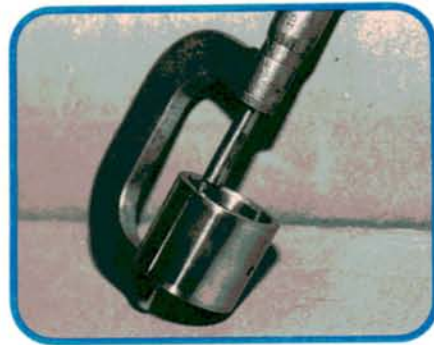
**20**

So what if a gear has too much end play? Replacement spacer collars may solve the problem if the gear faces themselves are not too badly worn. Measure the height of the old gear collar and compare that to available replacement sizes to see if a new, longer collar will solve your problem. (To be continued.)
