# Honda Auxiliary Valve

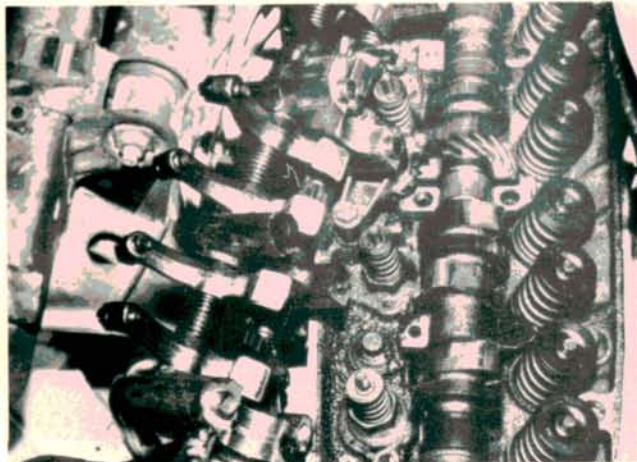
Remove the rocker shaft assembly and lay it aside. Unscrew the valve holder from the cylinder head and remove the valve assembly. Pull the valve chamber now and install new crush-style sealing washers or you may have a compression leak later.

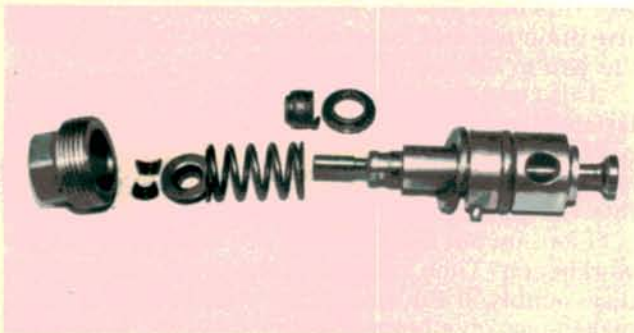
Here is an exploded view of the valve assembly. Always replace that o-ring on the valve holder. Clean the valve itself with a wire brush. Check the valve and valve holder sealing faces. Also check the valve stem where it rides in the seal for any roughness that could cut or ruin the new seal.
