# Sunroofs Repair And Adjustment

While all sunroofs aren't identical, most have a basic similarity in their design. We're going to take apart two separate sunroofs. Our first patient is a late model BMW 535i. We'll show you the major components of the system, and highlight some test and adjustment procedures.

## Nissan Maxima Sunroof Motor Rebuild

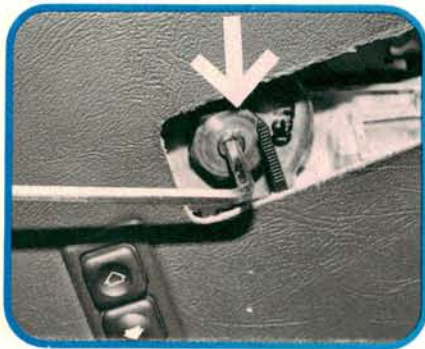
1

If the motor isn't working, the sunroof may be stranded somewhere between open and closed. BMW provides this emergency crank for closing the sun roof when the power goes out. Loosen the locknut with a spark plug socket. Then use the crank key to move the roof up or back so you can work on it.

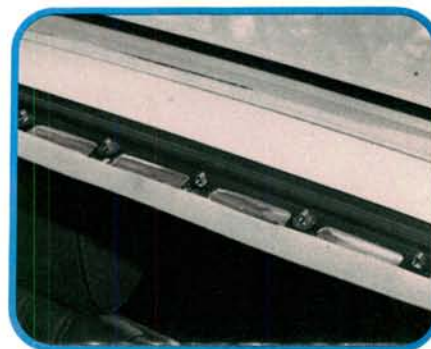
2

The front edge of the inner trim panel is held to the sunroof by metal clips. They snap in place and believe me, they're tight. Open the roof about halfway. Then use a wide-bladed tool to unsnap the clips so you don't tear them out of the trim panel. Slide the trim panel rearward into the roof.

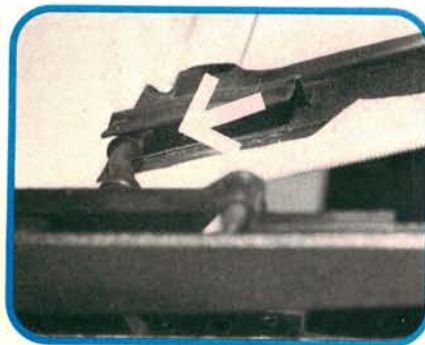
3

The rear of the trim panel is held to the sunroof by metal hooks that slide on two pins. The hooks float on the pins and pull the trim panel upward when the sunroof is in the tilt position. Sliding the trim panel rearward with the front clips removed unhooks the panel from the pins.

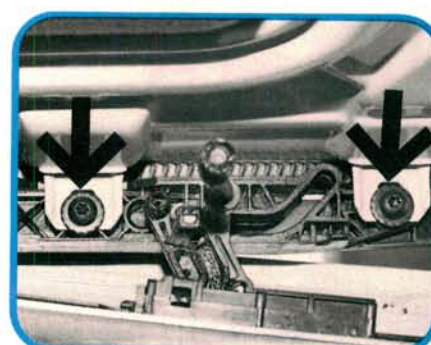
4

Slide the trim panel rearward to expose the six Torx®-headed screws holding the roof to the drive mechanism. The screws sit in elongated slots that allow you to adjust the sunroof height at reassembly. Remove all six screws. Carefully remove the sunroof and lay it aside on a clean, soft cloth.

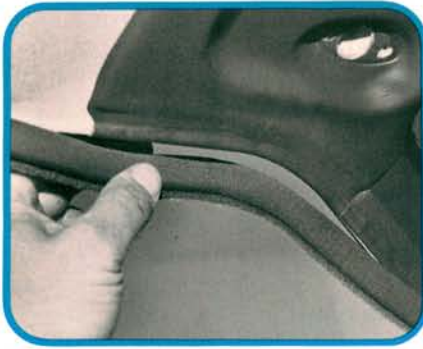
# 5

Getting to the drive motor is a little bit more complicated. Remove both sunvisors and both sunvisor support mounts from the headliner. Pull back the weatherstrip beading from the top of the A-pillars as shown. This frees the outer edges of the front headliner panel.

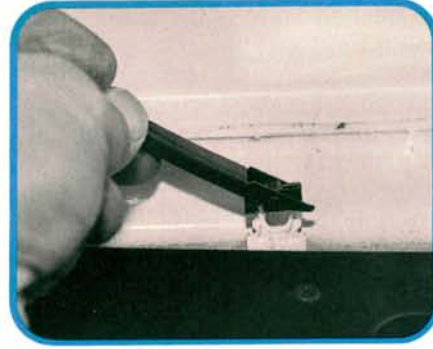
# 6

Now go upstairs again. Remove the wind deflector legs by gently prying up on these plastic clips. The clips snap into metal tabs in the rain gutter. Once they're loose, you can pull forward on the wind deflector and remove the screws holding the deflector assembly. Remove the assembly and lay it aside.

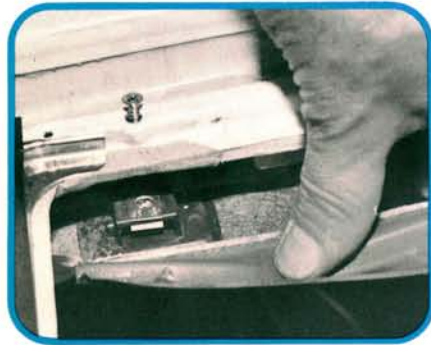
# 7

Pull back the headliner vinyl in the area below the deflector strip. There are two more screws hiding down there, and they're easy to miss. They screw into metal brackets glued to the headliner. If you forget these screws and start pulling on the headliner to remove it, something will break.

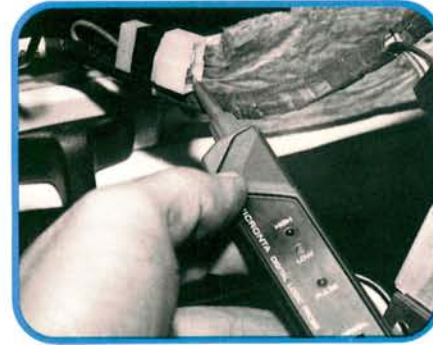
# 8

Now you can drop the front headliner trim panel. Your next step depends on the nature of your problem. If the motor isn't working at all, disconnect it. Check for voltage at the black wire with the ignition on and the "close" button pressed. The blue wire is hot when the "open" button is pressed.

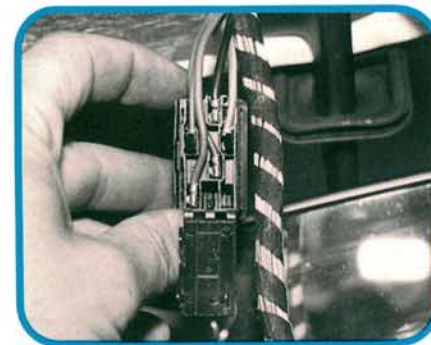
# 9

The switch values are also easy to check. Pop back the cover on the harness plug. Here are the values for the wires:

- The green/blue wire is hot with the key on.
- Brown wires are ground.
- The black wire is hot with the switch in the "close" position.
- Blue is hot when you press the "open" button.

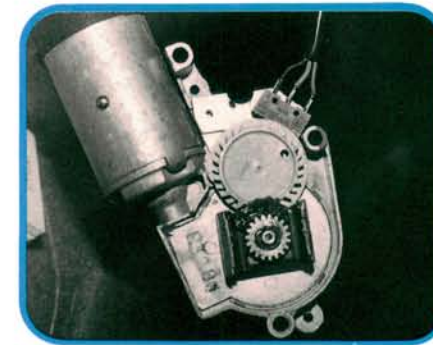
# 10

As we mentioned, the motor is also equipped with a microswitch that stops the motor in three separate positions: sunroof closed, sunroof fully open, and sunroof tilt. If you're replacing the motor, or remove the motor and run it, you'll need to resynchronize the motor stops to the drive cable mechanisms.

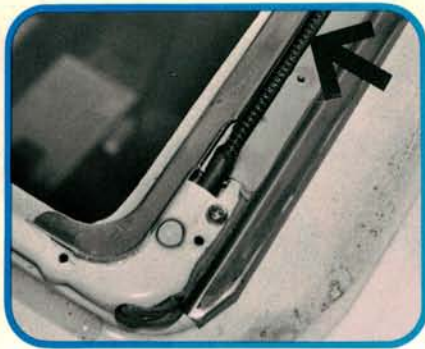
# 11

Another critical adjustment has to do with the drive cables themselves. If you are replacing one or both of the cables, you have to make sure they're installed evenly. If you've ever been on a horse, you know what happens when you pull too hard on only one of the reins. The sunroof will try to turn too.

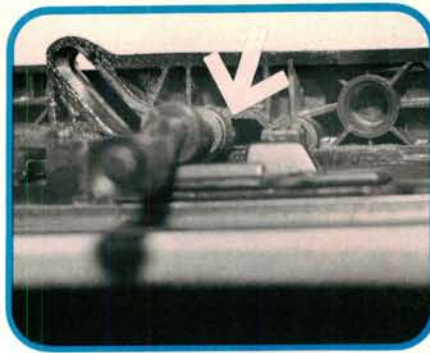
# 12

Here's one way to get everything working together. Run the motor until the drive mechanisms are in the position shown. This is the sunroof-closed position. Both pins should be at the same height. If one is higher than the other, remove the motor and move the cables until they're even.

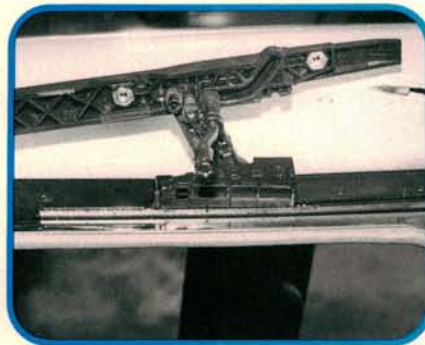
# 13

The slots in the drive mechanism are made so that the sunroof drops down slightly as it opens, or elevates the rear in the tilt position. "Closed" is that midpoint between the two where the mechanism just raises the sunroof flush with the roof. Run it back and forth a couple of times to get the idea.

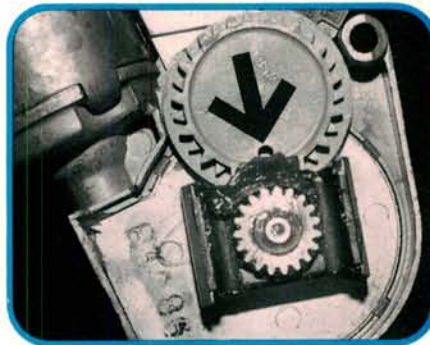
# 14

Run the motor until the microswitch shuts the motor off with the reference hole in the plastic gear next to the drive pinion as shown. Reinstall the motor. You've just synchronized the motor's microswitch with the cables. Run the motor back and forth to see that both drives move smoothly and evenly.

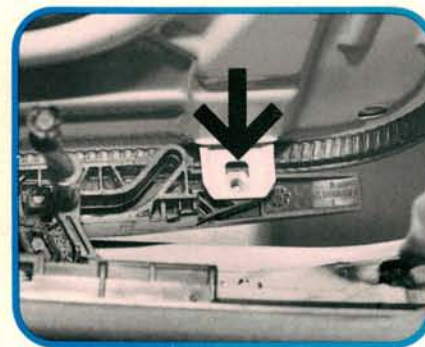
# 15

With the drive mechanism in the closed position, reinstall the sunroof. Remember that the mounting holes in the sunroof allow you to adjust the sunroof height. It's very important that you make this adjustment properly or you'll have wind noise. Put threadlock on the screws.

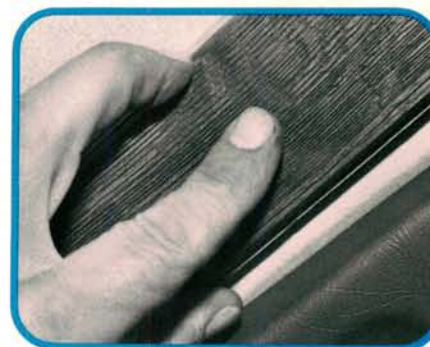
# 16

Run the sunroof back and forth several times to make sure everything is properly aligned and working smoothly. When you replace the sunroof liner, catch the hooks at the rear first. Then resnap the front of the liner using a piece of wood so your thumb won't leave indentations in the trim panel.

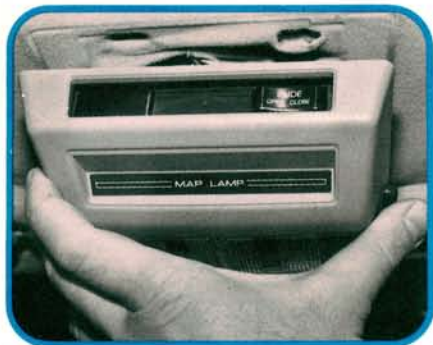
# 17

Pre-1985 Maximas had a removable plug for hand crank closing the sunroof like the BMW. 1985 and later Maximas still have a crank slot in the motor, but now it's hidden under the map light housing. Remove the two screws holding the housing and drop it down. Remove the sunvisors and rearview mirror.

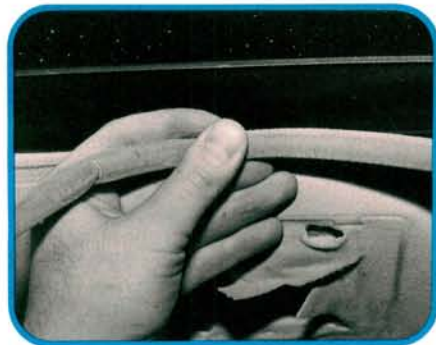
# 18

Don't disconnect the wiring from the sunroof switch just yet. Retract the sunroof about halfway, then remove the welt molding from the edge of the sunroof opening. Start at one side and carefully peel back the adhesive edge of the headliner until the motor is exposed.

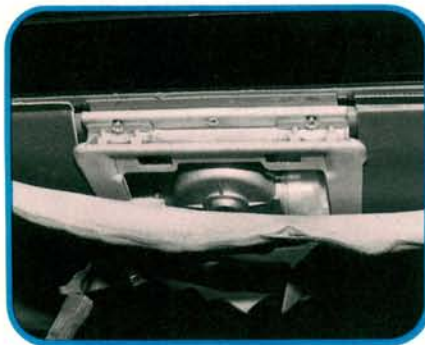
# 19

Remove the molding from the top of the windshield, then pull the headliner loose if you want a little more room. The headliner material is pretty fragile so take it slow to avoid ripping the headliner. Close the sunroof completely, then disconnect the map light and sunroof switch wiring.

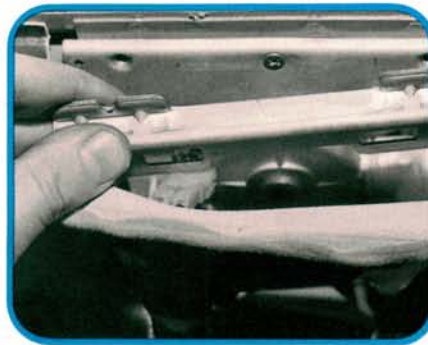
# 20

Remove the two small screws at the rear and two larger screws at the front of the reinforcement surrounding the sunroof motor. You may have to sneak your screwdriver through an opening in the headliner to get to the screws near the windshield. Slide the reinforcement out from under the headliner.

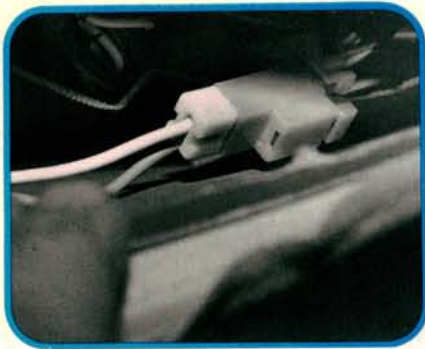
# 21

Peel back the blue plastic cover to the right of the sunroof motor and disconnect the motor wiring. Relays for the sunroof circuit are also located under this cover. Remove the three sunroof motor bolts, then drop the motor out through the opening you made when you lowered the headliner.

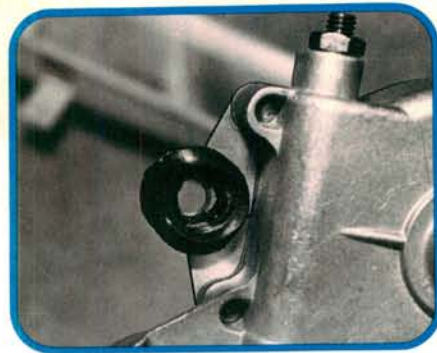
# 22

The original sunroof motor mounts are rubber insulated. It may be quieter when it's new, but the motor's high torque gradually pulls the rubber mounts out of shape. When the mounts get as bad as this one, the motor pinion jumps out of engagement with the drive cables when the sunroof is operated.

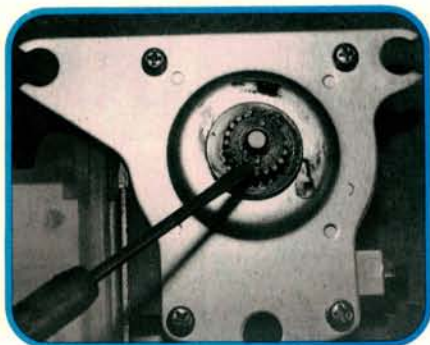
# 23

Remove and discard all three rubber mounts and spacers from the motor mounting plate. Pop the clip off the end of the motor shaft. Remove the drive pinion and washer. Put the washer aside for now. Remove the four mounting plate screws, then remove the mounting plate.

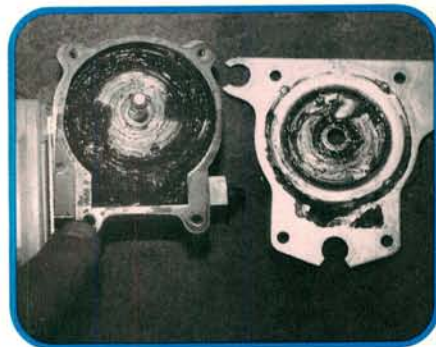
# 24

Remove one flat and one wave washer from the motor shaft. This motor gasket (or packing) isn't included in the rebuild kit. Check with your local dealer for parts availability before you tear into the job. I had to special order everything.

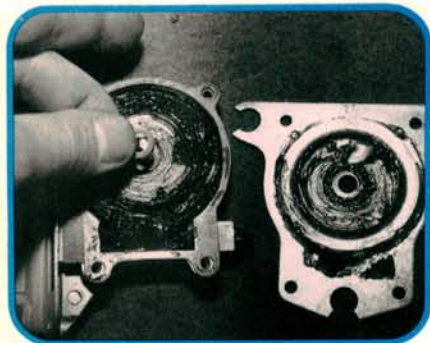
# 25

Replace the motor flat washer if it's damaged. Exchange the wave washer with the new flat washer from the rebuild kit. Replace the motor gasket if it's damaged. Coat the new washers and the motor shaft with grease from the mounting plate, then reinstall the old motor mounting plate.

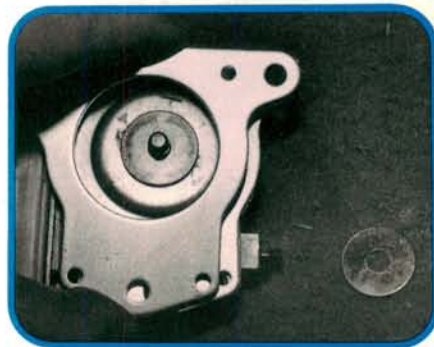
# 26

Position the new motor mounting plate on top of the old plate. Put a dab of thread lock on each of the four longer screws from the rebuild kit, then attach both mounting plates to the sunroof motor. The new plate converts the motor to a solid mounting.

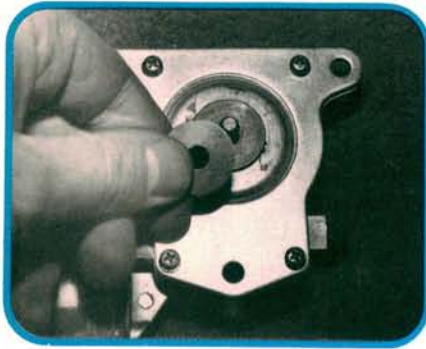
# 27

Place the original flat washer and the second washer from the rebuild kit on the motor shaft. Install the new drive pinion and retaining clip. The new flat washers inside and outside the motor will remove most of the end play. This keeps the pinion from jumping out of the drive cables.

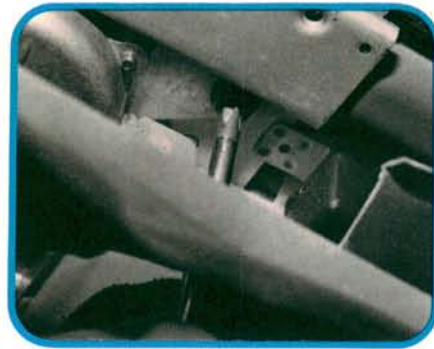
# 28

Reinstall the rebuilt sunroof motor. Temporarily install the sunroof switch and check for proper operation. The rebuild should stop the grinding. Even so, don't hold the switch in the "close" position after the sunroof has fully closed. The motor is still capable of damaging the drive cables.

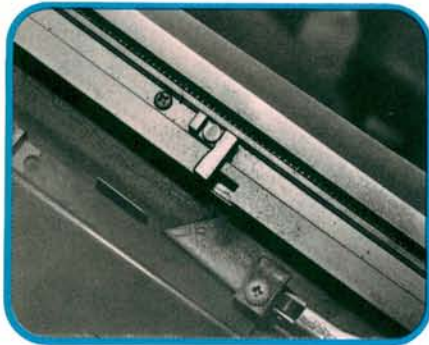
# 29

If the motor still grinds after the sunroof is fully closed, reopen it and check through the openings in the cable guides for signs of damage to the drive cables (arrow). Also check for bent cable guides near the motor. The sunroof tub must be lowered to replace the cable guide assembly.

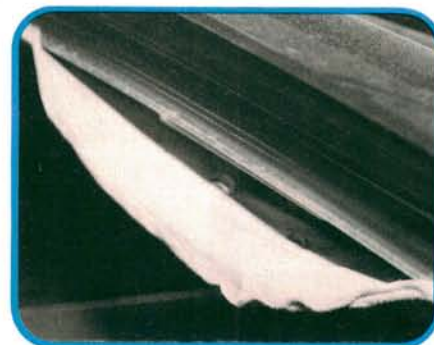
# 30

Pull the headliner back into position along the edge of the sunroof opening. This can get tricky because the headliner material is easily stretched out of shape, making it hard to get all of the wrinkles out. Reinstalling the molding around the sunroof opening will take up some of the slack.

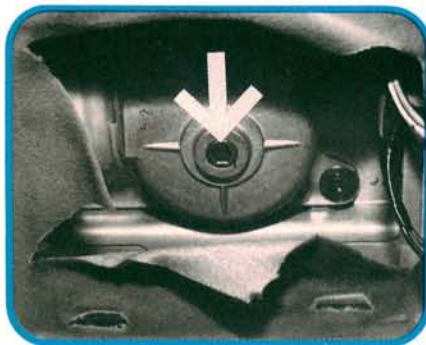
# 31

Pull any loose headliner fabric into the motor opening, then reinstall the map light housing. Nissan still provides a crank handle for the emergency slot (arrow) in the sunroof motor. Most owners probably wouldn't know where to put it. Reinstall both sunvisors and the rearview mirror.

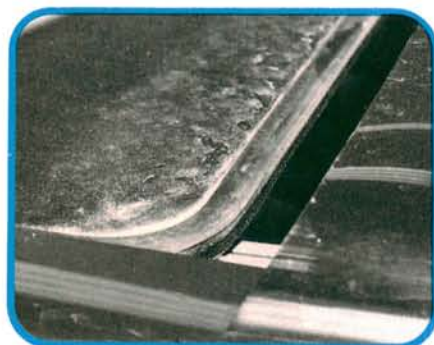
# 32

The Maxima's glass sunroof panel offers a lot less sound deadening than a conventional metal sunroof. Some owners complain of wind noise with the sunroof closed and the interior trim panel open. Even if there are no leaks, you'll still have some noise from air flowing over the sunroof.
