Audi

Automatic Transmission Overhaul

Audi's 087, 087-E, and 089 transmissions are fully automatic three-speed units consisting of a three-element torque converter and a compound planetary gear set. Three multiple disc clutches, a one-way roller clutch, and one friction band control the gear set's operation. These transmissions have been used in Audi 4000 and 5000 models since 1978.

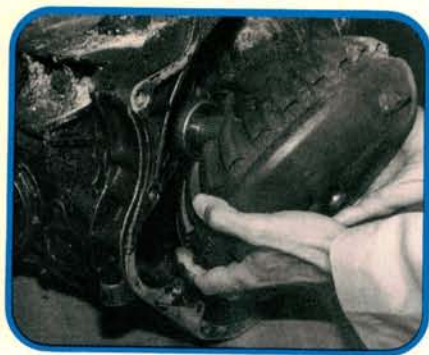
**1**

Drain the transmission and final drive units. Remove the torque converter. Keep the hub tilted up to avoid soaking your feet. Inspect the converter for a damaged roller clutch, thrust bearing failure, or interference between internal parts. Also check the hub for a scoring in the seal area.

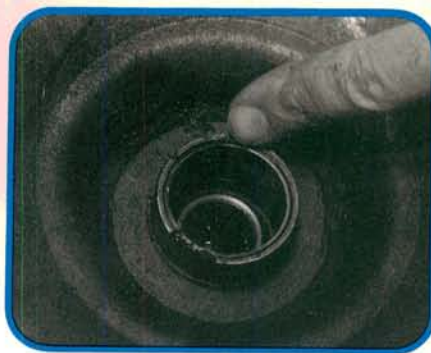
**2**

Remove the oil pump drive shaft. Check it for straightness, also check the condition of the splines at both ends. Measure the inside diameter of the converter bushing (finger) with vernier calipers. Maximum bushing I.D. is 34.12 mm (1.343 in). Out of roundness must not exceed 0.03 mm (0.001 in).

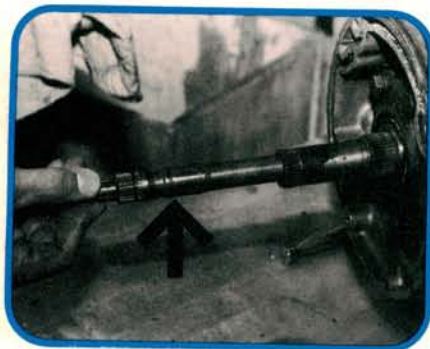
**3**

Remove the four transmission to final drive case nuts. Catch the end play adjusting shim as you separate the units. Don't pry on the o-ring sealing surfaces. Remove the turbine shaft and check the condition of the metal seal rings and ring lands (arrow). Remove small ring land nicks with a file.

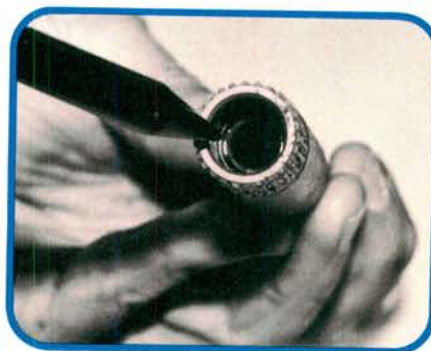
**4**

Replace the internal oil seal (pointer) at the converter end of the turbine shaft. Use an old oil pump shaft to drive out the seal. Seal leakage will cause converter drain back and delayed gear engagement. Turbine and oil pump shafts come in several lengths for different transmission models.

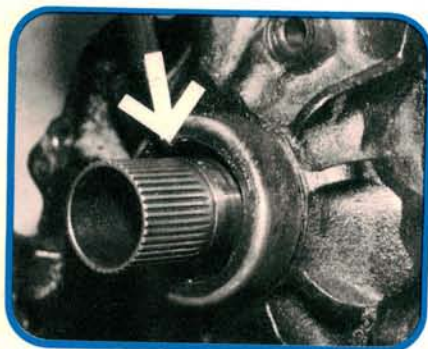
**5**

Remove the final drive front cover. Replace both front pinion oil seals to prevent gear lube and ATF inter-mix between the final drive and the torque converter. Inspect the torque converter stator support for scoring, galling, or spline damage. Replace the torque converter seal (arrow).

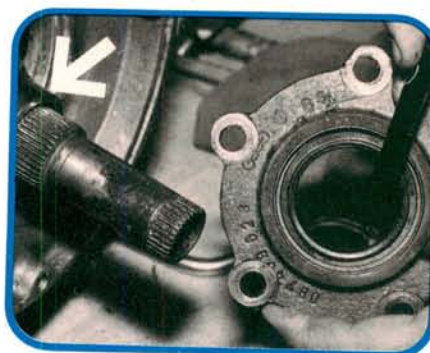
**6**

Remove the final drive rear pinion shaft cover. This is the most common spot for fluid inter-mix between the two units. Replace both pinion oil seals and the small O-ring seals used on each pinion shaft cover bolt. Also check the sealing surface of the pinion shaft (arrow) for wear.

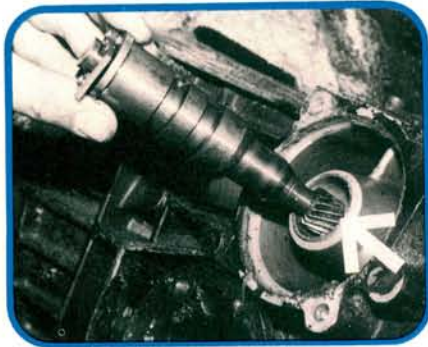
7

Remove and clean the governor assembly. Inspect the driven gear for damage, or scoring on the polished surface of the governor body. Install a new governor shaft oil seal. It's at the bottom of the governor bore (arrow). This is the third possible location for trans/diff fluid inter-mix.

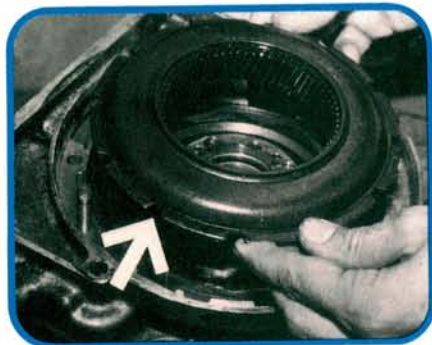
9

Remove the screw, gasket, and separation plate to get to the planetary gear set. Make sure the parking pawl is out of the way, then lift the reverse planetary ring gear and needle bearing out of the case. The parking pawl engages notches in the ring gear. Check the lock notches (arrow) for wear.

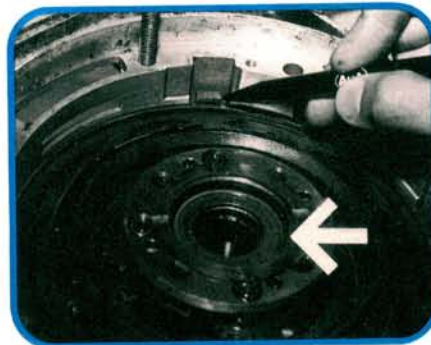
10

This retaining key (pointer) slots into the circlip and is used to retain the one-way clutch assembly. Don't forget it during reassembly. Remove the circlip, key, one-way clutch, and reverse planetary gear set. Check the planetary gear set's thrust washer (arrow) for wear.

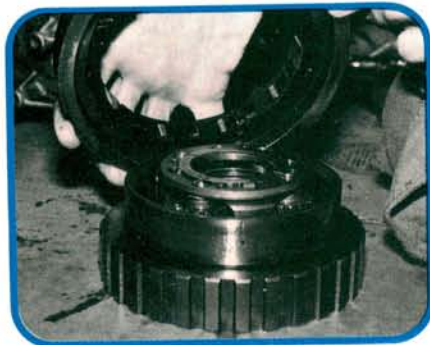
11

Inspect the rollers, springs, and all mating surfaces of the one-way clutch for wear. Pay attention to proper direction when you reassemble the one-way clutch rollers and springs. A properly assembled one-way clutch will let the reverse planetary gear set turn in only a clockwise direction.

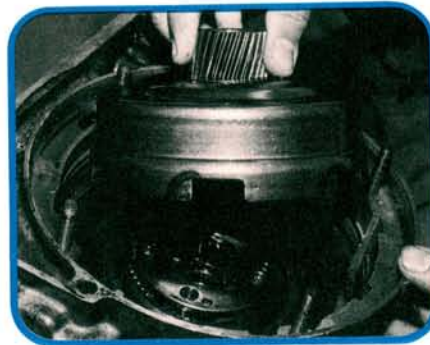
12

Notice the position of the double sun gear as you remove the drive shell. The shorter end of the gear faces the forward planetary gear set. This turbo 087 transmission has four forward planetary pinions, all other models use three.

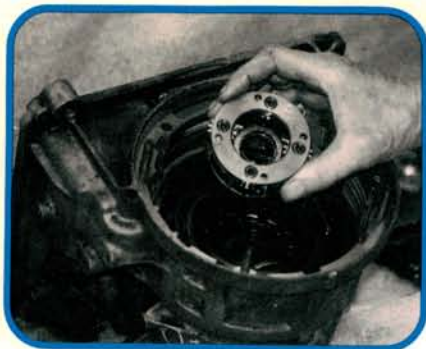
13

Remove the forward planetary gear set and needle thrust bearing. Inspect the planet pinion gears for wear or chipping, also loose or worn pins. Check the needle thrust bearings and contact surfaces closely for wear. Pinions are staked to the carrier, so worn parts must be replaced as an assembly.

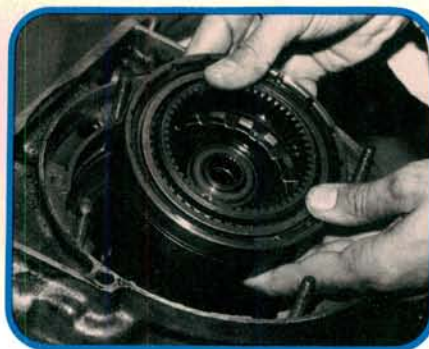
14

Remove the forward clutch. Disassemble the clutch assembly, keeping all related parts in order for easy reassembly. The forward clutch uses a single diaphragm spring instead of coil springs. Check the spring for finger wear, distortion, or hairline cracks. It's convex side faces the clutch bottom.

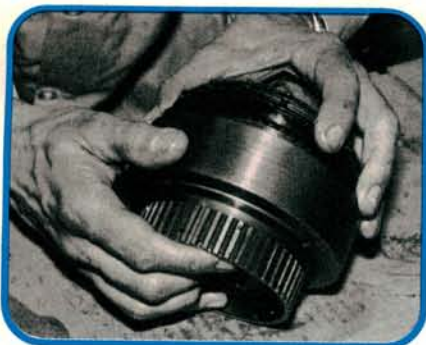
15

Reinstall the thrust plate and one friction plate under the ridge on the forward planetary ring gear. Install the rest of the plates and the waved circlip. Recommended assembled stack clearance is 0.5-0.9 mm (0.020-0.035 in). Selective pressure plates are available to adjust clearance.

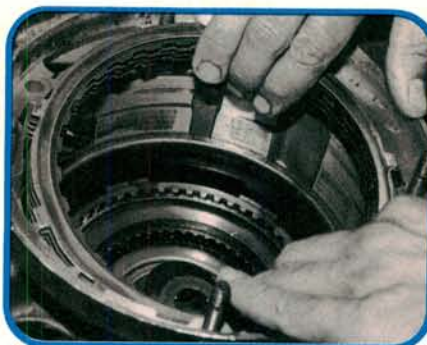
16

Remove the first/reverse clutch plates and inspect them for wear. Replace any steel plates that are burned, warped, or cone shaped. Loosen the second gear brake band lock nut, then remove the adjusting screw and push rod. Remove the retaining circlip while pushing in the band servo piston cover.

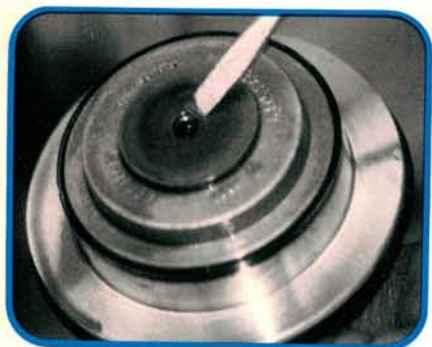
17

Early servo push rods are attached to the piston with a small circlip. Later push rods and all replacement parts have a riveted push rod. With the servo piston out of the way, pull the second gear brake band out of the case. Inspect the band's friction surface for heat damage.

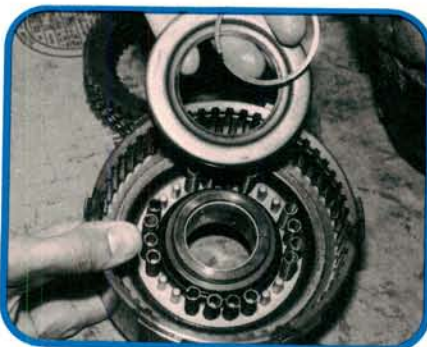
18

Remove the direct/reverse clutch assembly. Use a clutch spring compressor to remove the retaining ring. Check the return springs for distorted or collapsed coils. Also note spring spacing on the piston—it varies among transmission models. Inspect the other clutch components for wear.

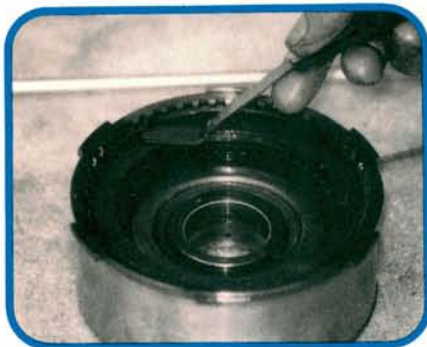
19

Reassemble the direct/reverse clutch, then measure the clearance between the selective circlip and the pressure plate. Recommended stack clearance for this 087 turbo transmission is 2.05-2.50 mm (0.081-0.098 in). Check a service manual for specifications on other transmission models.

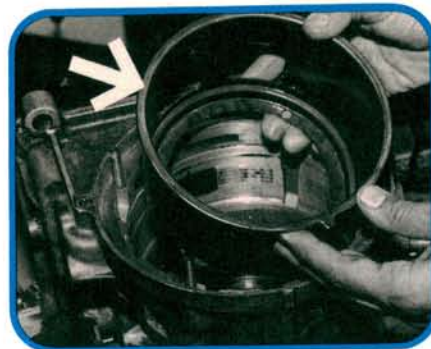
20

Remove the five oil pump bolts, then remove the first/reverse return spring plate, apply shell (arrow), and transmission oil pump. Inspect the pump oil rings, oil ring grooves, and thrust washer. Remove the first/reverse brake apply piston, then clean up the empty transmission case.

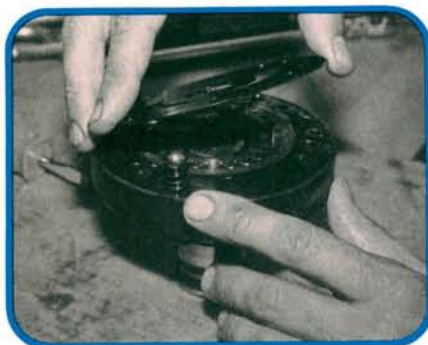
21

Remove both oil pump cover plate screws. Hold the plate down as you loosen the screws. The heavy pressure relief spring and 11 mm check ball will go into orbit if you don't. Check the back of the cover plate for wear. Disassemble the pump in a clean work area; dirt will kill it in a hurry.

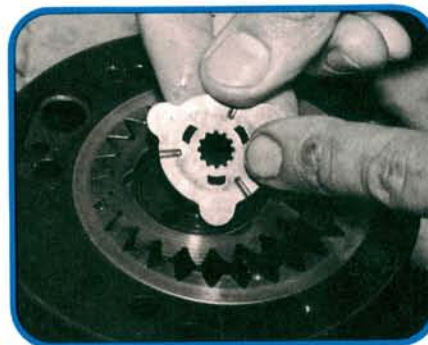
22

Inspect the pump gears for cracks, scoring, or galling. The center drive plate may crack if the transaxle is bolted to the engine with the oil pump drive shaft only partially engaged. The notched side of the drive plate and both pump gears must be installed facing the pump cover plate.

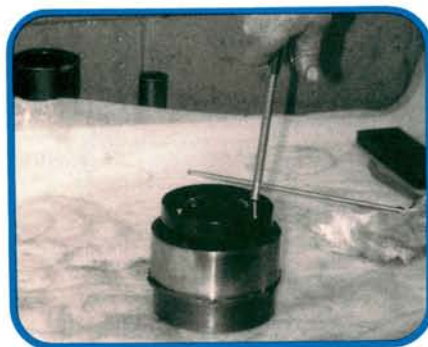
23

Assemble the oil pump, direct/reverse clutch, and forward clutch on the bench. Use compressed air to check the clutch seals and oil rings for leaks. It's better to find a leaking seal now, rather than after the transmission is back in the car.

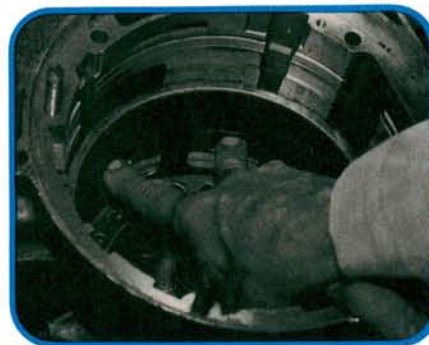
24

Reinstall the first/reverse brake piston, oil pump, first/reverse apply shell, and spring plate in the case. The two notches in the apply shell must face the openings in the case. A locator tab on the shell helps line it up. Torque the pump retaining bolts to 7 Nm (62 in-lb).

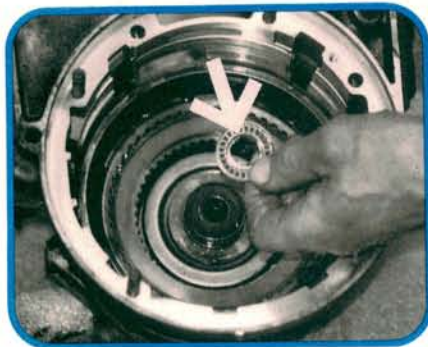
25

Several thrust washers and bearings are used in 08-series transmissions. Inspect each during teardown and replace any that are worn. This axial needle bearing (arrow) sits on top of the oil pump. Make sure both of its matching thrust washer lugs face the bearing.

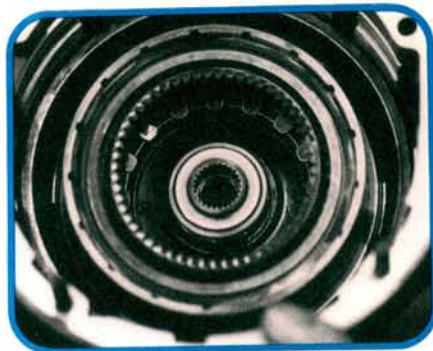
26

Install the brake band, direct/reverse, and forward clutch assemblies. All direct/reverse friction discs must engage the hub of the forward clutch. The forward clutch should make a solid clunk when it bottoms against the direct clutch. It will sit too high in the case if you miss one.

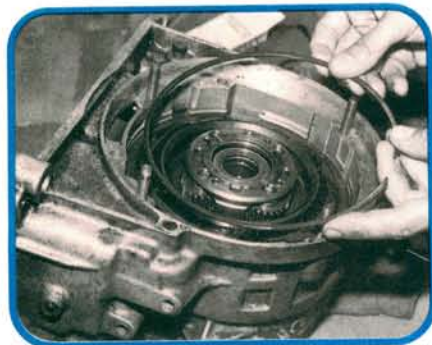
27

Reinstall the rest of the internal transmission parts. Install the short end of the sun gear facing the forward planetary gear set. Install the one-way clutch retaining key in its groove, then install the large circlip. If the circlip won't fit easily, something isn't properly installed.

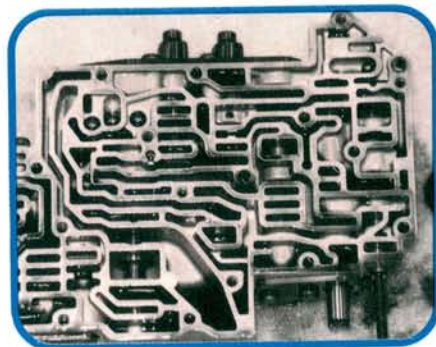
28

A complete valve body overhaul isn't always necessary. A good cleaning in mineral spirits and fresh spacer plate gaskets will usually do the trick. Don't take a chance if the transmission has been heavily damaged, however. Keep all valves and springs in order on a clean, lint-free cloth.

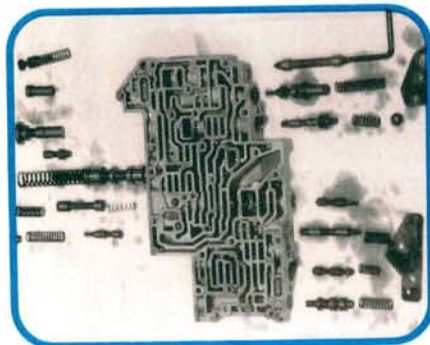
29

Flush all valve body passages with mineral spirits, then dry with compressed air. Each control valve should move freely in its bore. Improperly torqued valve body bolts can cause control valve seizures or hydraulic circuit leaks.

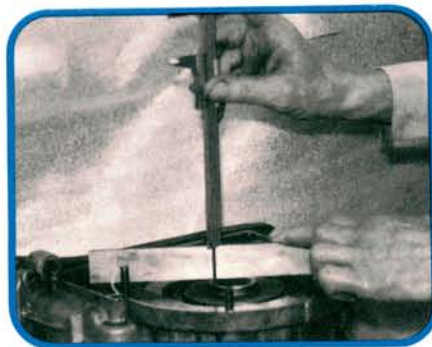
30

This photo shows one of the two measurements required to select the correct end play shim. If you haven't replaced any hard parts, assembled end play will usually be within specs. Consult a manual for end play shim selection procedures and an available shim table.
