# Volkswagen Transaxle Repair

The Volkswagen transaxle covered in this article has been with us in this basic form since it was used in the first VW Rabbit way back in 1975. It's been through some changes and modifications since that time, but old and new units are very similar in their basic design. And there sure are a lot of them out there.

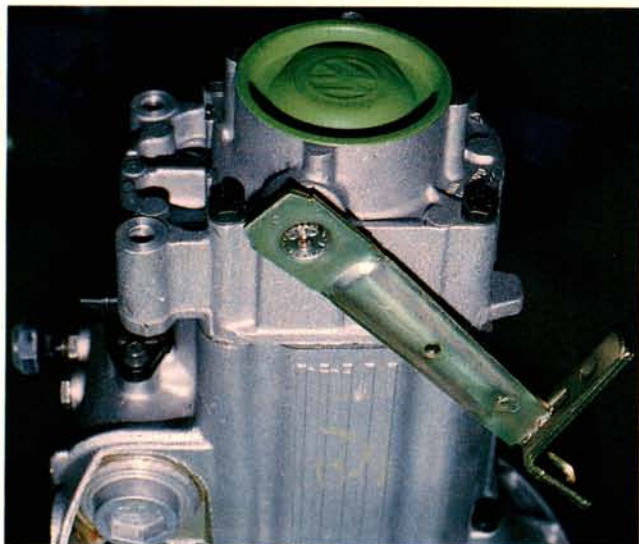
# 1

Remove the clutch push rod from the mainshaft. Bolt a bar across the bell housing that has an adjustable center bolt to support the mainshaft. Insert a spacer (copper or brass) between the end of the mainshaft and the adjusting bolt. Turn the bolt and spacer in until they just contact the end of the mainshaft.

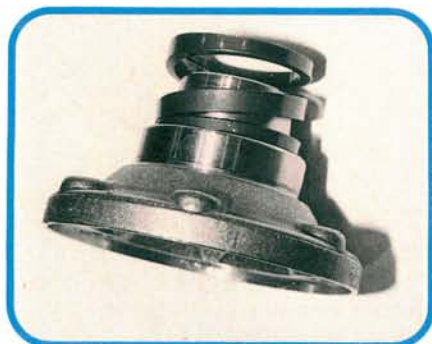
# 2

Now remove the final drive flanges. The noise reduction springs behind the flanges look like they once supported a small truck or a hay wagon. We'll need to compress the flanges against these springs so we can remove the circlips holding them to the final drive output shafts.

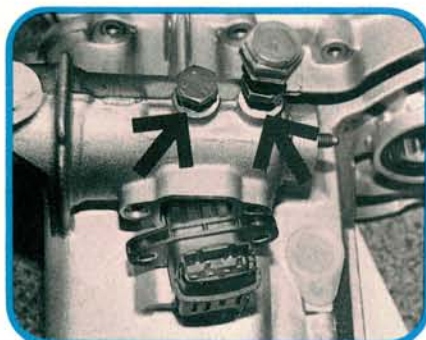
# 4

Remove the fifth gear detent plunger and shifter peg bolt. Also remove the back-up/upshift light combination switch. Check the plastic teeth on the backside of the switch to be sure none of them are missing or badly worn. Whenever possible, a test of the lights during the road test is a time saver.

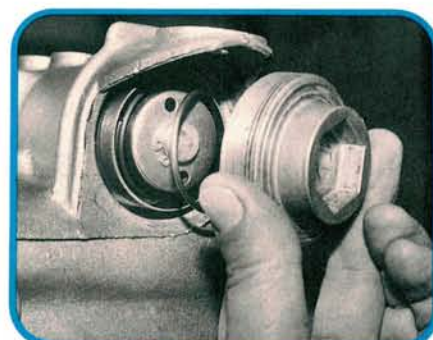
# 5

If possible, shift the trans to neutral. Unscrew the selector shaft retainer with a 27 mm hex head. Careful, there's a big bad spring hiding behind the cover. On 1985-86 models there was a small vent hole in the case above the plug. Make sure it's not full of debris or the tranny won't breathe.

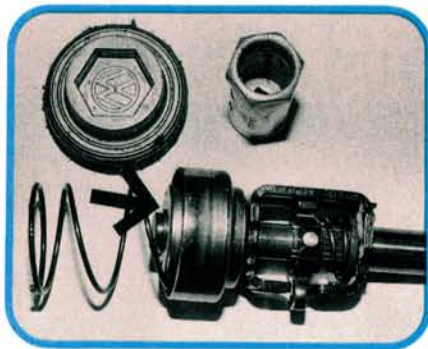
# 6

If the trans won't shift to neutral, you'll have to remove the selector in pieces. Carefully remove the snap ring on the retainer cup. We repeat, be careful! There's an even bigger, even badder set of springs in there that will send the cap and snap ring into never-never land. Trust me on this one.

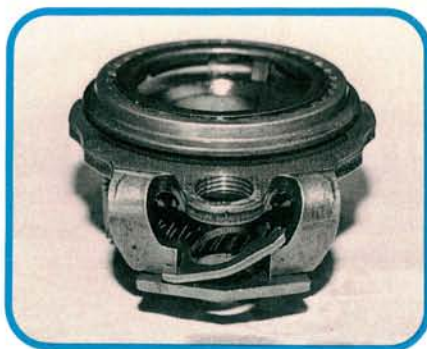
# 12

Remove the fifth gear synchronizer assembly. Then you can remove the four 5 mm internal hex head bolts directly beneath it that hold the clamping plate to the trans case. Also remove the circlip, washer, and fifth gear from the pinion shaft. You'll probably need a gear puller to remove fifth gear.

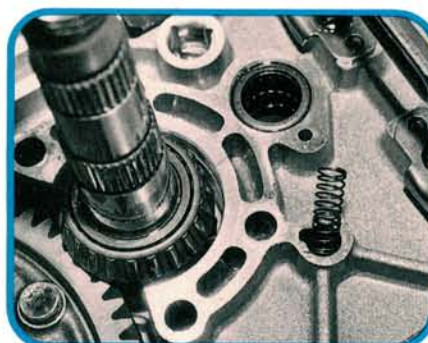
# 15

Disassemble the trans following the procedures in the repair manual. As you remove the shift fork pivot from its bore in the lower case half, keep track of this spring. If you put it somewhere for safekeeping, don't forget to reinstall it later.

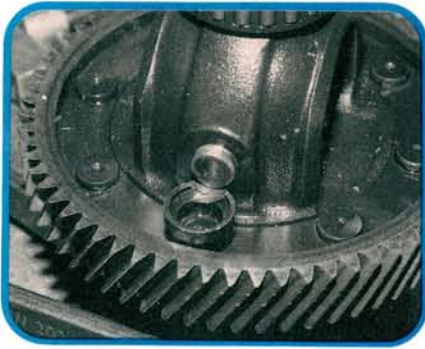
# 18

The problem with the cup-retainer design is that the shaft moves back and forth against the retainers in response to centrifugal force. The shaft acts like a battering ram. Gradually, it eats away at the cups until that same centrifugal force slides the shaft out far enough for it to hit the transaxle case. The chips fly as the differential carrier becomes a lathe.

Here's a better view of a damaged retainer cup. Once the pinion shaft has eaten through the cup as it's done here, centrifugal force throws the pin out far enough for it to come in contact with the case. You can see all the aluminum chips thrown up as the shaft ate at the case.

The replacement pinion shaft kit from Volkswagen wisely replaces the new with the old and contains two snap rings that fit in machined grooves in the shaft, preventing a recurrence of this problem. Some of the transaxle cases have been eaten all the way through, requiring some serious welding, or replacement of the

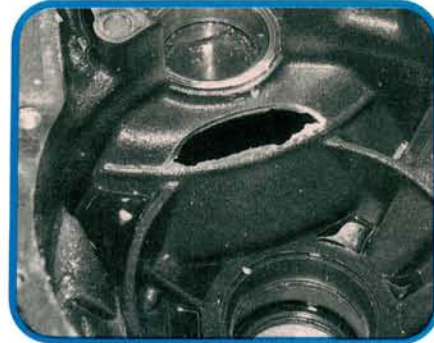
# 19

case. We'll show you a photo of an extreme case, no pun intended.

We promised you a photo of a case that was severely damaged by a runaway pinion shaft. Our host shop gives the customer the option of welding a hole like this, or of replacing the case. As bad as this is, they said they've welded a number of cases with damage this bad, and put them back in service.

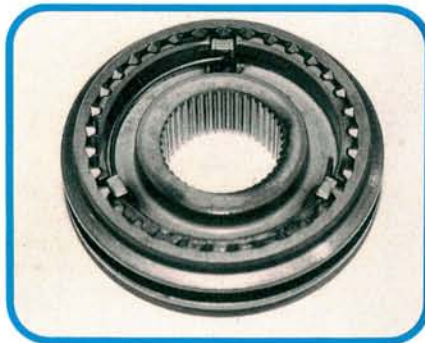
# 22

Engage fifth gear. Lift up on the operating sleeve just enough to take out any free play in the assembly. The inner edge of the operating sleeve should be 1 mm below the bottom face of the synchro hub. Adjust it by turning the threaded sleeve. Install a new lock clip and squeeze it tight to lock the adjustment.

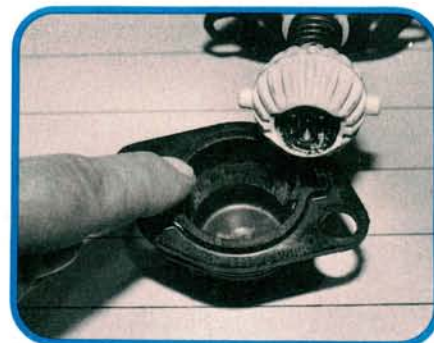
# 23

- **Reverse gear can be engaged without overriding the lockout mechanism.** Wear or distortion of the shift linkage housing, or shifter ball and socket allowed the driver to select reverse without overriding the reverse lockout. Grab the shifter and try to move it up and down. There should be no more than one millimeter

of up and down movement in the shifter. If there is more than one millimeter of up and down play, check the shifter ball and socket for excessive wear.

No transaxle overhaul is complete without a careful examination of the shifter ball and socket. Normal wear and lack of lubrication result in these chatter marks in the socket. This one was so loose that it was possible to select reverse gear without overriding the lockout mechanism.

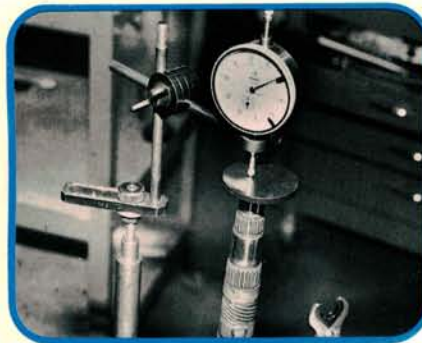
# 26

Rig your dial indicator as shown. Preload the gauge about 1 mm. Move the shaft straight up and down (do not turn the shaft or the reading will be inaccurate). Record the total travel (free play). Add the amount of free play plus 0.20 mm to the original thickness of the installed shim.

Figuring which selective shim to install is really very easy. Let's say we got a reading of 0.40 free play with our 0.65 mm starter shim installed. That means that a shim 1.05 mm thick (0.65 plus 0.40 mm) would eliminate all free play.

But we still wouldn't have any preload on the bearing at this point. Since the factory recommends 0.20 mm bearing preload, we need a shim 0.20 thicker than 1.05 mm, or a shim 1.25 mm thick.

Sixteen shims are available from 0.65 to 1.40 mm in 0.05 mm increments. Remove the bearing race again, and the 0.65 mm starter shim. Install the proper shim, and reassemble pinion and retainer. Same torque as before on the retainer bolts.
