Nissan Sentra

5-Speed Transaxle Repair

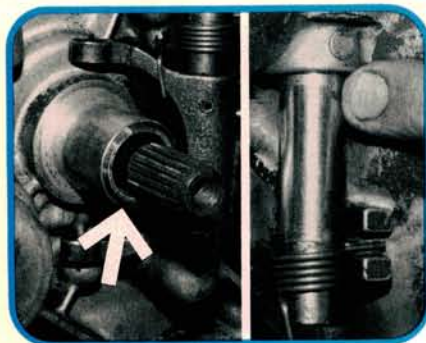
1

Take a look at the clutch housing's snout (left photo). Heavy clutch use can wear the aluminum casting, causing the release bearing to bind. Housing replacement may be the only cure in some cases. Clutch grit in the clutch shaft bushings (right photo) can cause stiff clutch pedal action.

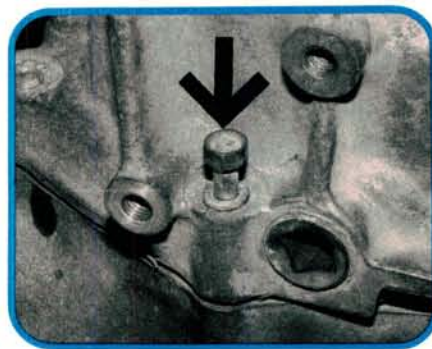
2

Drain the transaxle and give it a thorough cleaning before beginning your disassembly. Check the case and seals for signs of fluid leakage or other external damage. Remove the transaxle case bolts. They're all the same length except for this longer one next to the filler plug (arrow).

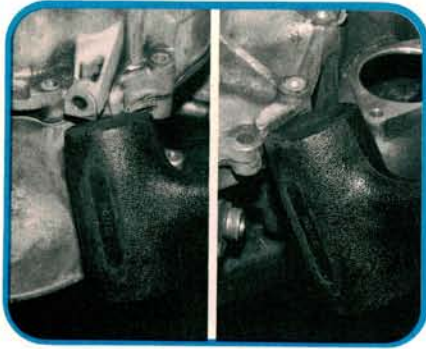
3

RTV sealer and two aligning dowel pins between the case halves do a good job of holding everything together, even after the bolts are removed. There are two spots on the transaxle case where you can safely tap with a soft-faced hammer to break the seal. Chisels and screwdrivers are off limits.

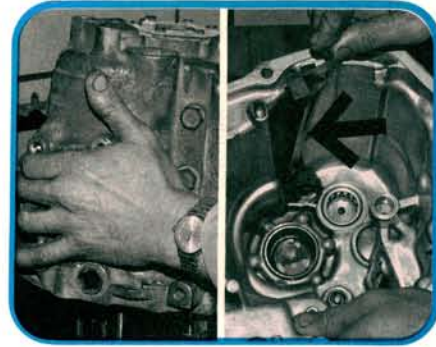
4

To remove the transaxle case, lift and turn it counter-clockwise to the eleven o'clock position. Now tilt the case to the left to keep the oil gutter from hanging up on the fifth gear shift fork. Note the position of the gutter (right photo). The transaxle won't last long if it's left out.

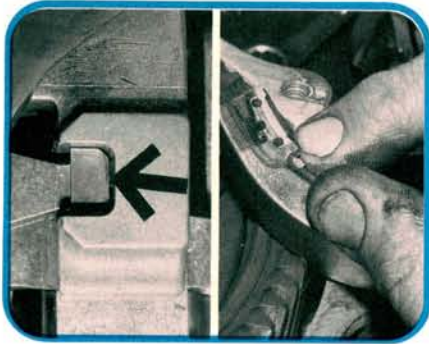
5

Slide the shifter shaft out of the shift forks and check it for wear. Remove the fifth and third/fourth gear shift forks, noting the location of the shifter caps (left arrow). Early transaxles used three caps. Later models omitted the cap on the fifth gear selector. Check the forks for wear (right photo).

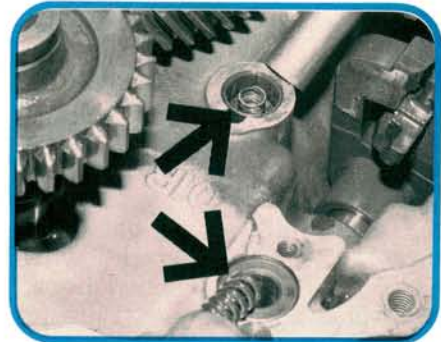
6

Remove the shift control mounting bolts, then remove the shift control along with the first/second shift fork. Remove the shift detent check ball, check ball plug, check ball spring, and fork shaft support spring (arrows) from their holes in the clutch housing.

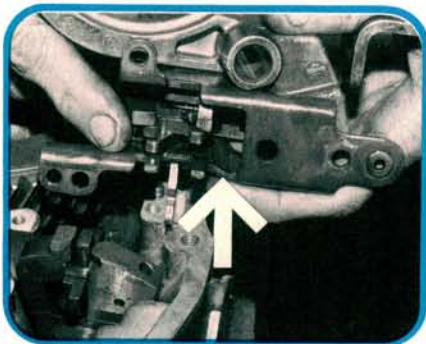
7

The stamped steel shift control assembly and aluminum shift forks can be a source of trouble. If the transaxle is hard to shift and your inspection of the other transaxle parts doesn't turn up anything else, one of these parts is probably distorted. Distortion is very difficult to detect with a visual inspection.

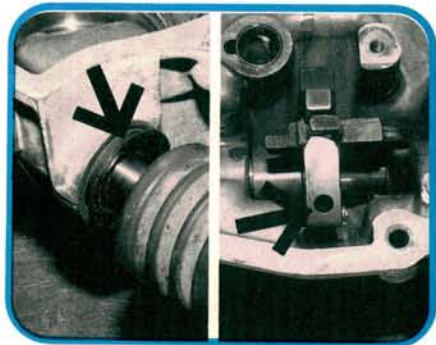
8

The striking rod seal can be replaced by removing the retaining pin and linkage outside the transaxle (left arrow). We left the striking rod and the rest of the shift linkage where they were, since they almost never cause problems. Early transaxles had a select check ball and spring in this hole (right arrow).

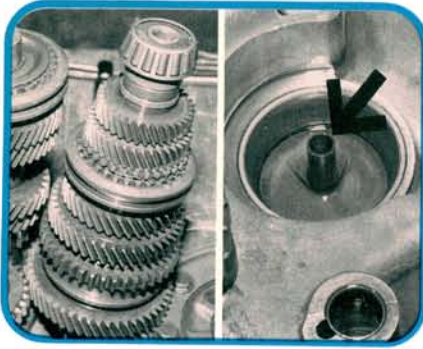
9

Carefully tilt the mainshaft away from the input shaft (left photo), then lift it up. If the main shaft is tilted too far, the plastic oil channel (arrow right photo) that's mounted under the mainshaft bearing race may break off. Lift out the final drive assembly and set it aside.

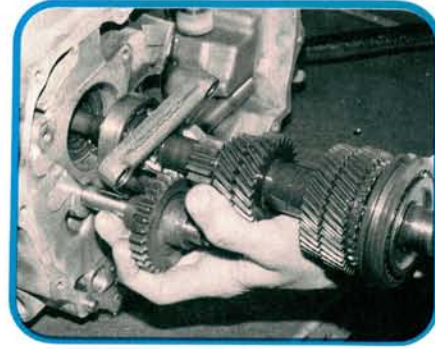
10

Remove the input shaft bearing retainer bolts. A notch in the retainer also holds the reverse idler shaft. Turn the clutch housing on its side and drive the input shaft and front bearing out of the housing by tapping on the input shaft with a soft-faced hammer. Remove the reverse idler gear and its spacer.

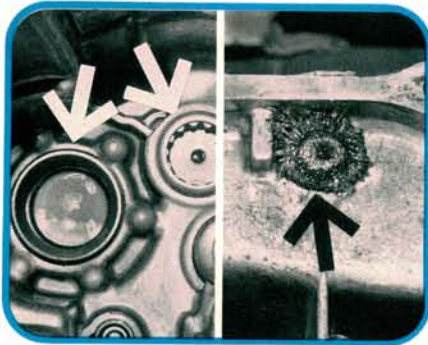
11

Check the transaxle bearings and races for wear. Dirty or low gear lube level will usually kill the rear input and mainshaft bearings (left arrows) first. Clean the case halves in a parts washer. The magnetic drain plug (right arrow) should give you an idea of how much wear to expect.

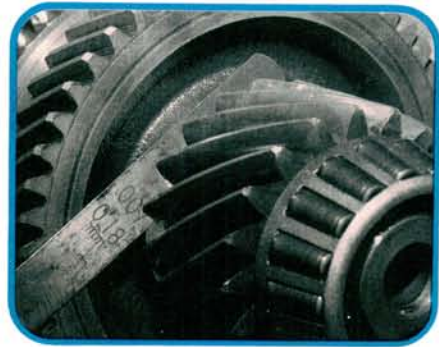
12

Check input shaft and mainshaft gear end play before disassembly. Mainshaft first gear end play should be 0.18-0.31 mm (0.0071-0.0122 in). End play for the mainshaft second, third, and fourth gears should be 0.20-0.40 (0.0079-0.0157 in). Input fifth gear end play should be 0.18-0.41 mm (0.0071-0.0161 in).

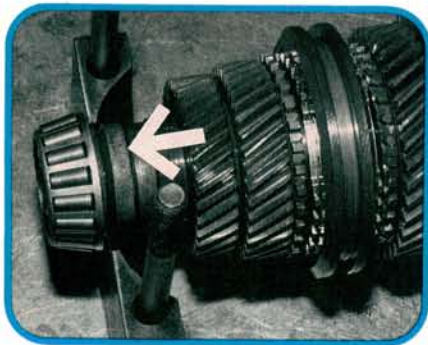
13

You'll need a press and the right size bearing splitters to disassemble the input shaft and mainshaft without damaging the gear teeth. Start by pressing off the rear mainshaft bearing. Mount the bearing splitter as shown to avoid damaging the selective C-ring holder.

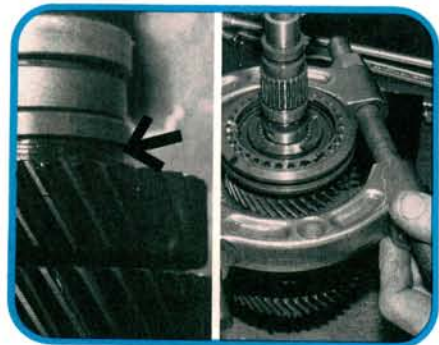
14

The first/second and third/fourth synchronizer hubs, as well as the fifth main gear, are all press fitted to the mainshaft. Attach the splitter under the flange on fifth gear (left arrow) to remove it. Push both synchronizer hubs off the mainshaft by mounting the splitter behind third gear, then first gear (right photo).

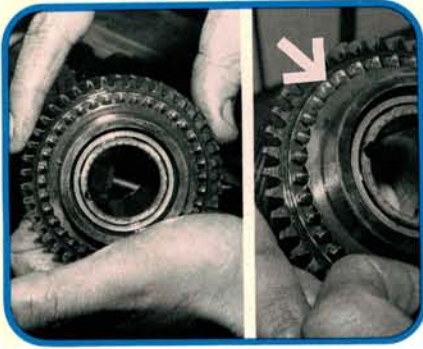
15

Inspect the mainshaft gears for wear and chipping. Gear edges that feel sharp to the touch (left photo) will sing under acceleration. First gear had been pretty badly hammered. Careless shifting had knocked the edges of several small gear engagement teeth (right photo).

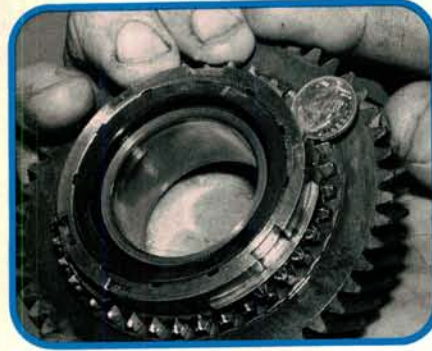
16

A dime can be used for a quick check of synchro ring clearance. Standard clearance for all synchro rings is 1.0-1.35 mm (0.039-0.0531 in). A new dime is about 0.050 inch thick and a worn one is close to the other end of the specification. Maximum wear limit is 0.7 mm (0.028 in). Measure the clearance in several spots.

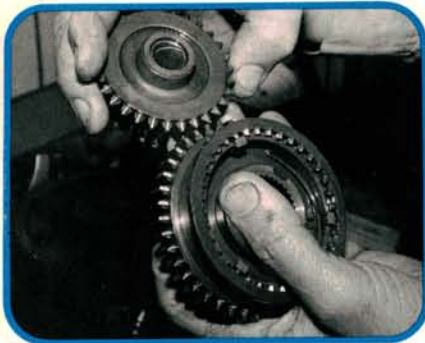
17

Check the synchronizer hubs, shifting inserts, and coupling sleeves for wear. The first/second coupling sleeve is also the reverse main gear. Check its teeth, along with those on the reverse idler gear for wear. Judging by the ground off teeth, this transaxle's owner must have done lots of rolling reverse shifts.

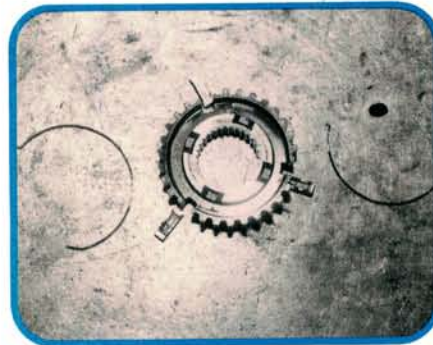
18

Replace any worn parts, then reassemble the synchronizer hubs and coupling sleeves. The spread springs must be hooked to the shifting sleeves in the position shown. Make sure the spread spring on the front side of the hub isn't hooked to the same shifting insert as the rear spread spring.

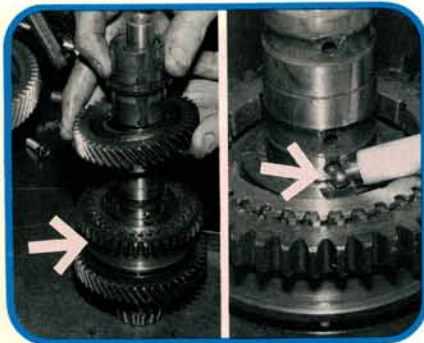
19

Reassembly of the mainshaft is the reverse of disassembly. Make sure the first/second coupling sleeve fork groove (left arrow) faces toward first gear. Steel balls locate the second/third and fourth gear (right arrow) bushings on the mainshaft. If the balls won't fit, the gears aren't on right.

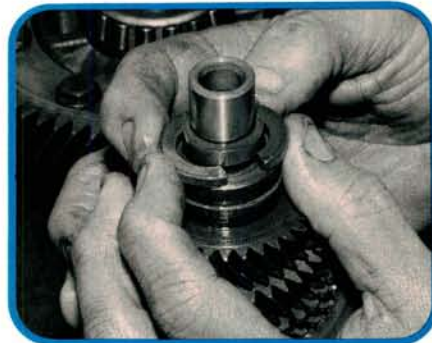
20

Install the mainshaft thrust washer after the mainshaft fifth gear has been reinstalled. Reinstall the selective C-rings above the thrust washer. Clearance between the C-rings and their groove in the mainshaft should be 0-0.1 mm (0-0.004 in). Reinstall the mainshaft rear bearing.

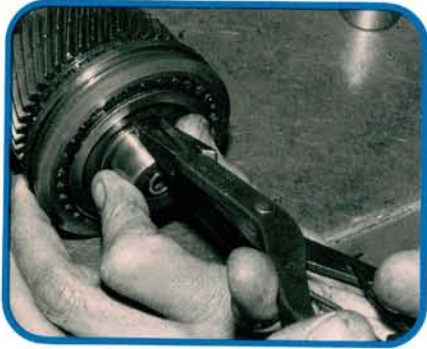
21

Remove the rear input shaft snap ring, then press off the fifth input gear and synchronizer hub. Inspect the parts for wear. The synchronizer hub and coupling sleeve are machined on both sides, although only one side is used for fifth gear. Flip both parts over to use the fresh side.

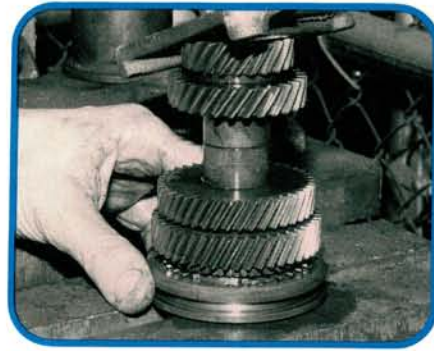
22

Use the press to reinstall the fifth input gear and synchronizer hub on the input shaft. Reinstall the stopper plate and snap ring, then measure the clearance at the input shaft groove. Allowable clearance is the same as mainshaft C-ring clearance. Four different selective snap rings are available.

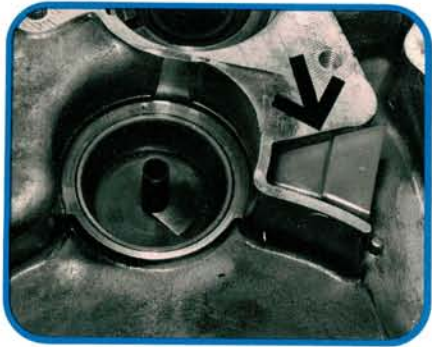
23

Use the proper puller if the front mainshaft bearing and race are being replaced. There's very little room between the plastic oil channel and the underside of the bearing race. Always reinstall the oil channel with its oil groove facing toward the oil collector pocket above it (arrow).

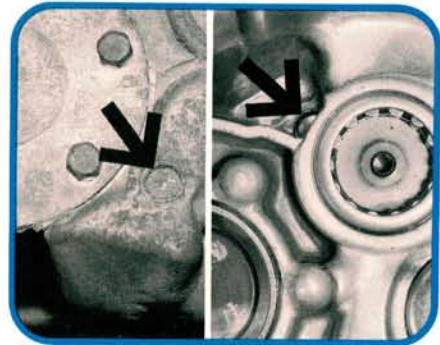
24

Drive out this welch plug (left arrow) from the inside of the case to replace the rear input shaft bearing. Removing the plug exposes a corner of the bearing (right arrow) so that it can be pushed out of the case with a punch. Too much RTV on the welch plug may block off the supply of oil to the bearing.

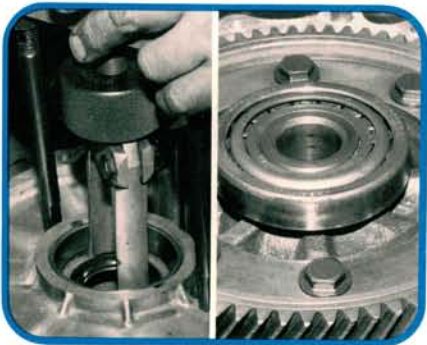
25

Differential side bearing preload needs to be checked and adjusted if new side bearings, a differential case, or either of the transaxle case halves has been replaced. Remove the side bearing race and selective shim from the transaxle case (left photo). Place the race on the differential side bearing (right photo).

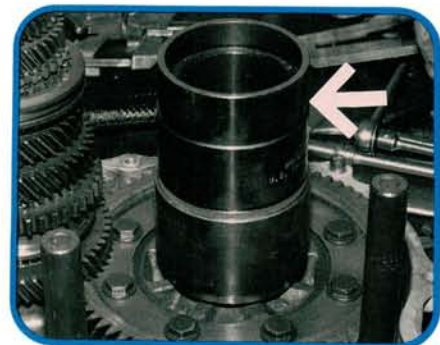
26

This dedicated Kent-Moore differential preload shim selector (arrow) mounts between the side bearing race and the transaxle case. The selector's four spacers and long bolts are placed evenly around the clutch housing, then torqued to 16-21 Nm (12-15 ft-lb).

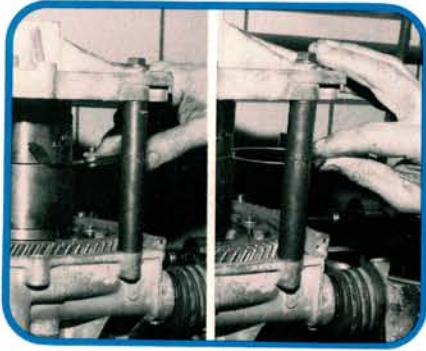
27

Rotate the final drive several times to seat the side bearings. Measure the widest gap around the tool using a feeler gauge (left photo). The gap measurement is the correct preload shim thickness. Preload shims can also be used for measuring the gap (right photo). Eleven different preload shims are available.

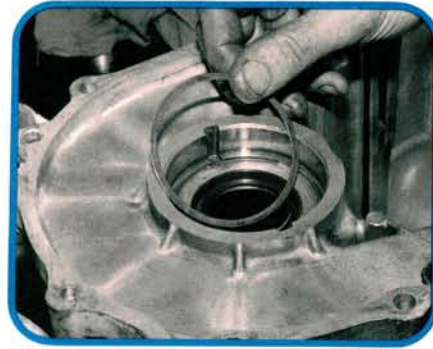
28

Remove the shim selector gauge assembly, then reinstall the selected preload shim and side bearing race in the transaxle case. If new side bearings were installed, temporarily install the transaxle case over the final drive. Torque the case bolts to 16-21 Nm (12-15 ft-lb).

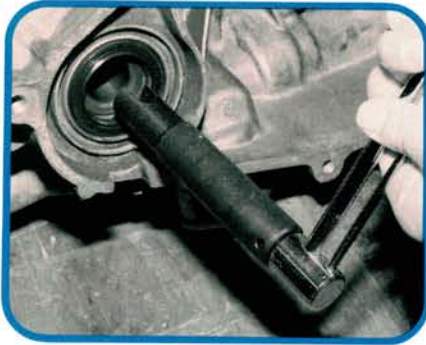
29

Slide the Kent-Moore Preload Adapter into the final drive, then rotate it at least ten times to seat the side bearings. Attach an inch-pound torque wrench to measure the turning torque. Readings should be between 4.9 and 74 Nm (43-65 in-lb) with no binding, and with no more than 1.0 Nm (8.7 in-lb) variance.

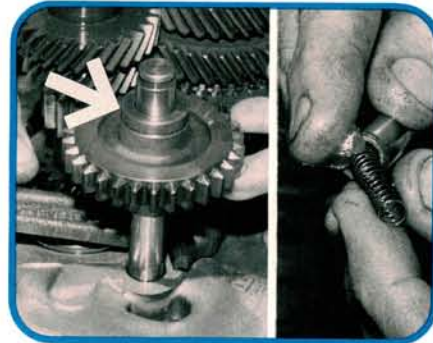
30

Input shaft and mainshaft reinstallation is the reverse of removal. Don't forget to reinstall the reverse idler gear and spacer (left photo) before reinstalling the input shaft. Reinstall the shift control bracket, detent parts, and forks. A dab of grease holds the fork shaft support spring (right photo) during reinstallation.

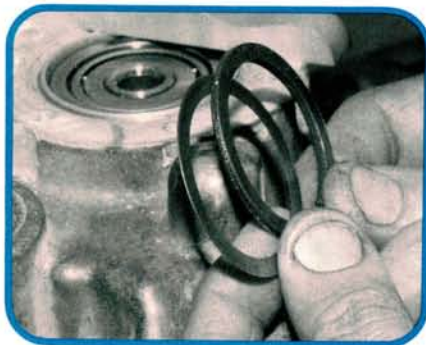
31

Apply RTV to the clutch housing mating surface, then reinstall the transaxle case and bolts (again). If the mainshaft, bearings, or case halves were replaced, the mainshaft bearing preload must be checked and adjusted. Remove the transaxle case cover, spacer, and adjusting shim.

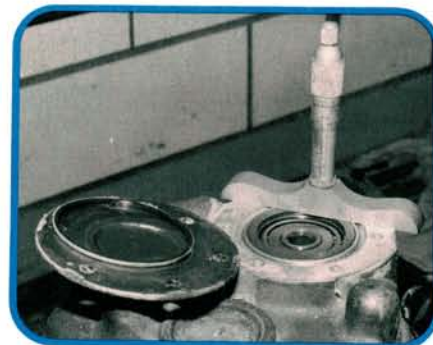
32

Use a depth micrometer to measure the distance between the case face and the rear surface of the mainshaft outer bearing race. A chart in the service manual converts the measured distance to the correct adjusting shim, including the right amount of bearing preload. Reinstall the shim first, then the spacer and case cover.
