Toyota W50 Transmission

We're gathered here today to say a few kind words about a venerable Toyota rear drive transmission called the W50. The W50 can be found in many late '70s and early '80s rear drive Toyotas (Celicas, Coronas, and 2WD trucks).

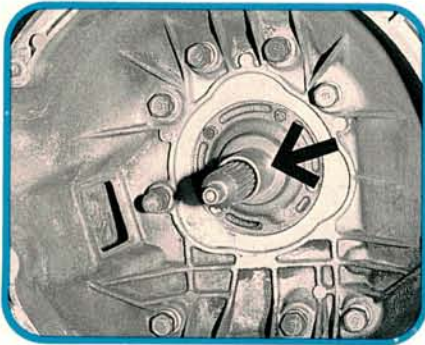
1

Remove the release fork and bearing. Check the front bearing retainer's sliding surface for wear. Then take a good look at the slave cylinder. Plenty of transmission damage can be caused by a leaking or sticking slave cylinder. Remove the bell housing bolts, then remove the bell housing.

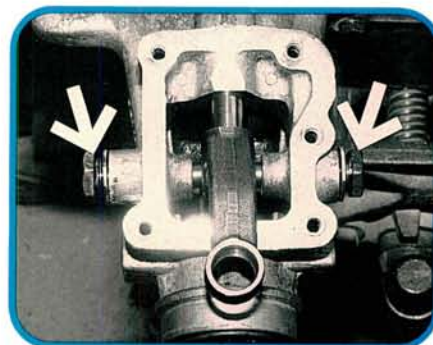
2

Remove the speedometer driven gear and back-up light switch. These steps aren't mandatory, but they make it easier to remove the extension housing and center case housing. Remove the shift lever retainer, then remove the caps, washers, springs, and restrictor pins (arrows) on either side of the shift lever.

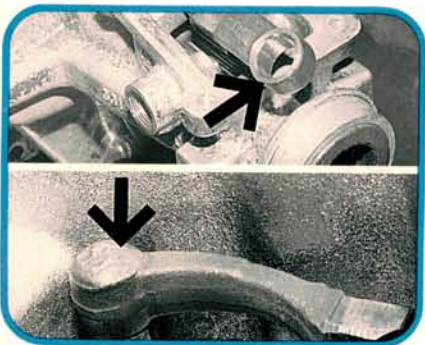
3

Remove the extension housing bolts. Turn the shift lever counterclockwise, then pull off the extension housing (upper photo). It may take some persuasion from a soft-faced hammer to get it moving. Flip the extension housing over and inspect the weld on the end of the shift lever (lower photo).

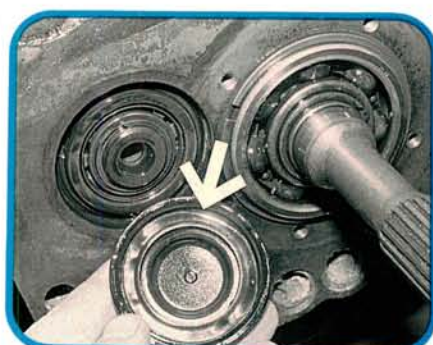
4

Remove the front bearing retainer, gasket, and countershaft bearing cover. Don't lose the countershaft bearing shim that's hidden under the cover. Remove both front bearing snap rings, then separate the center case from the intermediate bearing plate (no chisels please).

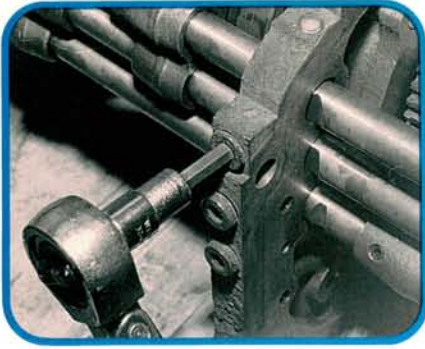
5

Mount the intermediate bearing plate in a vice using soft jaws or two blocks of wood. Clean the rust out of the hex-headed detent spring plugs before trying to remove them. A dab of valve lapping compound on the tip of your hex bit will improve your grip. The thin-shouldered plug goes on top during reassembly.

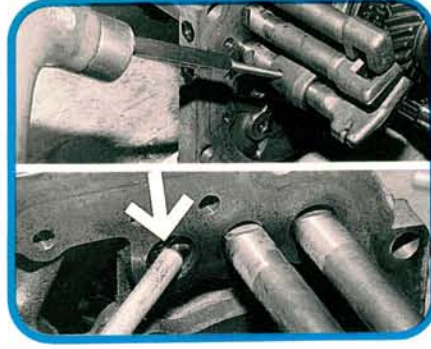
6

Remove the detent springs and balls, then drive the roll pins out of the shift forks (upper photo). Remove the selector shafts, starting with the fifth/reverse shaft. Use a magnet to remove the interlock pins from the intermediate bearing plate (lower photo). Inspect the selector shafts for wear.

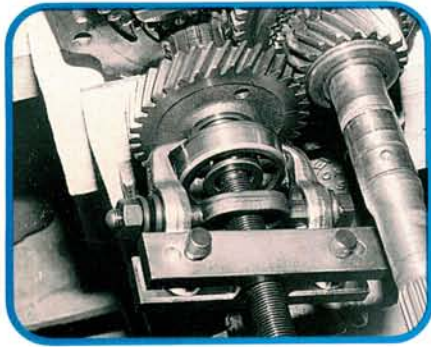
7

Gotten tired of reading "Remove the" yet? There's more. Remove the counter gear bearing snap ring, then use a puller to remove the counter gear rear bearing. You may need a puller to remove the countershaft fifth and reverse gears. A standard steering wheel puller will fit the holes in fifth gear. Ours slid off by hand.

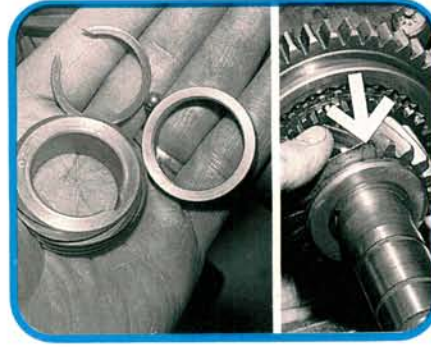
8

Remove the speedometer gear, snap ring, locating ball and spacer (left photo). Use a press or long-legged puller to remove the rear mainshaft bearing. Measure the fifth gear thrust clearance (right photo). Thirteen selective snap rings are available to adjust thrust clearance.

MAINSHAFT FIFTH GEAR THRUST CLEARANCE

Standard Clearance: 0.10-0.25 mm (0.004-0.010 in)
Maximum Clearance: 0.30 mm (0.012 in)

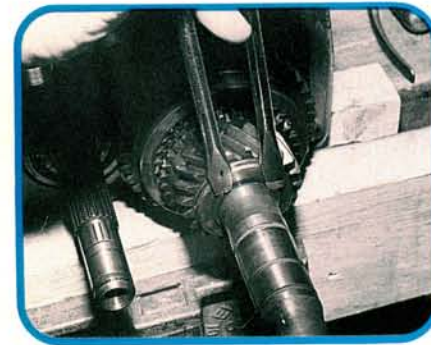
9

It takes two screwdrivers to remove the mainshaft fifth gear snap ring. Take careful aim and keep your eye on the snap ring. It likes to fly off to parts unknown. Remove fifth gear, then the fifth/reverse hub assembly. Don't drop the locating ball under fifth gear's inner race.

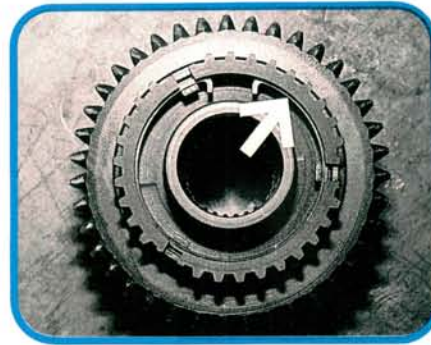
10

Disassemble the fifth/reverse hub assembly on the bench and check for worn synchronizer parts. This is the only hub that has this extra snap ring (arrow). The snap ring limits shift key travel and must be reinstalled facing the front of the transmission. Remember hub offset location during assembly.

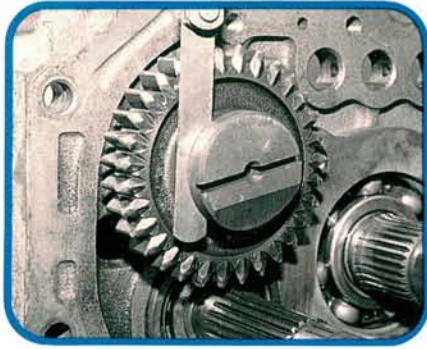
11

Measure the reverse idler gear thrust clearance. If the thrust clearance is too great, check for a worn spacer between the idler gear and the intermediate bearing plate. Reinstall the retaining clip with its bent corner facing away from the bearing plate.

FIRST, SECOND, THIRD AND REVERSE IDLER GEAR THRUST CLEARANCES

Standard Clearance: 0.15-0.25 mm (0.06-0.010 in)
Maximum Clearance: 0.30 mm (0.012 in)

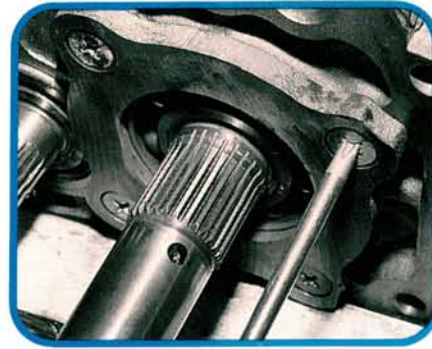
12

Use an impact driver to loosen the output shaft center bearing retainer bolts. Apply thread locker during reassembly. Remove the mainshaft intermediate bearing snap ring. Now push the output shaft and counter gear out of the bearing plate as an assembly. Soft-faced hammer persuasion may be necessary.

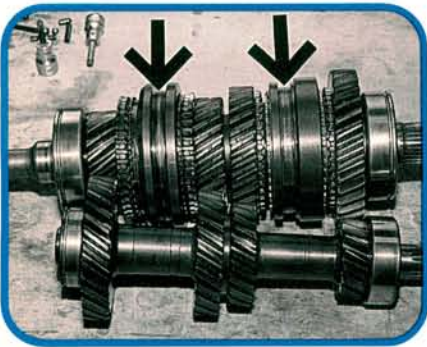
13

Check this photo of the mainshaft carefully before you dive in. The shoulders on the first/second and third/fourth hub sleeves are both offset and must be reinstalled as shown. Once you disassemble the mainshaft down to the synchronizer hubs, you'll find that they may be offset as well.

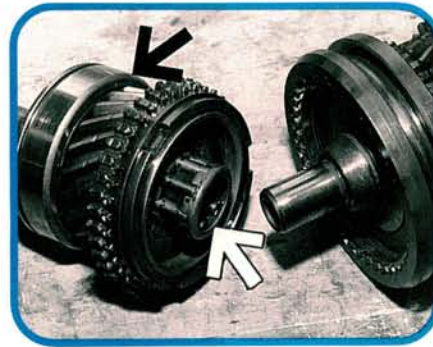
14

Separate the input shaft from the mainshaft. Check the internal needle bearings and races for wear (white arrow). You may need to change to a different snap ring thickness if the input shaft bearing is replaced (black arrow). A tight snap ring fit cuts axial play to a minimum.

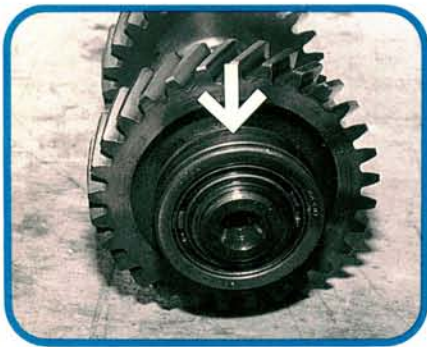
15

Check all the bearings carefully. Toyota technicians tell us that bearing failures are the most common problem in the W50 family. Countershaft and input shaft bearings usually lead the list. Sloppy bearings will increase the wear on other parts of the transmission. This transmission needed all new bearings.

The first components to feel the effects of this neglect are the bearings, and the countershaft bearings in particular. Bearing failure tops the W50's list of shortcomings.

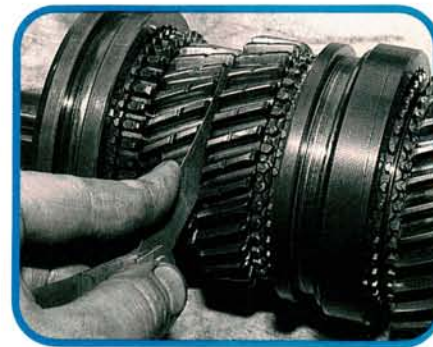
16

Measure the first, second, and third gear thrust clearances before disassembling the mainshaft. The third/fourth synchronizer hub and third gear are held in place by a selective snap ring, and are pressed off the front of the mainshaft. Everything that's left is pressed off the mainshaft from the rear.

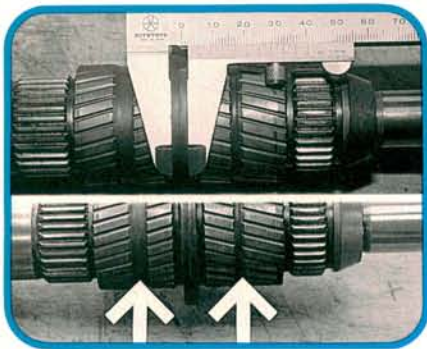
17

Inspect the mainshaft's gear and bearing contact surfaces for wear or damage. Minimum output flange thickness is 4.8 mm (0.189 in) (upper photo). Minimum gear bushing diameter is 40.8 mm (1.606 in) (lower photo). Use v-blocks and a dial indicator to check mainshaft runout (0.05 mm/0.0020 inch maximum).

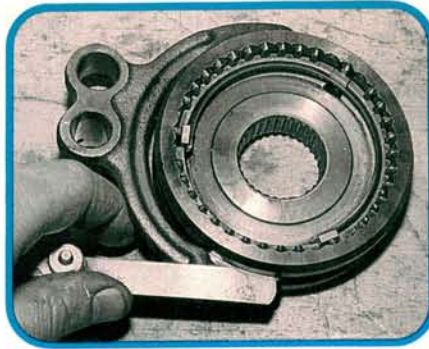
18

The three most important things on this transmission are end play, end play, and end play. Too much end play can cause the transmission to jump out of gear and puts extra stress and wear on the shift forks and hub sleeves. Clearance between the forks and sleeves shouldn't exceed 1.0 mm (0.039 in).

End play (or thrust clearance) is particularly important on the W50. It doesn't pay to take the transmission apart, throw some new parts at it, then put the whole thing back together without measuring and adjusting the thrust clearances to specifications. Excessive thrust clearance will play havoc with internal transmission parts and bring your transmission overhaul back to haunt you sooner rather than later.

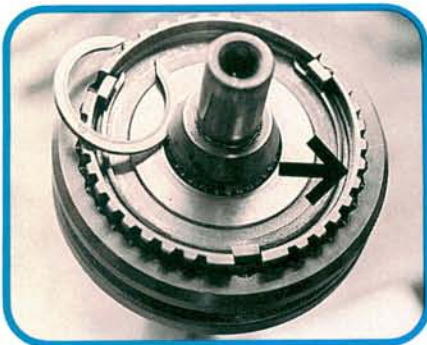
19

Worn bearings may cause a noise that sounds like marbles rolling around in the transmission. A replacement third/fourth synchronizer hub is available to correct a rattling noise during light acceleration in first or second gears between 2000 and 3000 RPM on W55 transmissions.

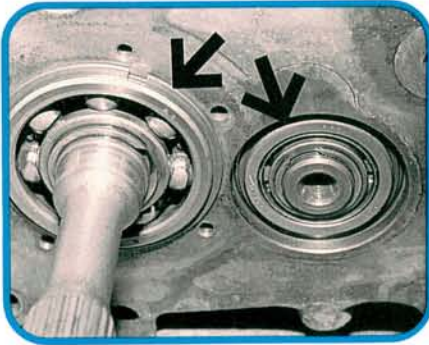
20

We'll hit the high spots instead of going through a step-by-step reassembly process, since we'll be retracing our steps for the most part anyway. The input shaft, center mainshaft, and front countershaft bearings are all installed with their snap ring grooves facing outward toward the ends of the shafts.

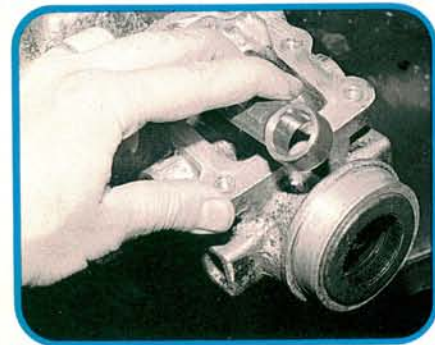
21

You've got to hold your mouth just right to reinstall the extension housing. The gear selector shafts must be in neutral. Rotate the shift rod counterclockwise, then push it all the way forward. Partially install the housing, then fish with the rod until the rod hooks up with the selector shafts.

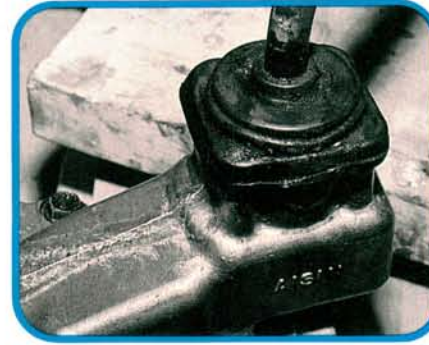
22

Finish installing the extension housing, then temporarily install the rest of the shift linkage. It's reassuring to know that all of the gears are engaging before the transmission goes back into the car. After the transmission is reinstalled, make sure the shift boot allows full engagement of all gears.
