TECH TIPS

FLOPPY A/C VENTS

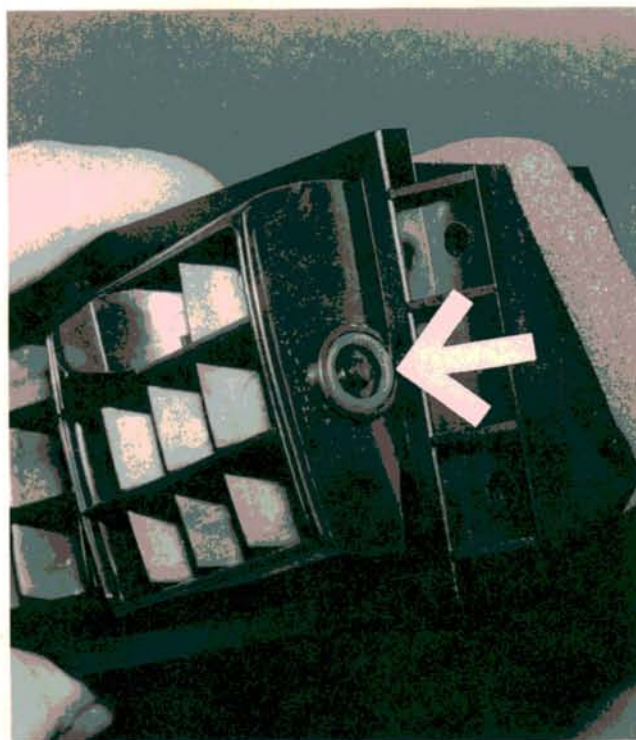
The air conditioning vents on Volkswagen Rabbits (and other cars too) can get loose and floppy over time. A loose vent can end up pointing at the floor or freezing your leg, instead of cooling the rest of the car as intended.

To correct this problem, remove the loose vent. Install two o-rings on each tab at the sides of the vent. The o-rings will put enough pressure on the vent housing to keep the louvers in position, while still allowing adjustment.
